**ROOFING CONDITION ASSESSMENT REPORT  
QUEEN'S GATE  
8500, 8520, 8560 AND 8580 GENERAL CURRIE ROAD  
RICHMOND, BC**

This Roofing Condition Assessment Report pertains to the Queen's Gate residential complex located at 8500, 8520, 8560 and 8580 General Currie Road, Richmond, BC.

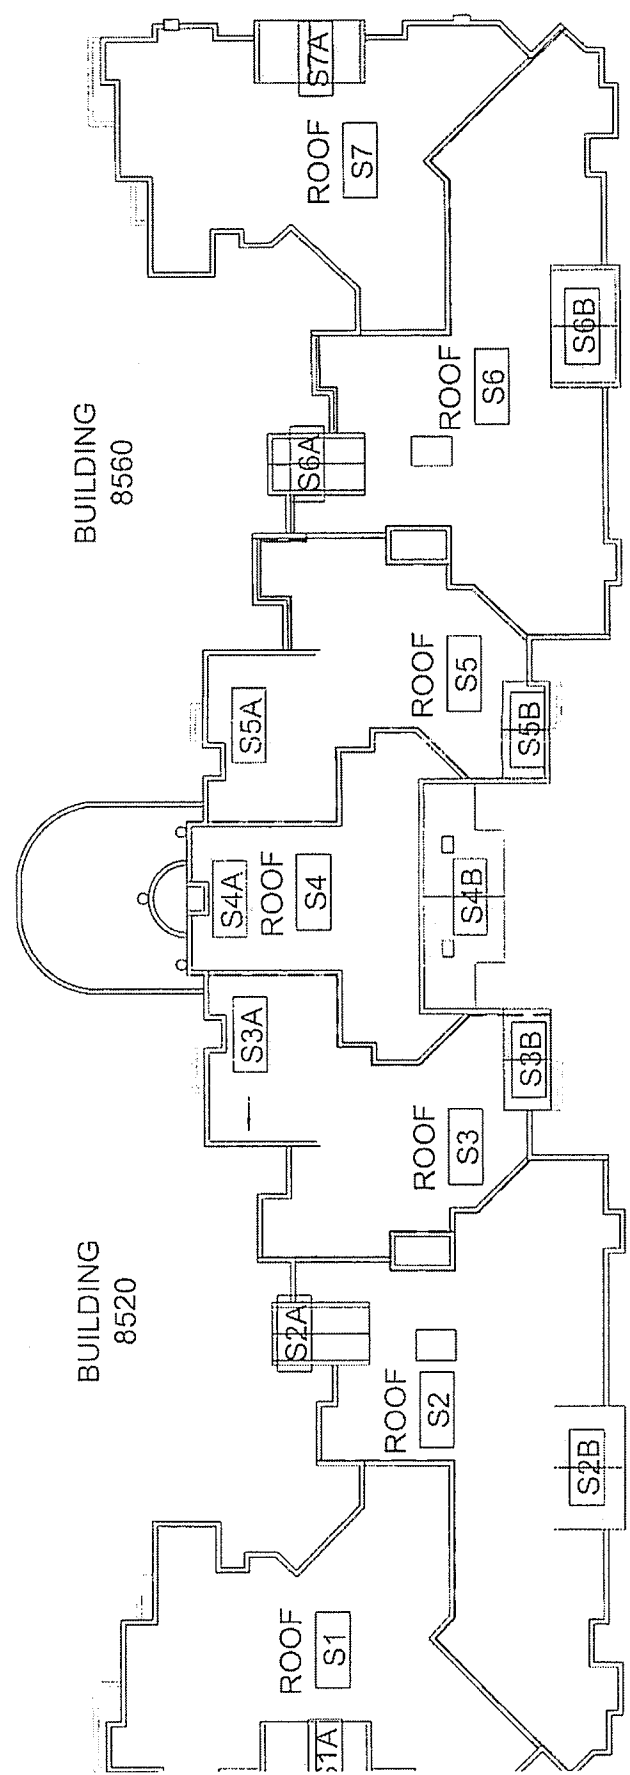
BUILDING 8520

- (2) LOOSE MEMBRANE AT GUTTER DRAIN
- (3) FASTENER INSTALLED THROUGH METAL CAP FLASHING

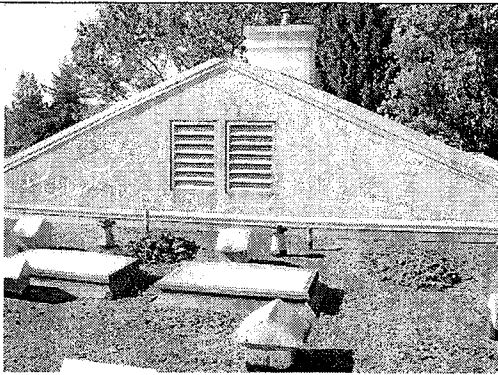
1

<p><b>Building 8520 Roof Area S1A</b></p> <ul style="list-style-type: none"> <li>Cracks in stucco wall sealed with caulking as part of ongoing maintenance.</li> </ul>
2

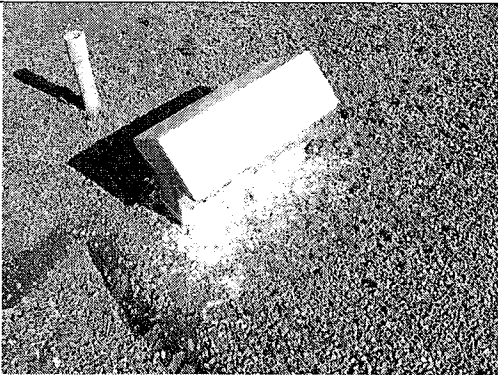
- Bird screen at the dryer vents were clogged with lint (Photo 2). Lint build-up can prevent moisture laden air from discharging causing moisture to migrate internally. Lint build-up can also create a fire risk. Further, the ducting at several vents was observed to be too low (Photo 3), missing or incomplete bird/insect screen (Photo 34), and one duct was observed to be off set to the vent box at Roof Area E4 (adjacent to the roof access hatch), which will restrict air flow.

<p><b>Building 8520 Roof Area S1</b></p> <ul style="list-style-type: none"> <li>Lint from dryer duct collecting on the roof.</li> </ul>
3

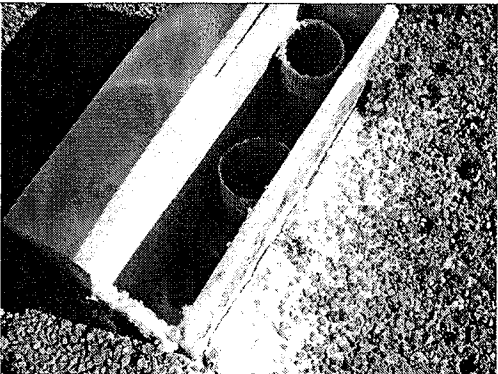
<p><b>Building 8520 Roof Area S1</b></p> <ul style="list-style-type: none"> <li>Metal cap over dryer duct not secured.</li> <li>Missing insect screen.</li> <li>Exhaust ducts should extend to top of vent.</li> </ul>
4

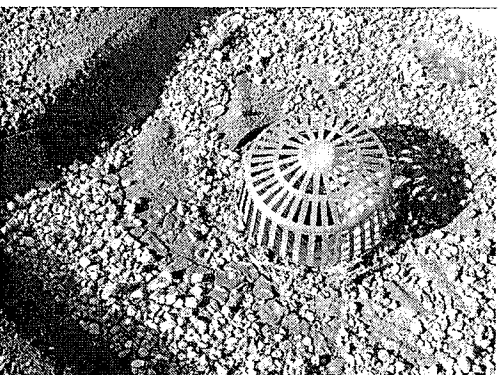
<p><b>Building 8520 Roof Area S3</b></p> <ul style="list-style-type: none"> <li>Open lap edge.</li> </ul>

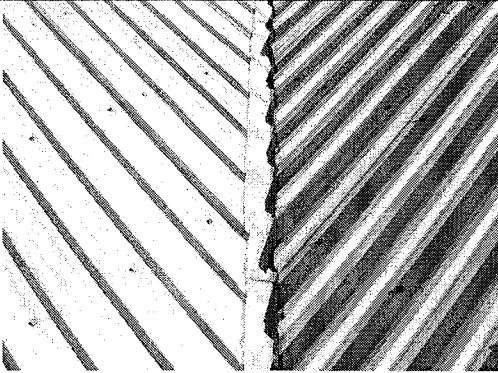
5

<p><b>Building 8520 Roof Area S4A</b></p> <ul style="list-style-type: none"> <li>• Scratches in paint coating</li> <li>• Corrosion forming on bare metal.</li> </ul>
6

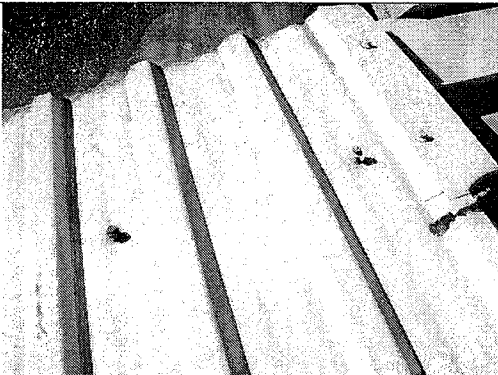
<p><b>Building 8560 Roof Area S4A</b></p> <ul style="list-style-type: none"> <li>• Fasteners “popping” up.</li> </ul>
7

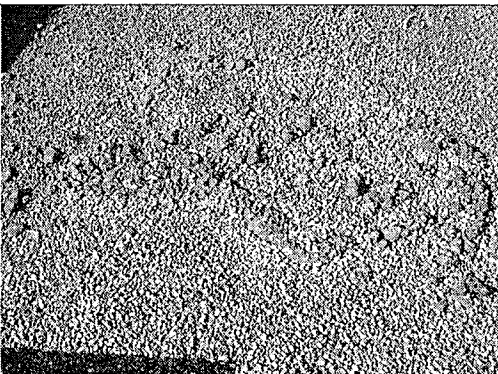
Small 'clumps' (bubbles) of asphalt migrating up through the gravel surface coating of the roofing, caused by heat. (Photo 7) If these bubbles break, small craters are formed and the thickness of the asphalt is reduced, which may eventually expose the underlying felts to the weather.

<p><b>Building 8560 Roof Area S6</b></p> <ul style="list-style-type: none"> <li>• Exposed asphalt – clumps of asphalt forming through gravel protection exposed to ultraviolet light.</li> </ul>
8

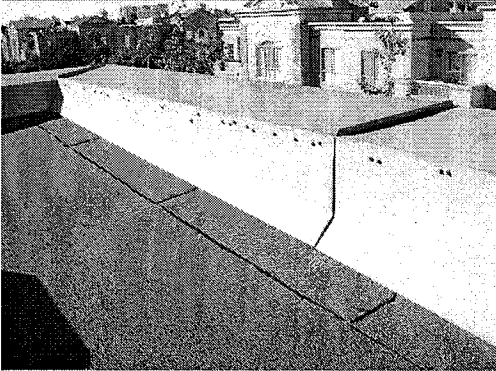
9

<p><b>Building 8560</b> <b>Roof Area S7</b></p> <ul style="list-style-type: none"> <li>• Several fasteners installed through metal cap flashing.</li> </ul>
10

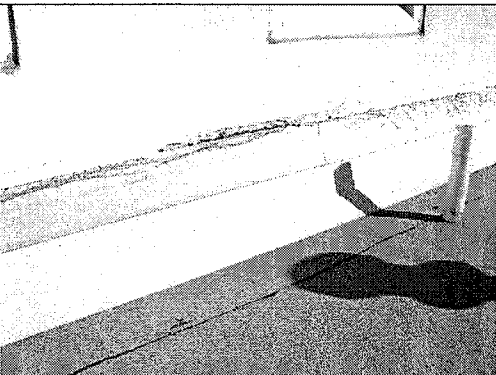
<p><b>Building 8560</b> <b>Roof Area S7A</b></p> <ul style="list-style-type: none"> <li>• Base of stucco wall was left unfinished.</li> </ul>
11

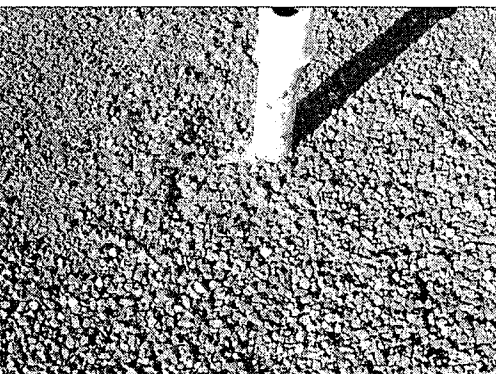
- Sealing compound was used around a lead vent stack (Photo 11) to prevent further water ingress as a result of a leak in Building 8520.
- Split (or crack) in the membrane has developed (Photo 27). If left, the crack could further open up creating a point of water ingress.

<p><b>Building 8520</b> <b>Roof Area S3</b></p> <ul style="list-style-type: none"> <li>• "Sealing" compound used to stop leak in roof system.</li> </ul>
12

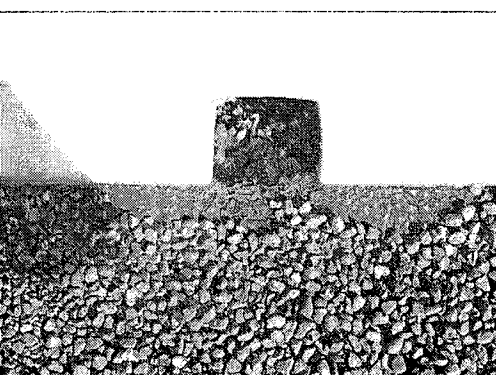
<p><b>Building 8560</b> <b>Roof Area S6</b></p> <ul style="list-style-type: none"> <li>• Exposed asphalt at drain scupper is U.V. damaged.</li> </ul>

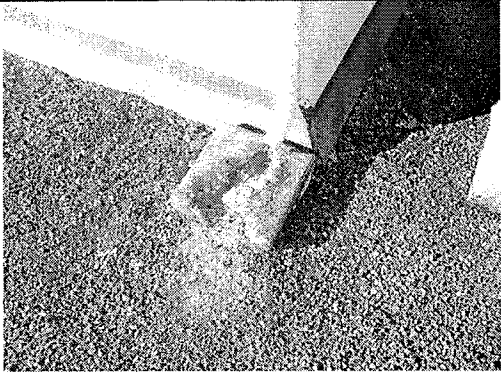
13

- The PVC vent caps used are deteriorating (Photo 2). Some of the vent caps have been replaced as part of ongoing maintenance (see Photo 31).
- Splash pads were missing (Photo 30) or deteriorated (Photo 13) at some locations. This condition can wash away gravel, exposing the unprotected bitumen.

<p><b>Building 8560</b> <b>Roof Area S6</b></p> <ul style="list-style-type: none"> <li>Deteriorated concrete splash pad.</li> </ul>
14

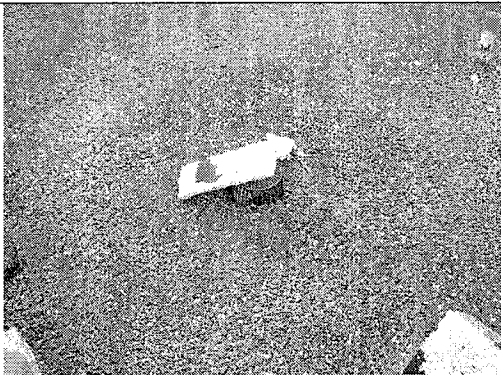
<p><b>Building 8500</b> <b>Roof Area W1</b></p> <ul style="list-style-type: none"> <li>Concrete used to "secure" drain guards.</li> </ul>
15

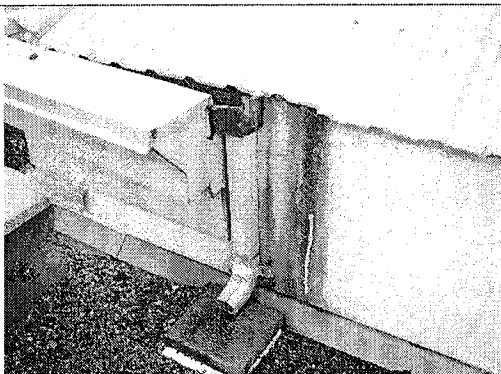
<p><b>Building 8500</b> <b>Roof Area W1A</b></p> <ul style="list-style-type: none"> <li>Metal roof panels do not extend long enough causing staining on stucco wall from water run off.</li> </ul>
16

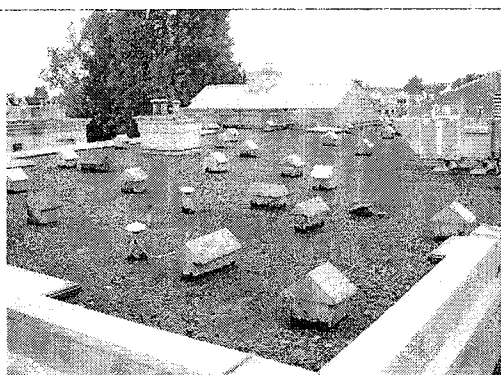
- Moss growth will be an ongoing maintenance item. Most roof areas exhibit moss over the B.U.R. membrane (Photo 16).
- Alligator cracking was observed at the base of flashing at firewalls, stucco walls of slopped roof, skylights, roof vents, etc., due to exposed bitumen (bare spots) (Photo 12) to ultra-violet light. These locations should be covered with modified bitumen (SBS) strips, which will protect the underlying felts from ultra-violet exposure.

<p><b>Building 8500</b> <b>Roof Area W1</b></p> <ul style="list-style-type: none"> <li>General view of roof area.</li> <li>Some moss growth occurring.</li> </ul>

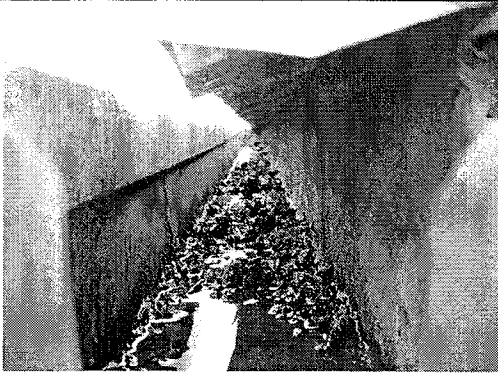
17

<p><b>Building 8500 Roof Area W2C</b></p> <ul style="list-style-type: none"> <li>• Debris in gutter.</li> </ul>
18

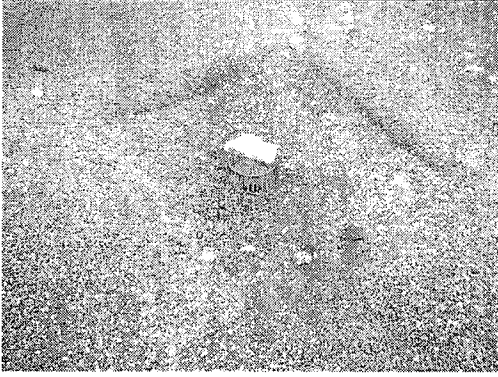
- At a number of drain sumps, there was exposed bitumen and cracking at the edges and the corners (Photo 18). The exposed bitumen is inadequately protected by the surface gravel. Some existing BUR drain sumps have been repaired using modified bitumen SBS membranes. Since the water can pond at the drains, any defects

around the drain sumps should be repaired. Blisters and open membrane laps were observed at some repaired sump drain areas.

<p><b>Building 8500 Roof Area W2</b></p> <ul style="list-style-type: none"> <li>• Exposed asphalt around perimeter of sump drain.</li> </ul>
19

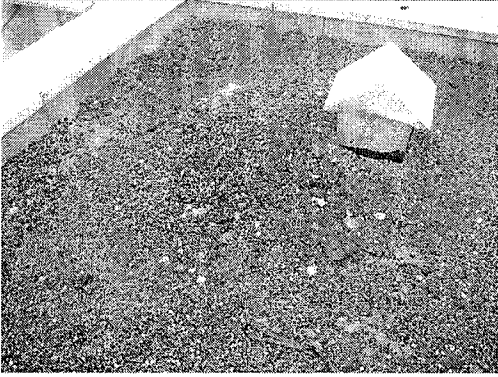
The perimeter areas of several roof areas on all three (four civic addresses) buildings have been remediate as part of the building envelope remedial repairs. The portion of B.U.R. removed (debris) has been left on the roof surface. (Photo 19)

- Waterproofing membrane was not installed underneath the perimeter curb flashing. The condition is being repaired as part of the ongoing building envelope repairs to the exterior walls. Most perimeter areas have been rectified, although debris (clumps at asphalt) has been left on the roof (Photo 19).

<p><b>Building 8500 Roof Area W1</b></p> <ul style="list-style-type: none"> <li>• Debris from roof repairs left on roof.</li> </ul>
20

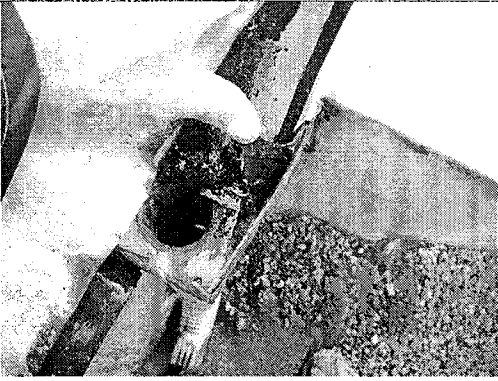
<p><b>Building 8500 Roof Area W1A</b></p> <ul style="list-style-type: none"> <li>• EPDM membrane not bonded at drain scupper.</li> </ul>

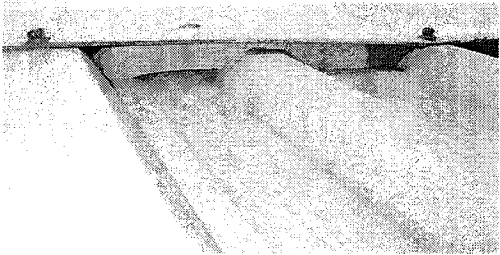
21

<p><b>Building 8500 Roof Area E1C</b></p> <ul style="list-style-type: none"> <li>• Foam closure strip at top of metal roof (under ridge cap) is not continuous.</li> <li>• U.V. damaged.</li> </ul>
22

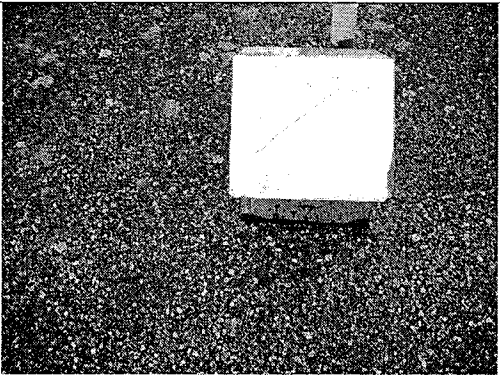
<p><b>Building 8580 Roof Area E5</b></p> <ul style="list-style-type: none"> <li>• Blister forming next to the vent.</li> </ul>
23

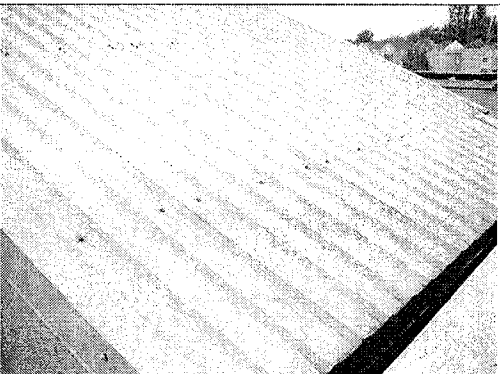
<p><b>Building 8500 Roof Area W4B</b></p> <ul style="list-style-type: none"> <li>• Fasteners were installed too high above the bottom of metal roof panels.</li> </ul>
24

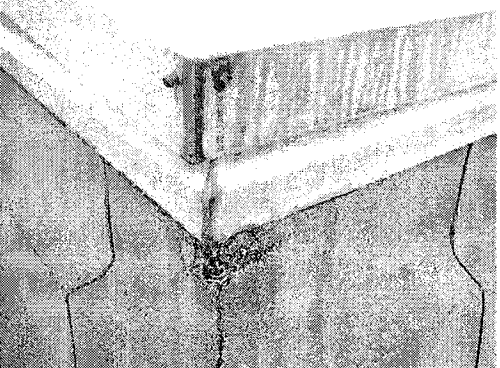
- SBS repairs have been made throughout. The roof access hatch curb on Building 8500 was repaired with an SBS membrane. Damage has occurred at one corner (Photo 24), exposing the bitumen.

<p><b>Building 8500 Roof Area W5</b></p> <ul style="list-style-type: none"> <li>• Damaged membrane at corners of roof access hatch.</li> </ul>

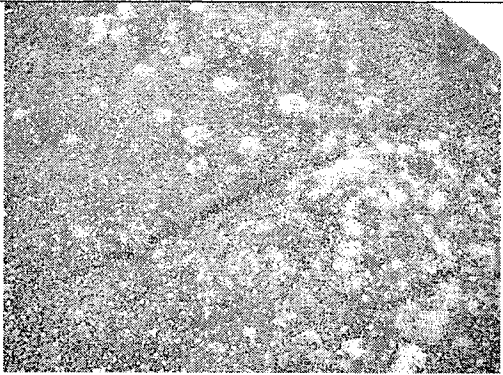
25

Narrow ripples in membrane caused by movement of either the felts or substrate under moisture or thermal effects. (Photo 25)

<p><b>Building 8500 Roof Area W4</b></p> <ul style="list-style-type: none"> <li>• Ridge forming in BUR membrane.</li> </ul>
26

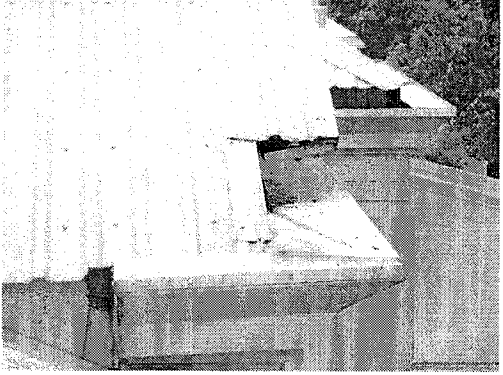
<p><b>Building 8580 Roof Area E5</b></p> <ul style="list-style-type: none"> <li>• Soffit not secured.</li> </ul>
27

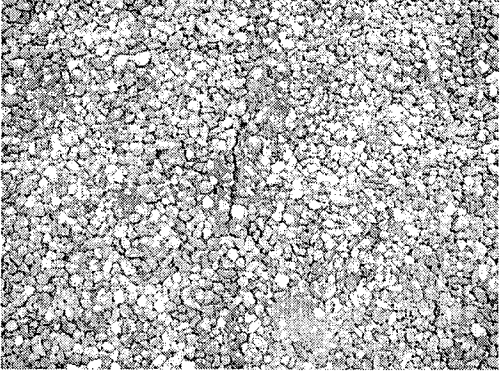
<p><b>Building 8580 Roof Area E5</b></p> <ul style="list-style-type: none"> <li>• Split in membrane.</li> </ul>
28

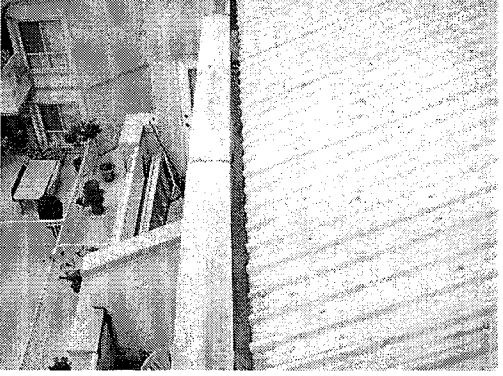
<p><b>Building 8500 Roof Area W3A</b></p> <ul style="list-style-type: none"> <li>• Ponding water in gutter.</li> <li>• Drain restricted.</li> </ul>

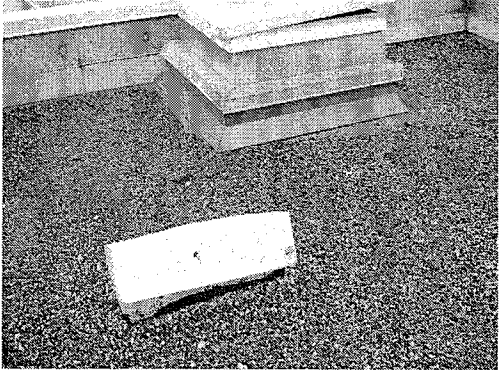
29

<p><b>Building 8580 Roof Area E4</b></p> <ul style="list-style-type: none"> <li>• Top of vent cap not properly secured.</li> </ul>
30

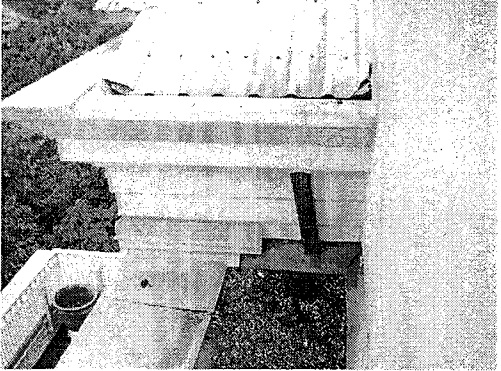
<p><b>Building 8580 Roof Area E5</b></p> <ul style="list-style-type: none"> <li>• Missing splash pad.</li> </ul>
31

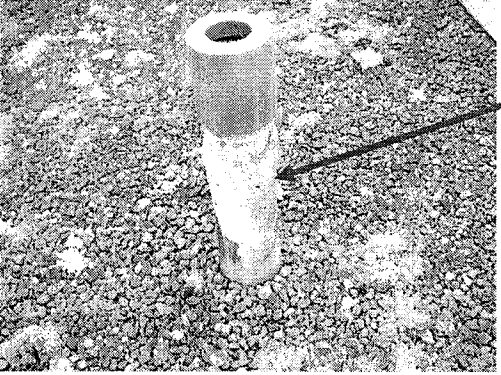
- Some lead pipes were too low on the BUR roof. Snow and/or water build-up on the roof may enter the short lead pipes. A hole was observed in one pipe (Photo 31).

<p><b>Building 8580 Roof Area E5</b></p> <ul style="list-style-type: none"> <li>• Hole in lead vent stack.</li> <li>• New PVC cap installed.</li> </ul>
32

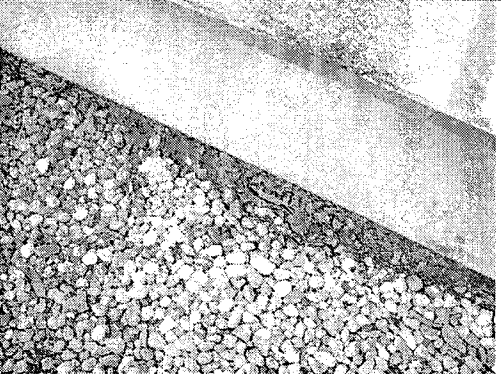
- There have been SBS repairs around the roof perimeter parapet curb, although not all areas have been addressed. The protection course has degraded exposing the asphalt to U.V (Photo 32).
- It appears that some repairs around lead stacks were completed that ran electrical cable to the roof top mechanical units. The repair included the use of gum/pitch pans which are not recommended by the Roofing Contractors Association of BC. The 'mastic' used to seal/fill the gum pan has been reapplied as part of the ongoing maintenance.
- Exposed felt edges, ridges (Photo 25), and surface blisters (Photo 22) were noted throughout roof areas. The exposed felt edges appear to occur at the 1<sup>st</sup> felt layer and are no longer protected by the surface gravel. If not repaired, the exposed felt will continue to deteriorate (crack, blister) through the remaining 2 plies.

<p><b>Building 8500 Roof Area W1</b></p> <ul style="list-style-type: none"> <li>• Exposed asphalt at perimeter due to protection course sliding down.</li> </ul>

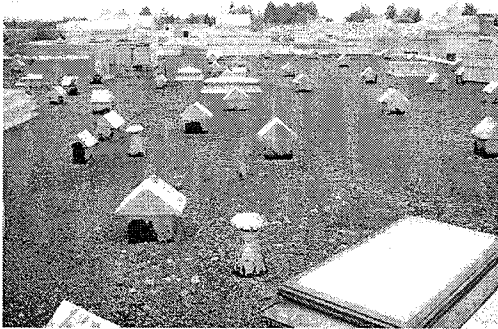
33

<b>Building 8500 Roof Area W5</b> <ul style="list-style-type: none"> <li>• General view of roof area.</li> <li>• Corrosion to vent box caps.</li> </ul>
34

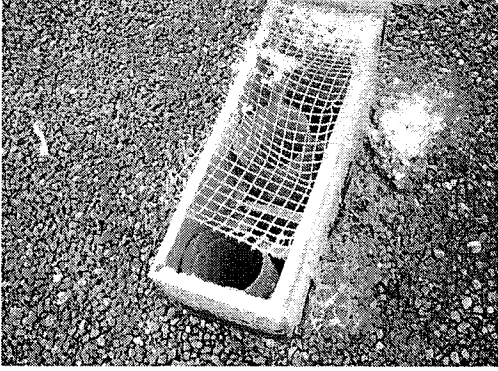
<b>Building 8500 Roof Area W4</b> <ul style="list-style-type: none"> <li>• Vent cover not secured</li> <li>• Screen not continuous</li> <li>• Vent ducts do not extend to top of vent box.</li> </ul>
35

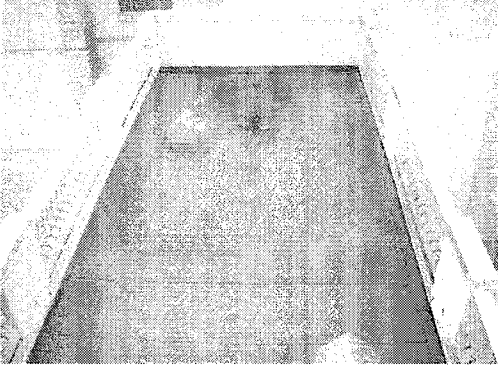
<b>Arch / Entrance Roof</b> <ul style="list-style-type: none"> <li>• Ponding water.</li> </ul>
36

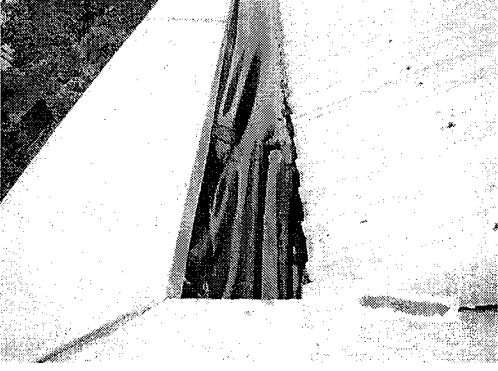
<b>Building 8500 Roof Area W1C</b> <ul style="list-style-type: none"> <li>• EPDM membrane wrinkling.</li> </ul>

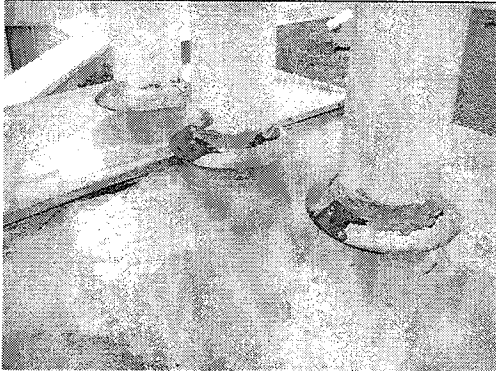
37

- Sealant was used to seal the flashing joints to prevent water penetration. The use of sealants to manage moisture penetration is not a recommended long term situation. Acknowledging that this is inherent in the design of the metal flashing, frequent maintenance is required to ensure the sealant has not failed. A small crack or hole in the sealant may allow water ingress. Sealant is deteriorating due to ultra-violet exposure. Sealant used around storm collars (Photo 37) will be an ongoing maintenance requirement.

<p><b>Building 8500 Roof Area W1</b></p> <ul style="list-style-type: none"> <li>Sealant at storm collars is deteriorating.</li> </ul>
38

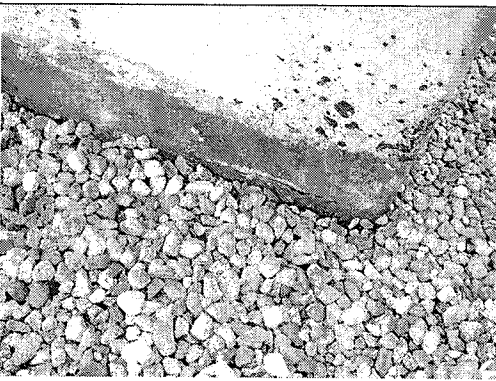
- Some galvanized vent boxes were submerged in water, and are now corroding at the base of the flashing. Some of the exposed bitumen around the base of the vent has cracked due to U.V. exposure (Photo 38 and 40).

<p><b>Building 8560 Roof Area S4</b></p> <ul style="list-style-type: none"> <li>Exposed asphalt at base of box vent is degrading due to U.V.</li> <li>Cracked asphalt can allow water to migrate behind asphalt.</li> </ul>
39

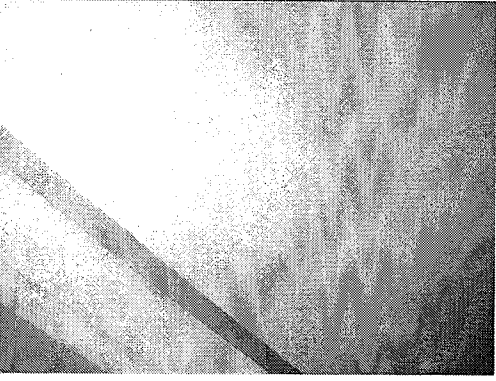
<p><b>Building 8520 Roof Area S3</b></p> <ul style="list-style-type: none"> <li>Water stained ceiling in hallway outside Unit 318.</li> </ul>
40

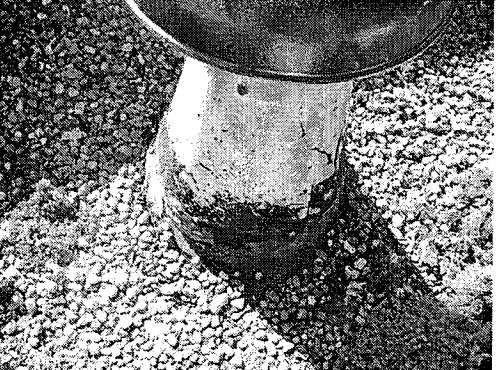
<p><b>Building 8520 Roof Area S1</b></p> <p>'B' Vent:</p> <ul style="list-style-type: none"> <li>Exposed asphalt at base has cracked which will allow water to migrate past.</li> </ul> <p>Note: Top of vent has been "painted" to minimize corrosion as part of ongoing maintenance.</p>

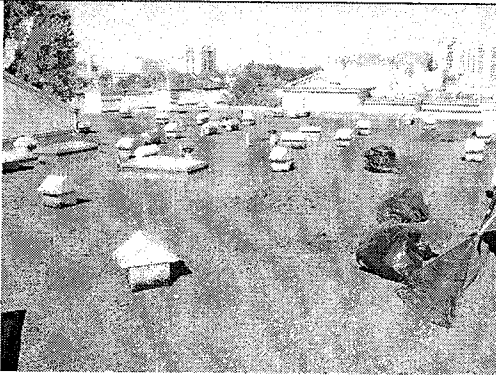
41

<p><b>Building 8520 Roof Area S1</b></p> <ul style="list-style-type: none"> <li>• Removal of moss growth as part of ongoing maintenance.</li> </ul>
42

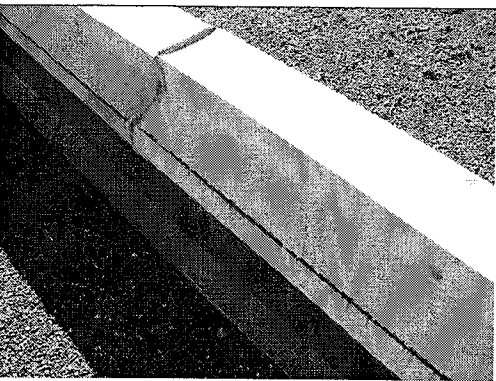
<p><b>Building 8520 Roof Area S2</b></p> <ul style="list-style-type: none"> <li>• Corrosion occurring to metal cap flashing at firewall.</li> </ul>
43

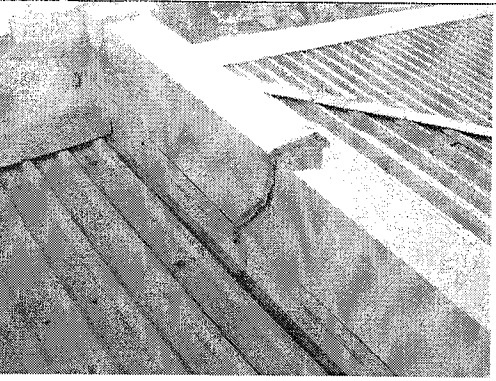
<p><b>Building 8560 Roof Area S4A</b></p> <ul style="list-style-type: none"> <li>• Caulking at cap flashing over firewall failing.</li> <li>• Cap flashing does not fit/lock together correctly.</li> </ul>
44

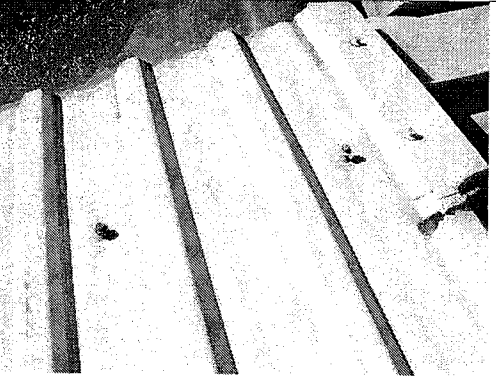
<p><b>Building 8560 Roof Area S4A</b></p> <ul style="list-style-type: none"> <li>• Fasteners backing out.</li> <li>• Fasteners are corroded.</li> <li>• Metal roof panels are corroded.</li> </ul>

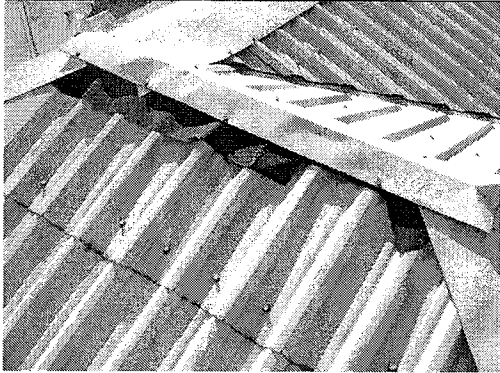
45

<p><b>Building 8560 Roof Area S5A</b></p> <ul style="list-style-type: none"> <li>• Membrane used under metal cap flashing is deteriorating.</li> <li>• Metal cap is damaged.</li> <li>• Corrosion to metal roof panels.</li> </ul>
46

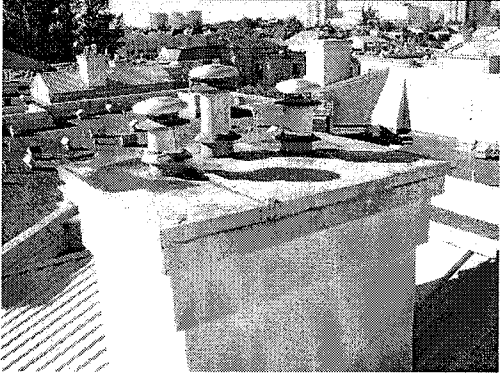
<p><b>Building 8520 Roof Area S4B</b></p> <ul style="list-style-type: none"> <li>• Corrosion to top of metal cap flashing.</li> <li>• Sealant at storm collars is failing. Some previous repairs have been completed.</li> </ul>
47

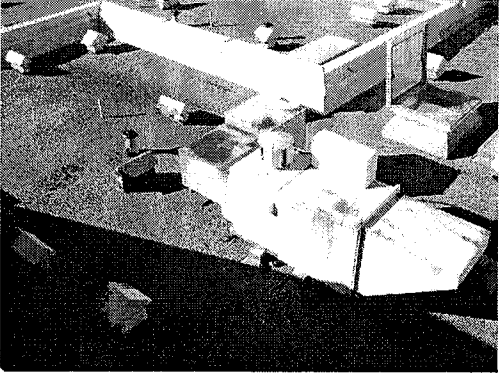
<p><b>Building 8520 Roof Area S4</b></p> <ul style="list-style-type: none"> <li>• General view of roof area</li> <li>• Corrosion to top of mechanical equipment.</li> </ul>
48

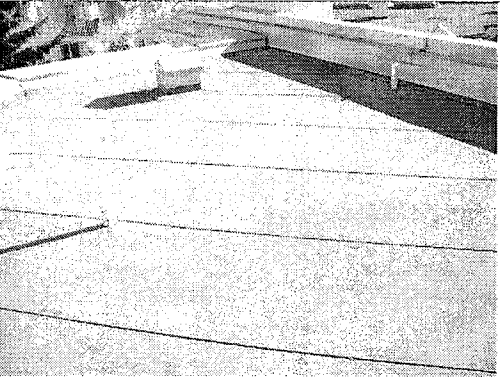
<p><b>Building 8560 Roof Area S7</b></p> <ul style="list-style-type: none"> <li>• Minor wrinkling of 2-ply SBS membrane.</li> </ul>
