4 August 2011

**Re: NW 3119, Queens Gate, 8500-8580 General Currie Rd. Richmond  
Domestic Water Piping Evaluation (the "Project")**

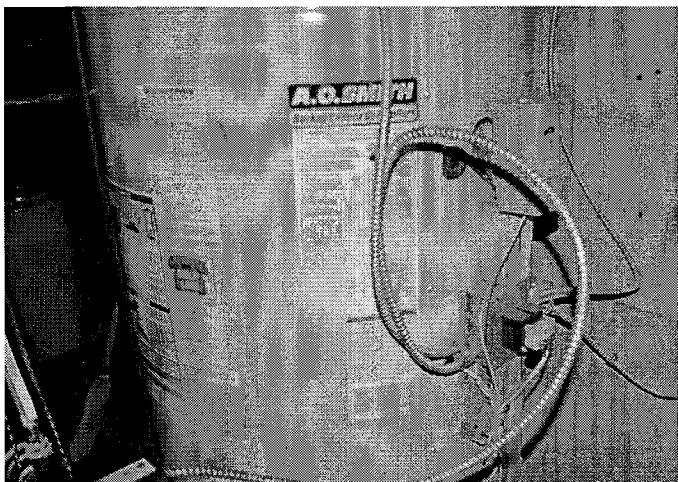
Hot water is supplied by an AO Smith direct fired gas water heater with an input of 611,000 BTUH. It supplies hot water to 2 x 119 US Gallon glass lined AO Smith storage tanks. Water temperature was noted to be approximately 55° Celcius.

*Photo 1--(8500) Gas fired, direct water heater*

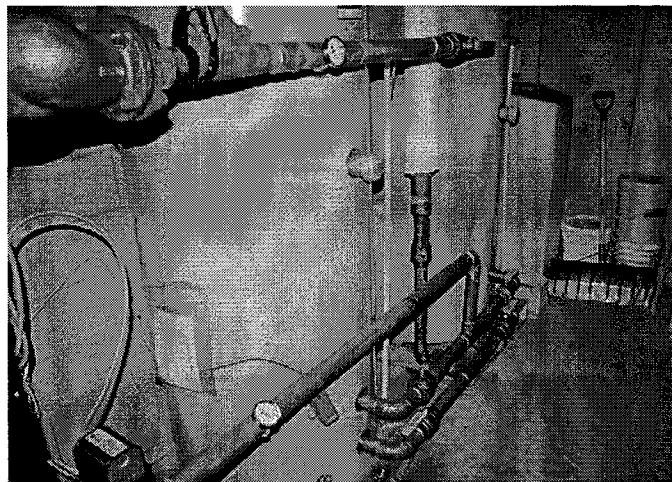
*Photo 2--(8500) Glass lines storage tanks*

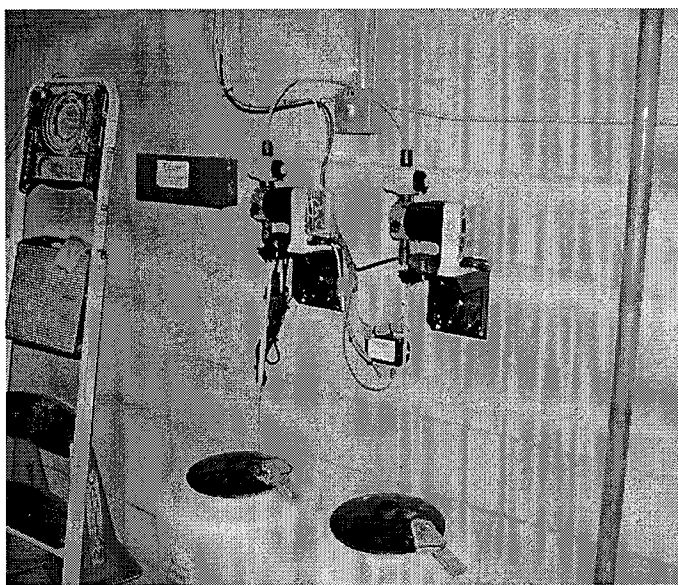
The domestic water system has recently been upgraded to include a water treatment system supplied by Hytec Water Management (604 628-2421).

*Photo 3 --(8500) Hytec chemical storage and feed system*

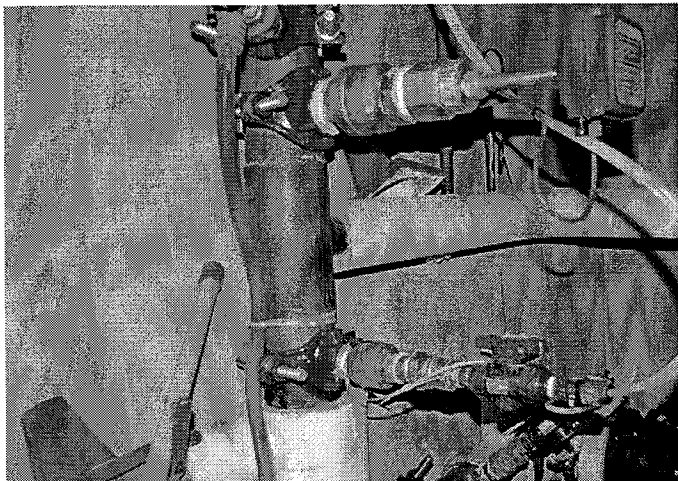
The domestic water system has recently been upgraded to include a water treatment system supplied by Hytec Water Management (604 628-2421).

*Photo 4--(8520/8560) Taps for Hytec chemical feed system*

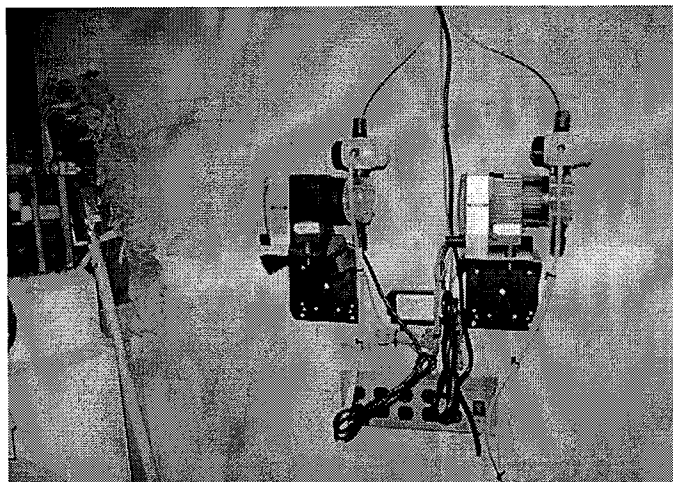
*Photo 5--(8520/8560) Metering pumps for chemical feed system*

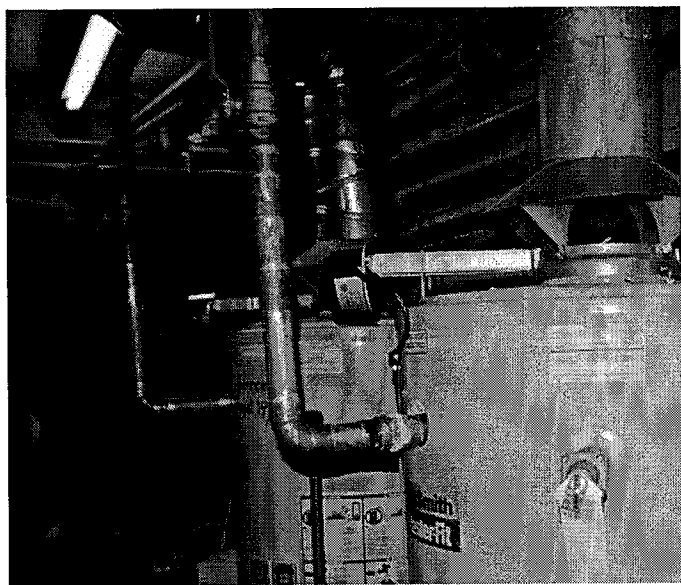
Hot water is supplied by an AO Smith three (3) direct fired gas water heaters each with inputs of 611,000 BTUH. There are no storage tanks. Water temperature was noted to be approximately 55° Celcius.

*Photo 6--(8520/8560) Direct, gas fired water heater (typical of 3).*

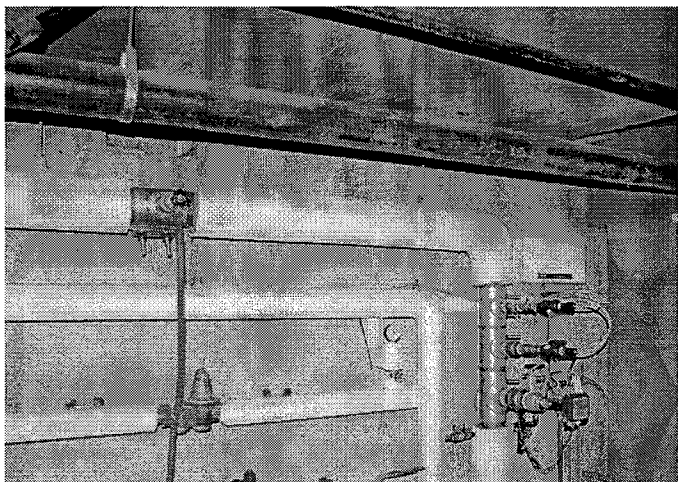
The domestic water system has recently been upgraded to include a water treatment system supplied by Hytec Water Management (604 628-2421).

*Photo 7--(8580) Chemical feed system on main supply piping*

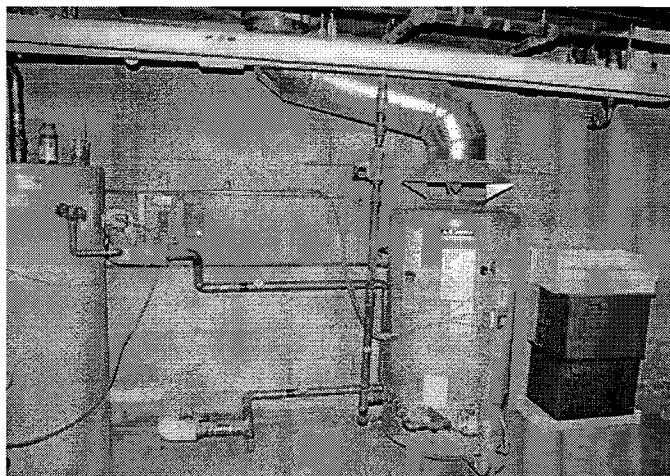
Hot water is supplied by an AO Smith direct fired gas water heater with an input of 611,000 BTUH. It supplies hot water to 2 x 119 US Gallon glass lined AO Smith storage tanks. Water temperature was noted to be approximately 55° Celcius.

*Photo 8--(8580) Direct gas fired water heater and storage tank (typical of 2)*
