Our File No.: F19-192
June 11, 2019

Re: Strata Plan NWS 3119 – Queen’s Gate
Suite No. 318 - 8500 General Currie Road, Richmond, B.C.
– Review of Damage to Wood Framing Due to Water Ingress

STRATA PLAN NWS 3119 – QUEEN'S GATE
SUITE No. 318 - 8500 GENERAL CURRIE ROAD, RICHMOND, B.C.
PHOTOGRAPHS TAKEN BY LEANNA STURLEY, B.Sc., E.I.T.
ON JUNE 5, 2019

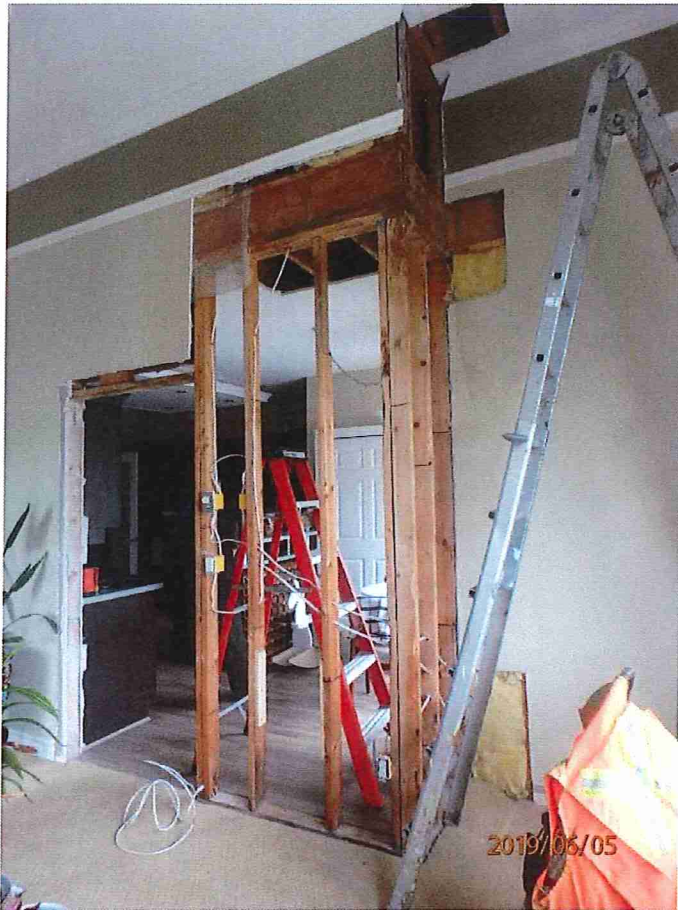
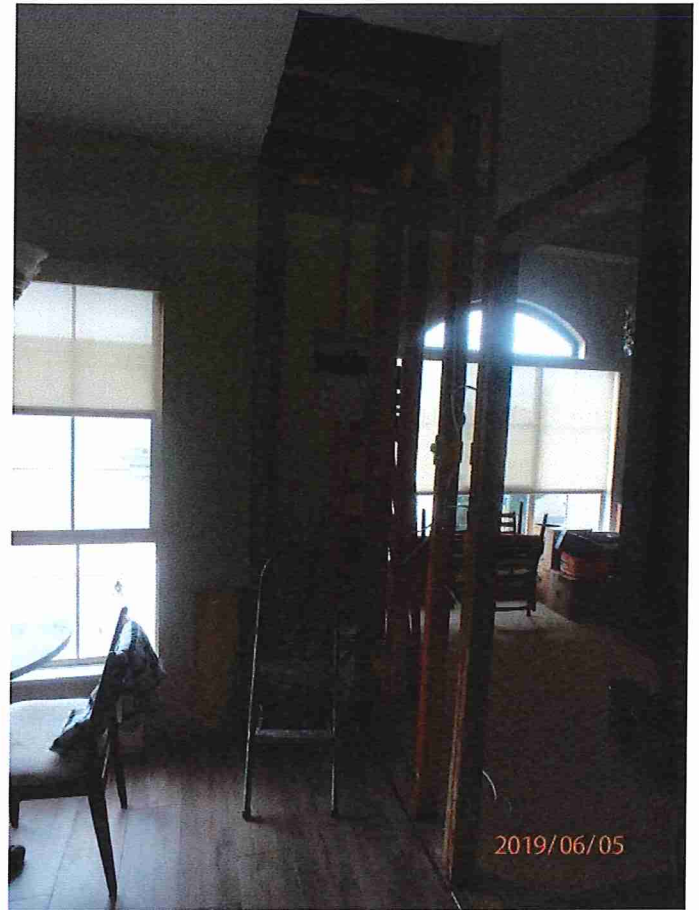
Photos No. 1 and 2

- 2.1 Wood framing has been revealed where interior finishes were damaged due to water ingress (**Photos No. 1 and 2**). Gypsum wall board, polyethylene sheet vapour barrier, and batt insulation have been removed as needed. Framing revealed includes: the interior wall separating living room from kitchen and floor structure between this suite and the suite above. The framing was visually reviewed, tested by touch for 'punkiness'¹ or wood rot and tested with a moisture meter to determine moisture content (M.C.).

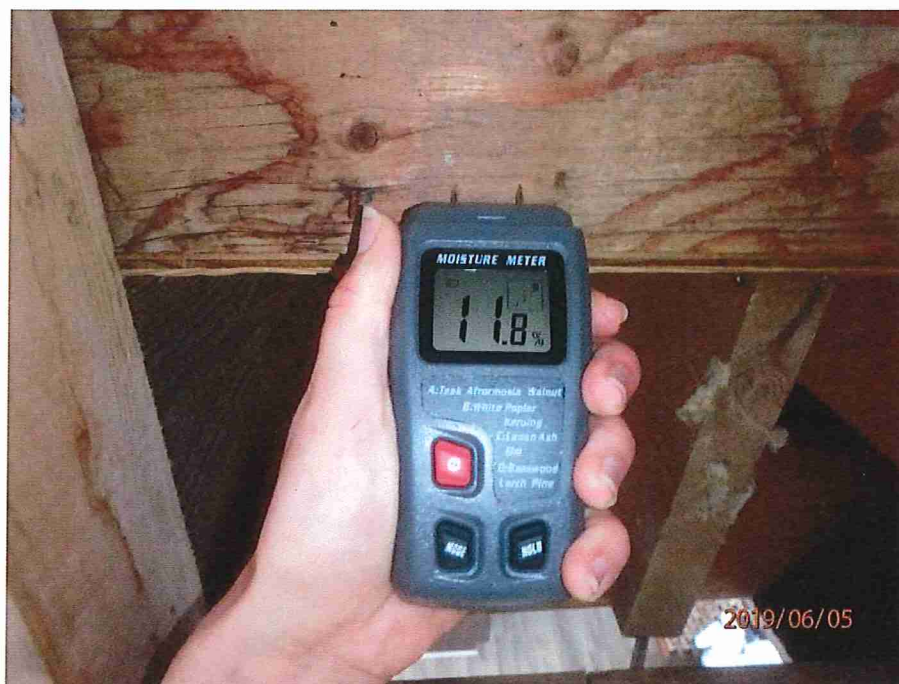
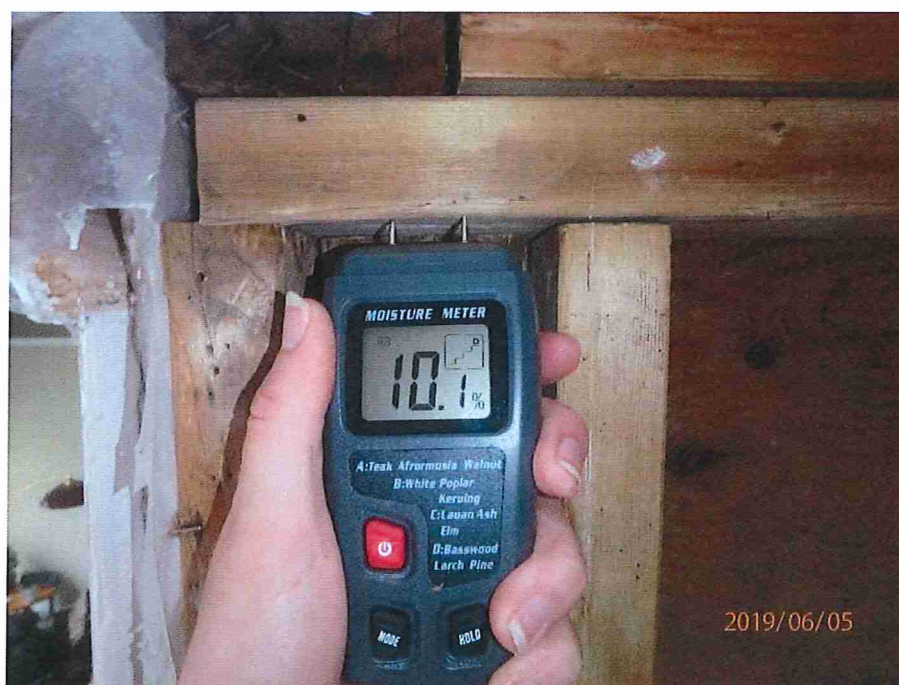
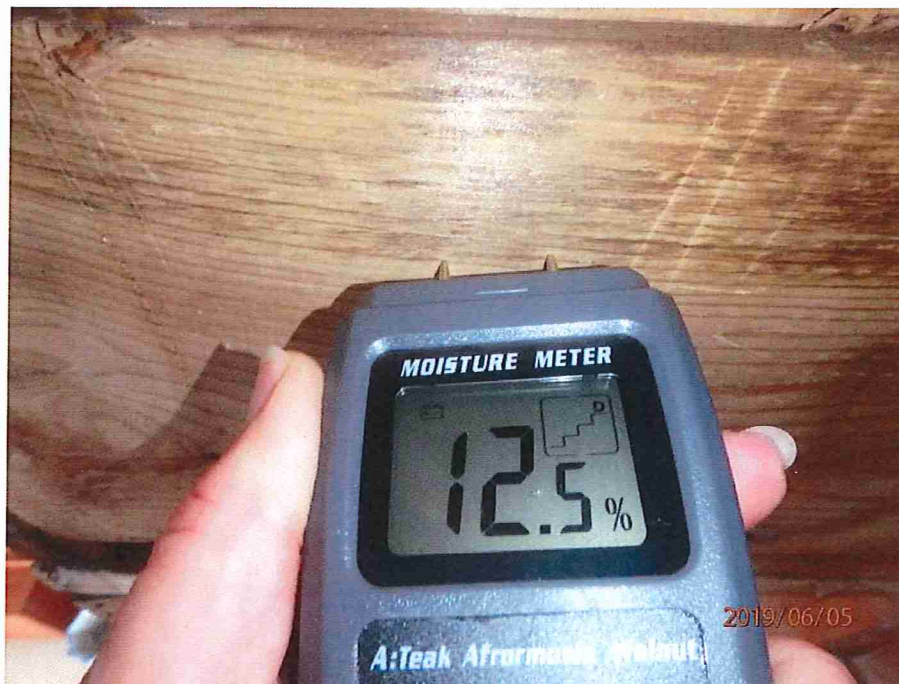
Photos No. 3 and 4

- 2.2 All components tested with moisture meter read below 13% M.C (**Photos No. 3 to 5**). This M.C. is within acceptable levels to continue with interior repairs following replacement of select framing members.

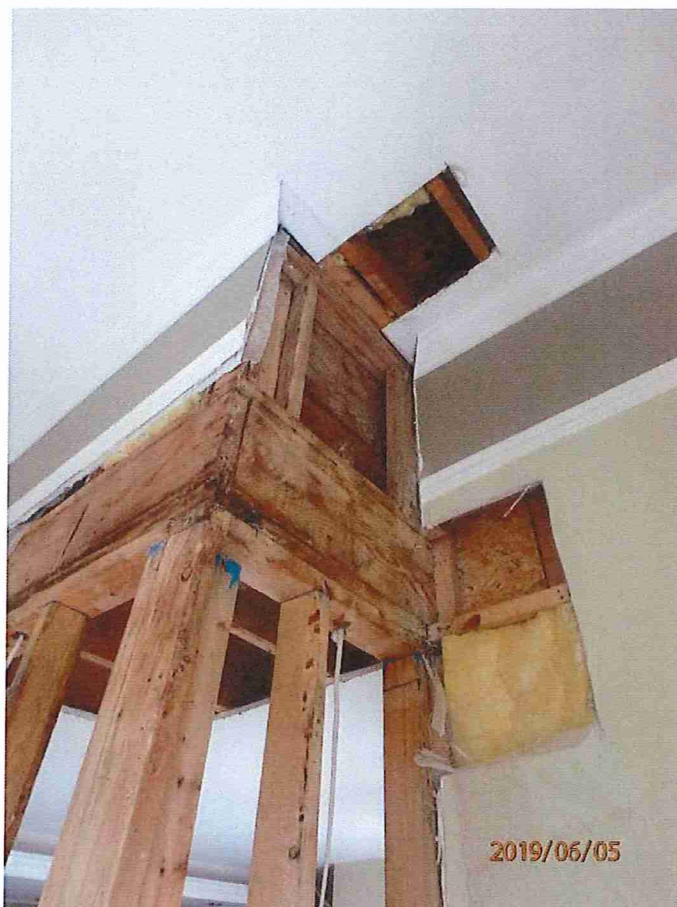
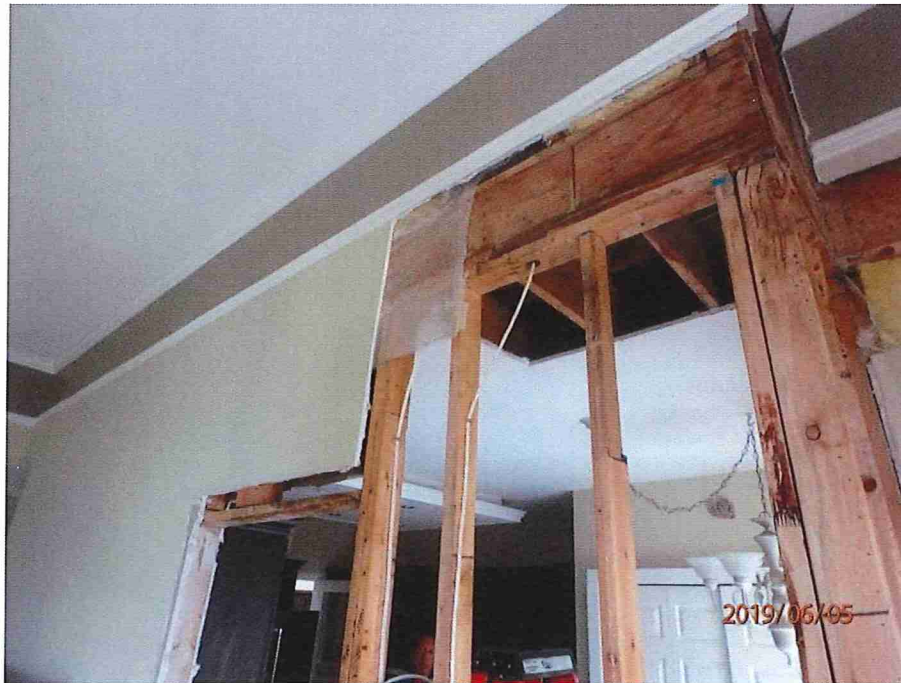
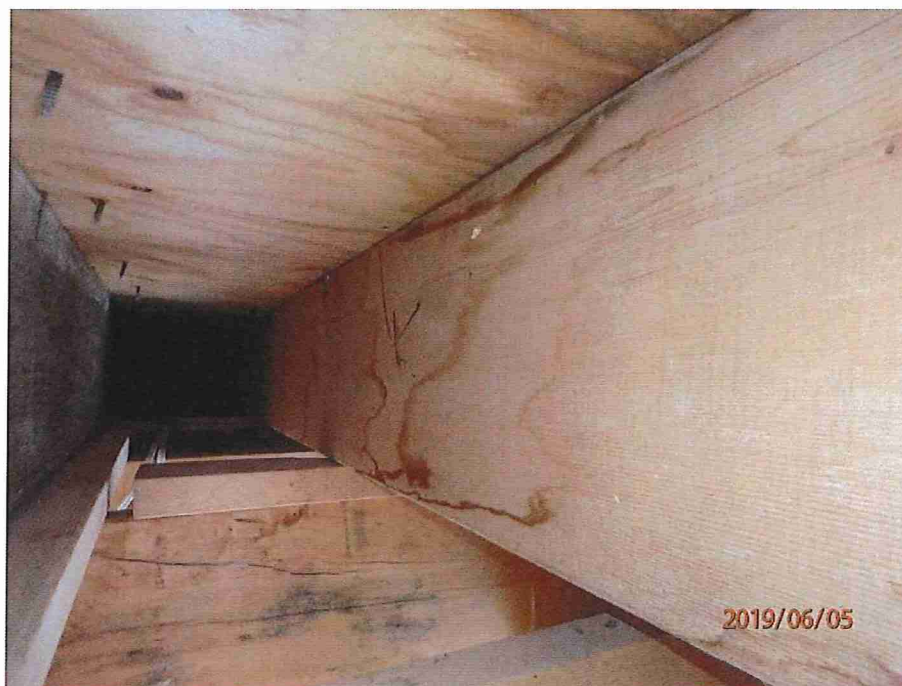
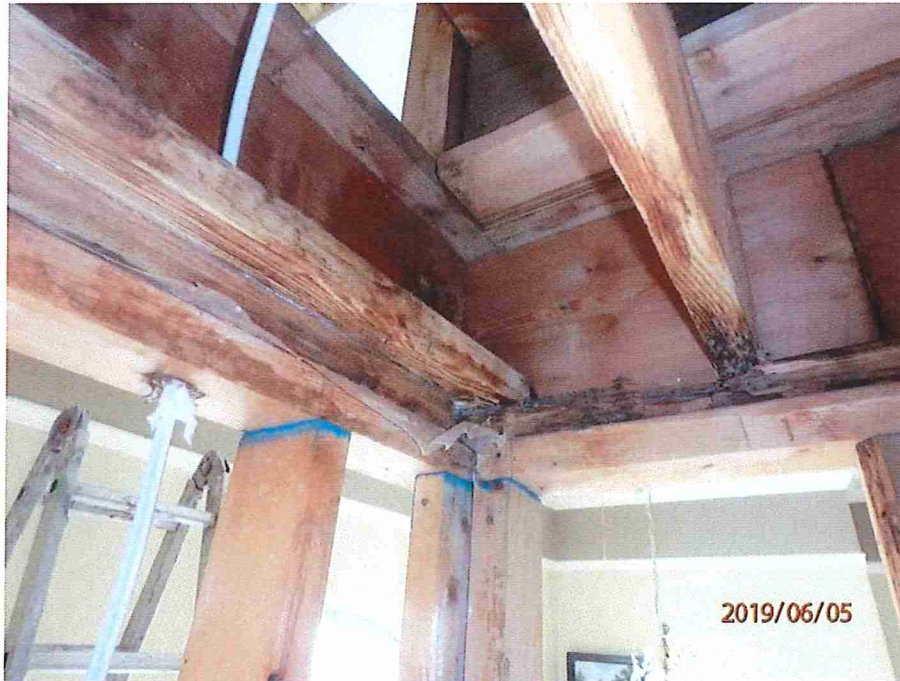
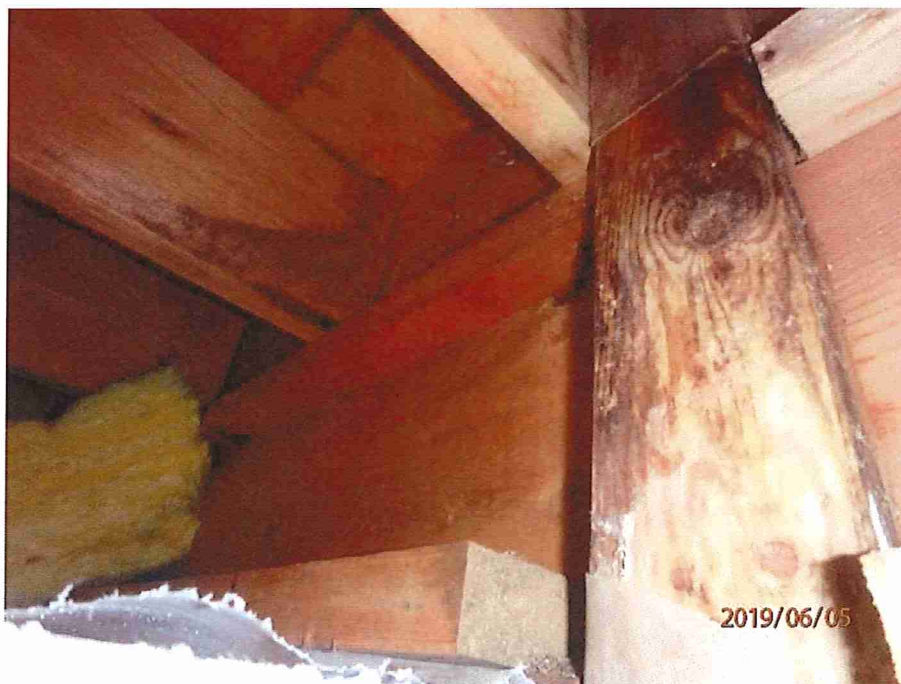
- 2.3 Some moisture staining of the wood is noted here and there. Some wood rot, now dried, is also noted at some spots (**Photos No. 6 to 10**). All visible structural elements were reviewed: 2x4 studs and plates; 2x10 floor joists; plywood subfloor; and rim joists where visible. Wood framing is noted to be solid except where called out below.

- 3.1 All wood rot must be replaced with new dimensional lumber of matching size. The identified members in this report require full replacement. Any additional wood framing found in the course of work or further exploration with a punky condition is to be replaced as well.

- 3.2 All water damaged existing framing left in place should be coated with a liquid-applied decay inhibitor, such as Sansin Boracol 20-2 to prevent any further colonization by fungus and mould.

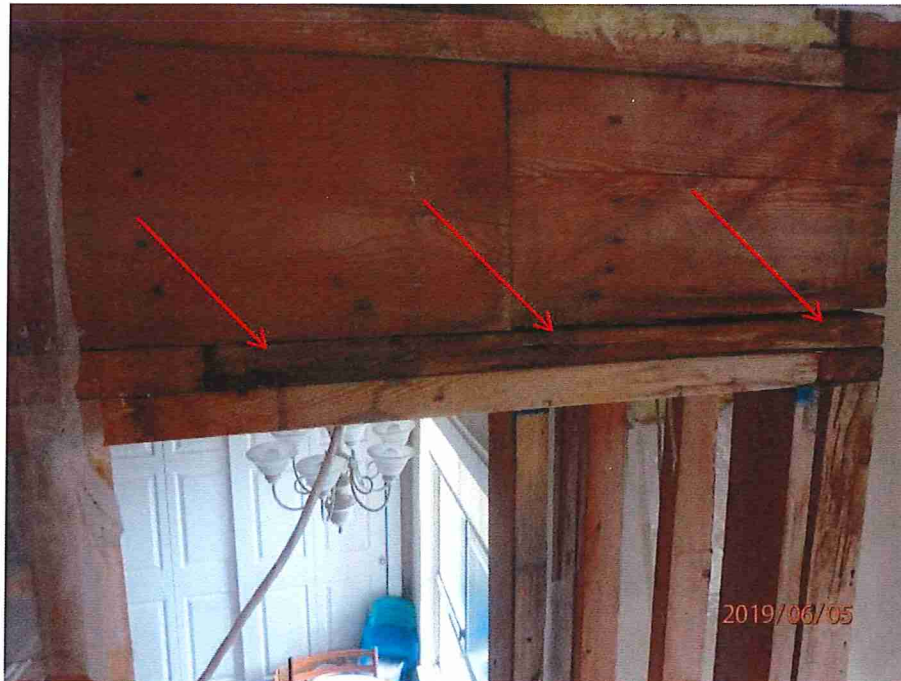
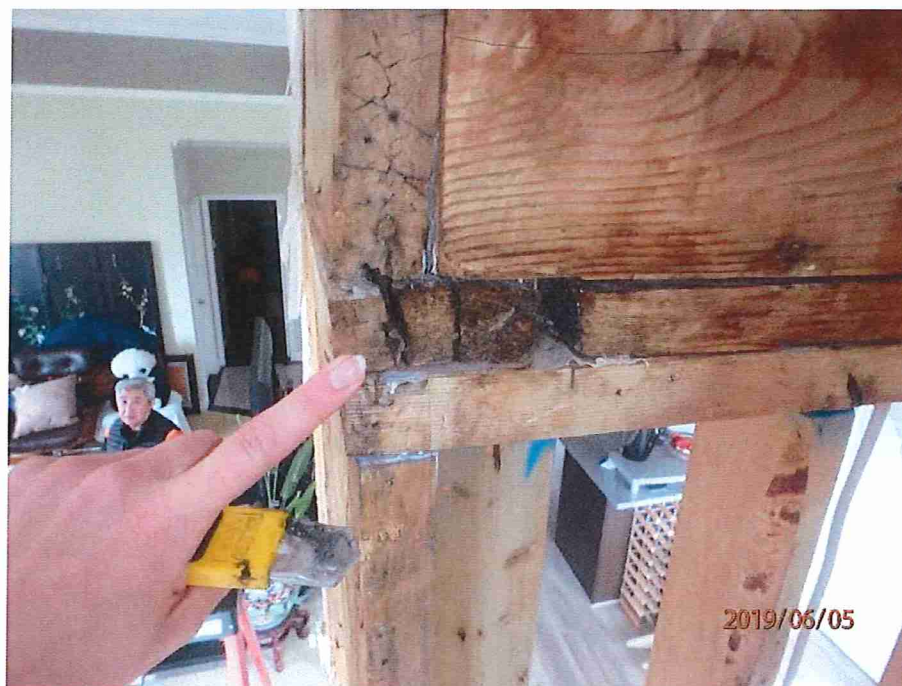
Photos No. 11 and 12

- 2.4 A punky condition was noted at the 2x4 intermediate plate between the interior wall top plate and end joist above, at the corner (**Photos No. 11 and 12**). This plate requires replacement.

- a. Per Item 2.4, the full rotted length of plate must be replaced.
 - b. Per Item 2.5, cut the joist vertically 3' back from the exposed end and splice in a new piece. Sister a new 2x10 beside the repaired 2x10. Fasten together using 3" wood screws at 6" o.c. staggered at 1.5" from the top and bottom edges.

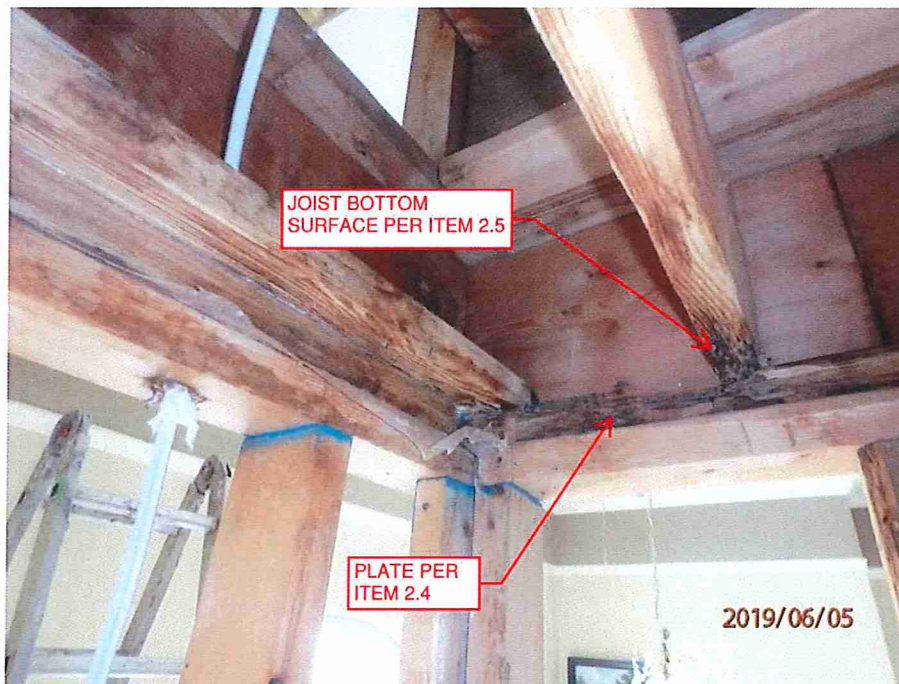
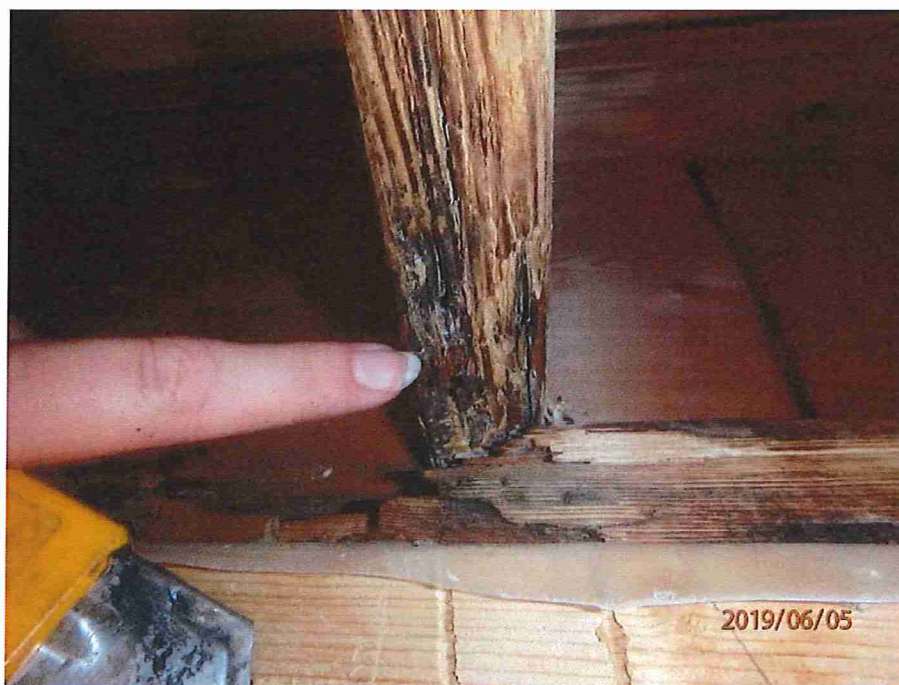
Photos No. 13 and 14

- 2.5 Resting on this plate is a 2x10 floor joist with a punky bottom surface (**Photos No. 13 and 14**). The 2x10 floor joist should be cut to remove the rotted section and new dimensional lumber spliced in. Repairs are elaborated upon in the following section.

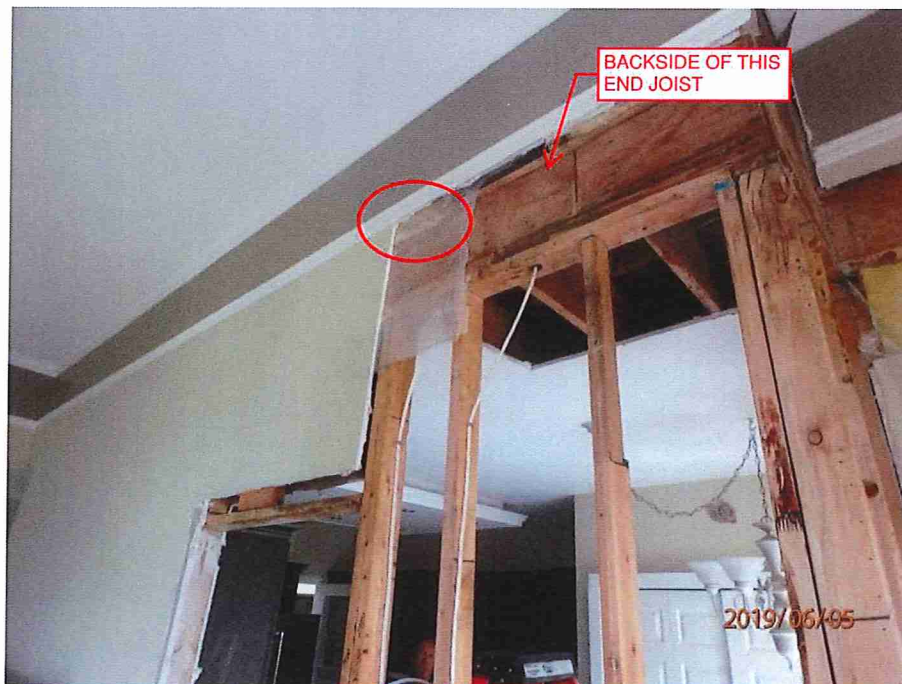
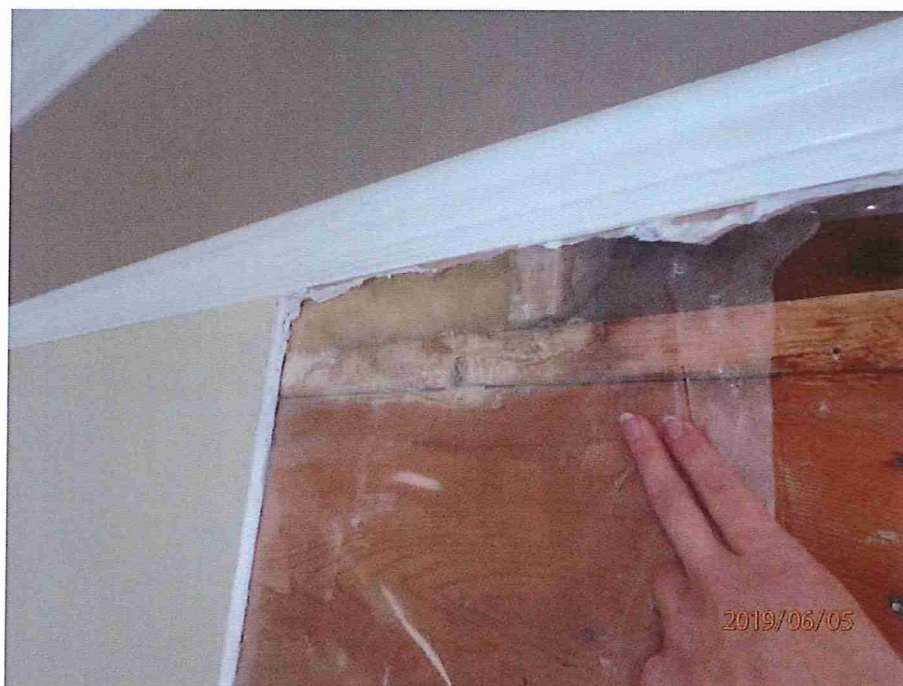
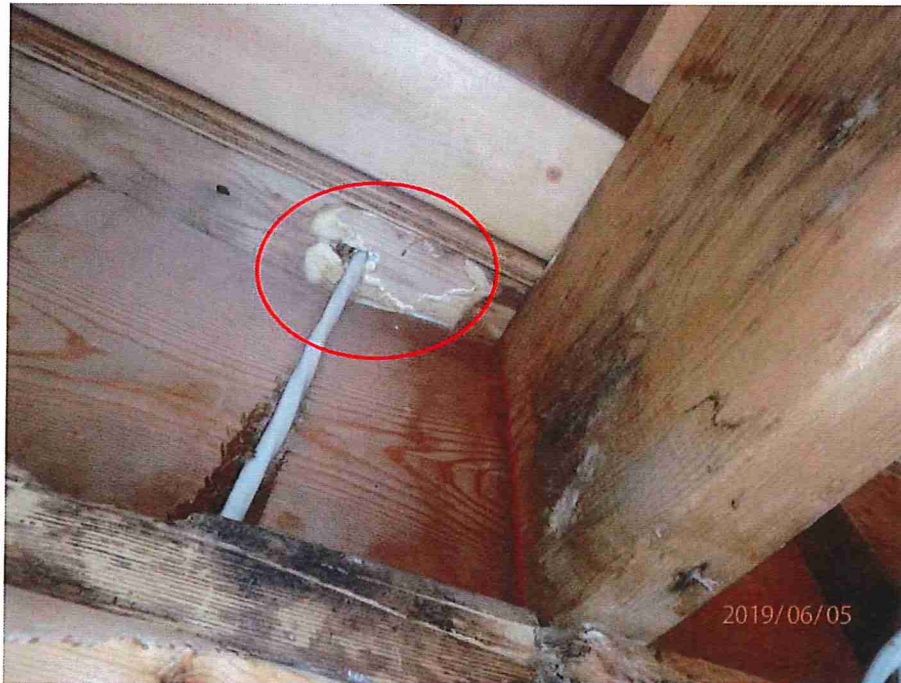
- 2.6 Some fungus was noted at a few spots in the revealed framing (**Photos No. 15 to 17**). The spots were found to be solid. The remaining fungus should be scraped off and a fungal inhibitor applied to wood.

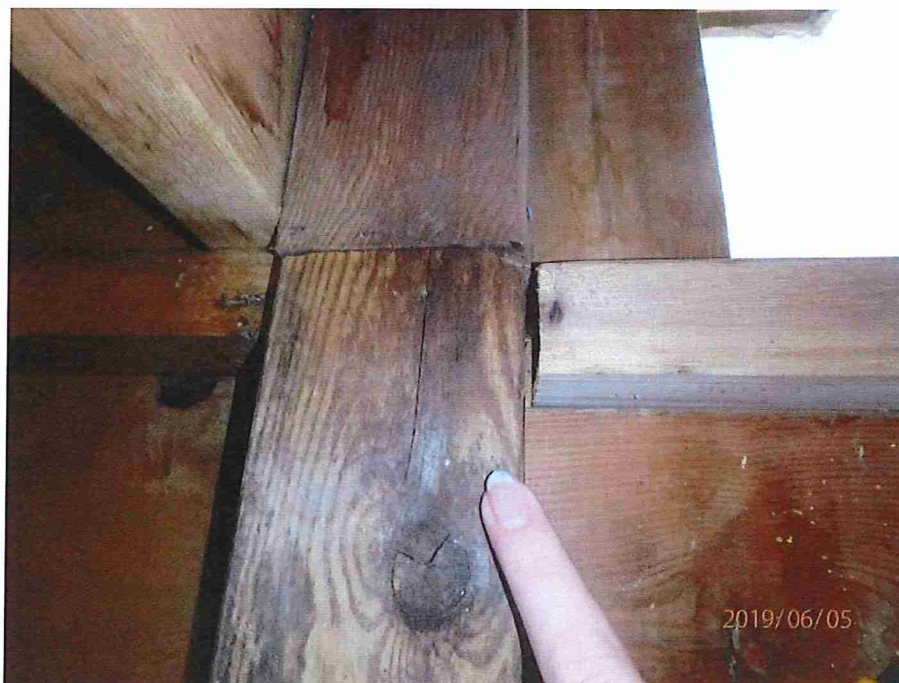
- 2.7 A suspect connection was noted while reviewing the framing: a vertical butt connection between two 2x4s (**Photo No. 18**). The butt connection is toe-nailed together, with joint closely in plane with other framing joints. Additional material should be spliced on to correct this. This connection can be seen from within the kitchen, to the left side of the opened area.

- 3.3 The 2x4 butt connection noted in Item 2.7 should be corrected by sistering a length of 2x4 over the connection to provide rigidity. The length of the sistered 2x4 should be the maximum achievable length, held in place with screws at 6" o.c.
