Depreciation Report

NW1803 – Blue Mountain Place

RE: Depreciation Report for Strata Plan NW1803
File No. 20160215-DR-NW1803

The subject of this depreciation report consists of “Blue Mountain Place”, a 47-unit apartment complex constructed in 1982 and located at 1177 Howie Avenue in Coquitlam, BC. We are pleased to present you with the enclosed depreciation report, which we believe will serve as the basis of your reserve planning to help better equip your members for future expenditures.

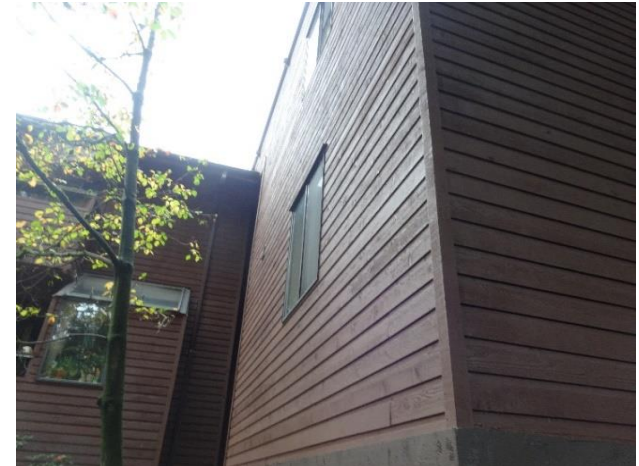
Replaced section of wood cladding

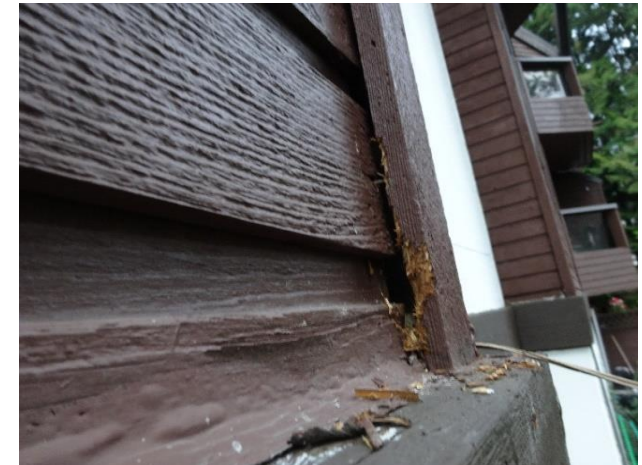
Reserve Component B20100111	Cladding				
Properties	Wood siding				
Potential Deterioration	Generally, exposed wood products are vulnerable to weathering, cracking and warping.				
Condition Analysis	Deterioration	None apparent.			
	Overall Condition	Acceptable.			
Repair History	Some local replacements have been performed over the years.				
Life Cycle Analysis	DOI	CA	EUL	EA	RUL
	1982	34 years	45 years	35 years	10 years
Cost Estimates	Starting Year	Current Cost		Future Cost	
	2026	\$315,000		\$440,064	
Funding Method	Budget for full replacement.				
Preventative Maintenance	Every 3 years review for warping, damage, loose panels and discoloration. Touch up painting or staining. Clean with non-pressurized soapy water.				
Remarks	For a more accurate condition and remaining useful life, a building envelope assessment has been budgeted in section "Waterproofing Membrane".

Rotten wood cladding/trim

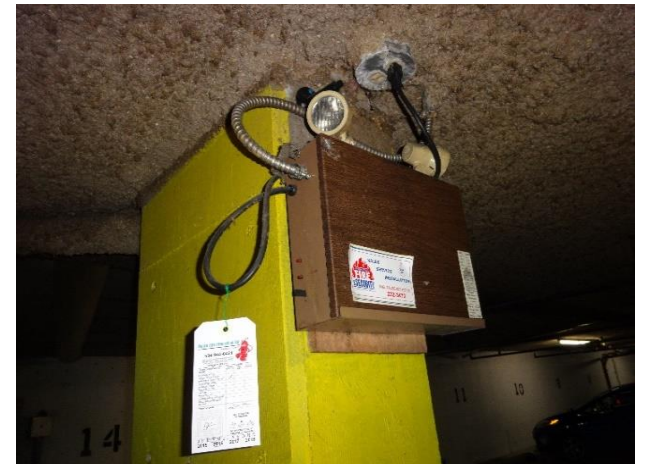
Obsolete emergency lights and battery package

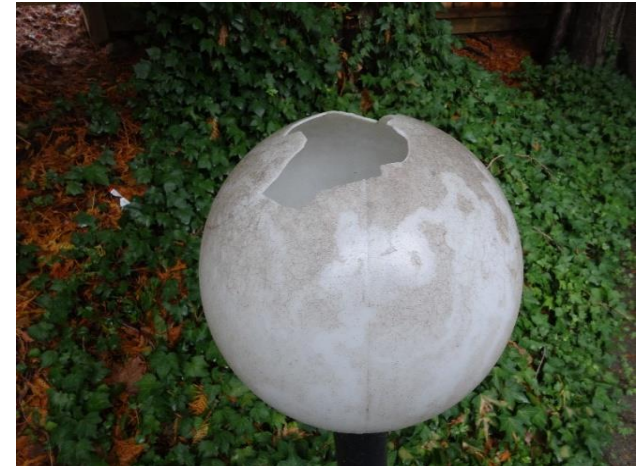
Broken plastic globe
