eSH342573-06-Form B - Information Certificate_Strata Engineering - Depreciation Report - NW1803 (revised).pdf

Absolute Building Science
Strata Engineering Inc.
#234 - 5589 Byrne Road
Burnaby, BC V3J 3J4

*NW1803 – Blue Mountain Place
1177 Howie Avenue
Coquitlam, BC*

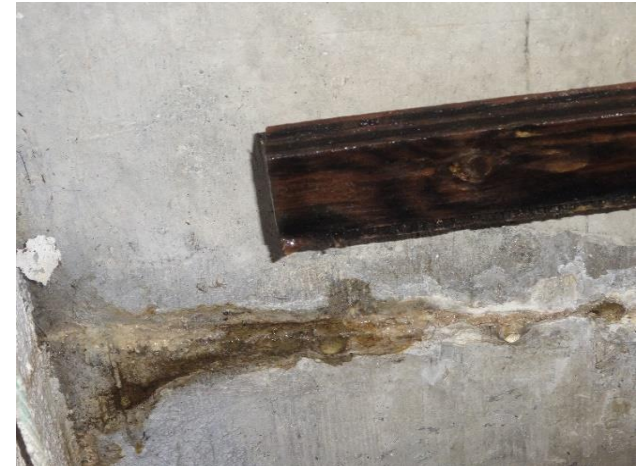
| Remarks | Localized repairs of the cracking may not be feasible anymore, given condition/age. An intrusive investigation is recommended to establish condition and provide optimal remedial solutions/costs. Deferral to address the issue may lead to remedial costs increasing exponentially. A presumptive cost for assessment was provided within the next year. | | | | |

Leaking crack on suspended slab

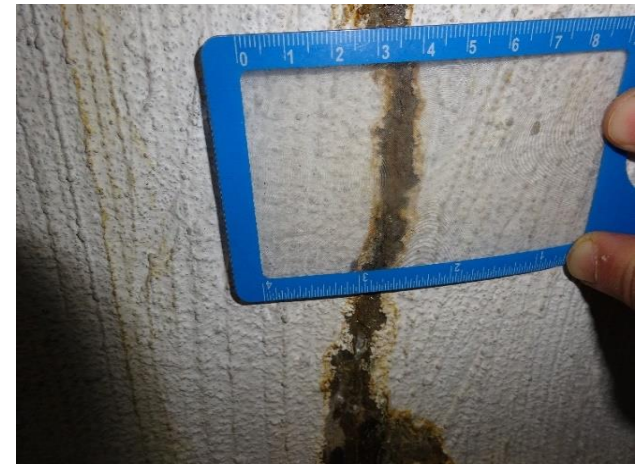
Leaking crack on wall

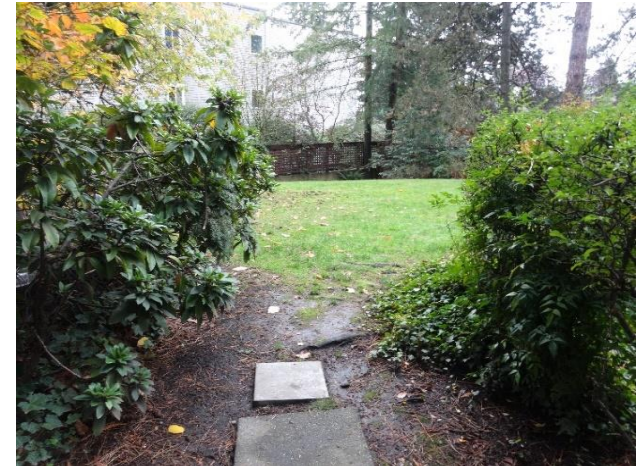
| Remarks | An intrusive investigation is recommended in order to establish condition and provide optimal remedial solutions/costs. Deferral to address the issue may lead to remedial costs increasing exponentially. A presumptive cost for the assessment was included in the cost for partial replacement of the waterproofing membrane. | | | | |

Landscaping on top of the waterproofing membrane over concrete suspended slab

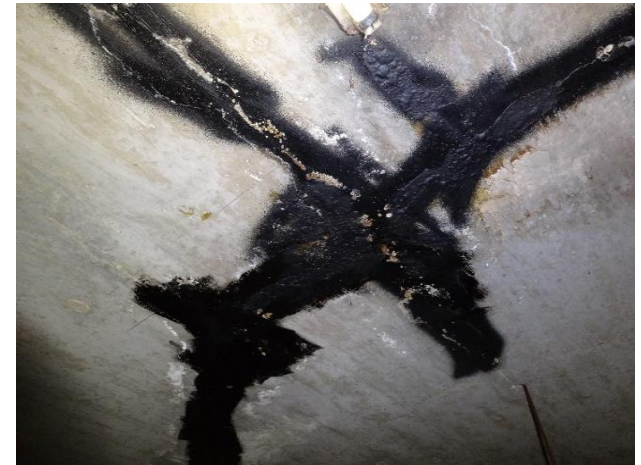
Repaired crack on the suspended slab but still leaking

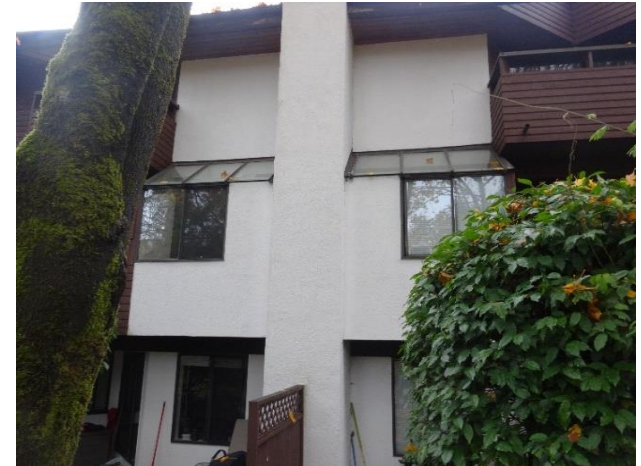
| Reserve Component B20100106 | Cladding | | | | |
|---|---|---|---|---|---|
| Remarks | An intrusive investigation is recommended in order to confirm if inner wood sheathing and structural members were not affected by the moisture trapped beneath the stucco finish. A building envelope condition assessment is budgeted for 2017 - see "Waterproofing Membrane" section. | | | | |

Stucco finishes

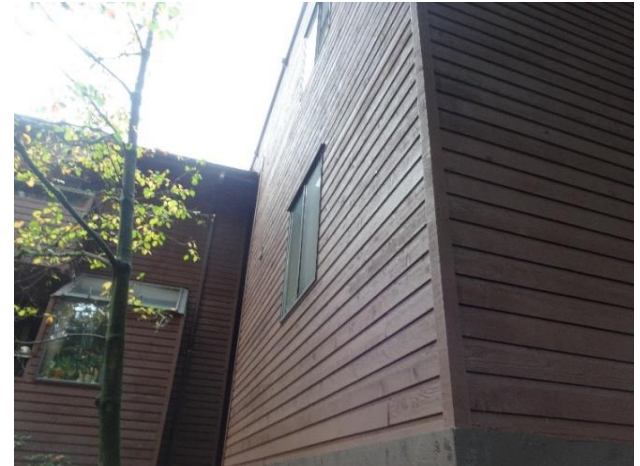
| Reserve Component B20100111 | Cladding | | | | |
|---|--|---|---|---|---|
| Remarks | For a more accurate condition and remaining useful life, a building envelope assessment has been budgeted in section "Waterproofing Membrane". | | | | |

Replaced section of wood cladding

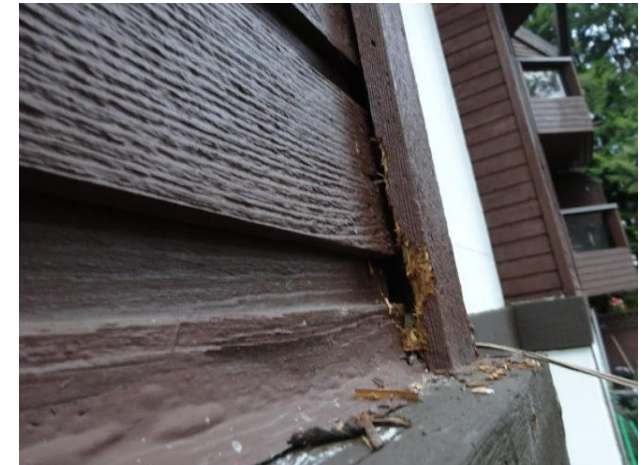
Rotten wood cladding/trim

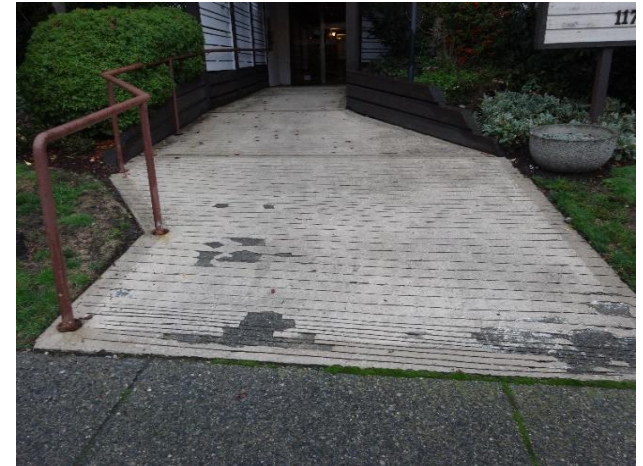
Front walkway with delamination

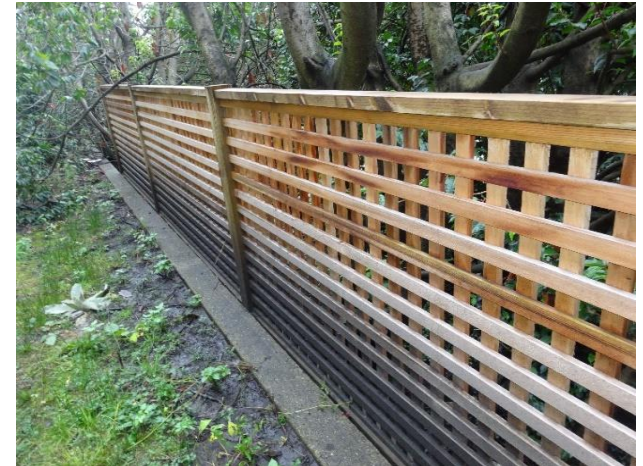
| Remarks | Partial replacement were performed recently. Further partial replacements, as needed, are expected within the next 3-5 years. | | | | |

Newer wood fence

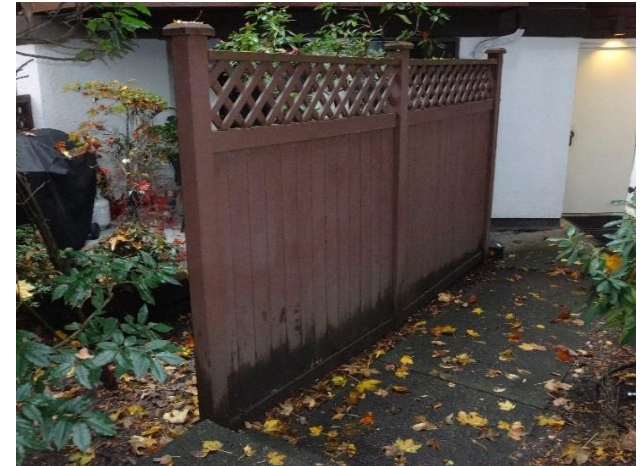
| Remarks | Repainting off the wood works are expected within the next 3-5 years, in the same time with partial replacements of more advanced deteriorated portions - see previous item. | | | | |

Paint on patio wood divider

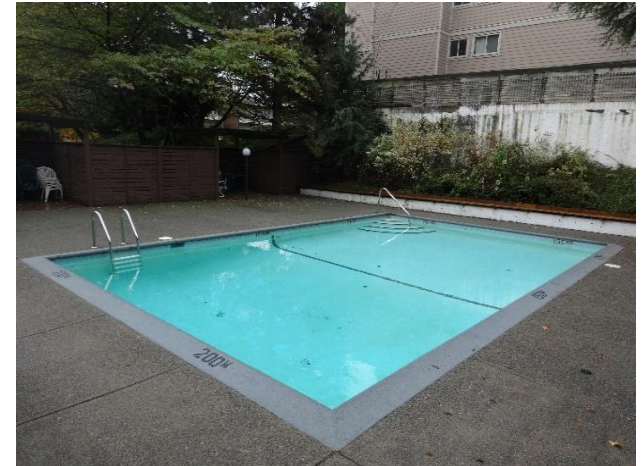
| Remarks | Inspection and local repairs of the lining in order to prevent water leaking. Generally a major rehabilitation is known to be necessary every 10-15 years. | | | | |

Pool lining

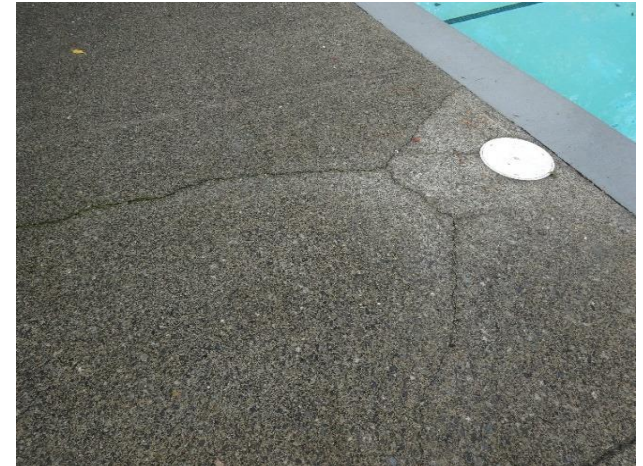
| Remarks | A general retrofit of the pool decking and related accessories is expected to be performed at the earliest convenience in order to avoid water seepage and further damages. | | | | |

Cracked pool concrete decking

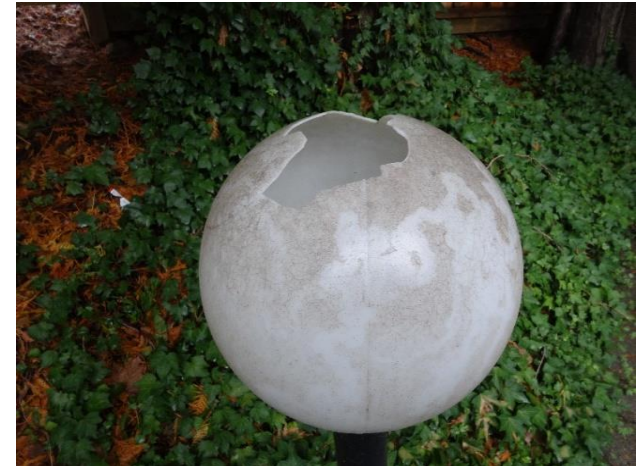
Broken plastic globe

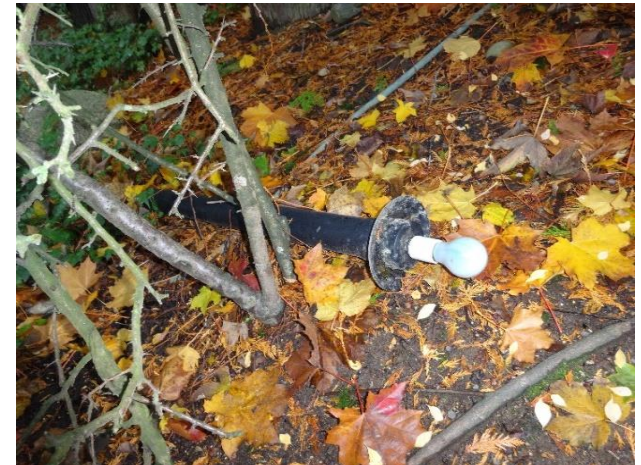
Fallen post with light fixture
