NW1389 THE WILLOWS

1103 and 1121 Howie Avenue, Coquitlam, BC

**DEPRECIATION REPORT
MAY 2014**

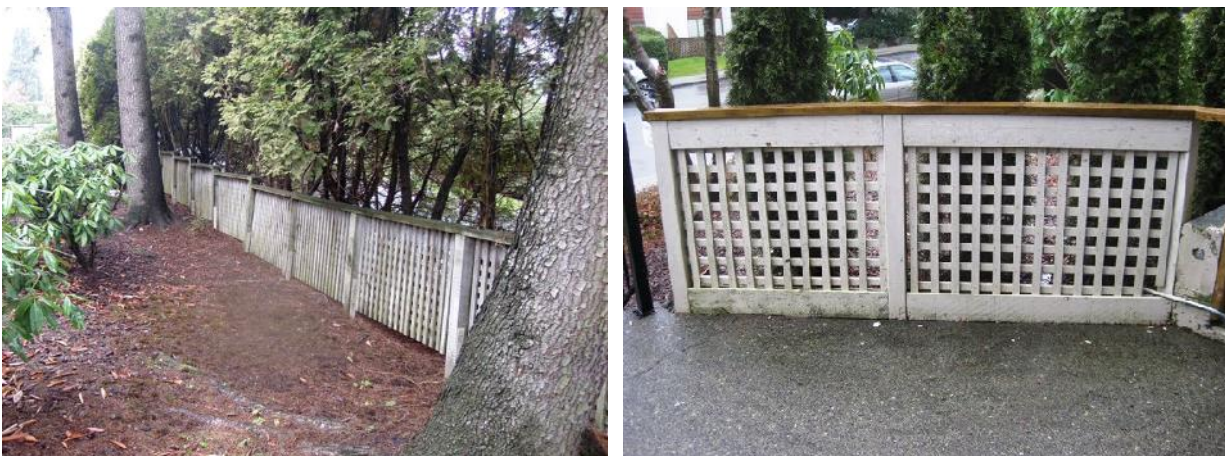
Cedar lattice fencing is at the north and east perimeter of the property. This fencing is weathered. A budget estimate for replacement and staining is provided in the Costs section. We recommend staining every ten years to extend the lifespan.

Fig 31. Cedar lattice fencing on the north side of the property (left). Painted cedar lattice fencing near one of the front entrances (right).

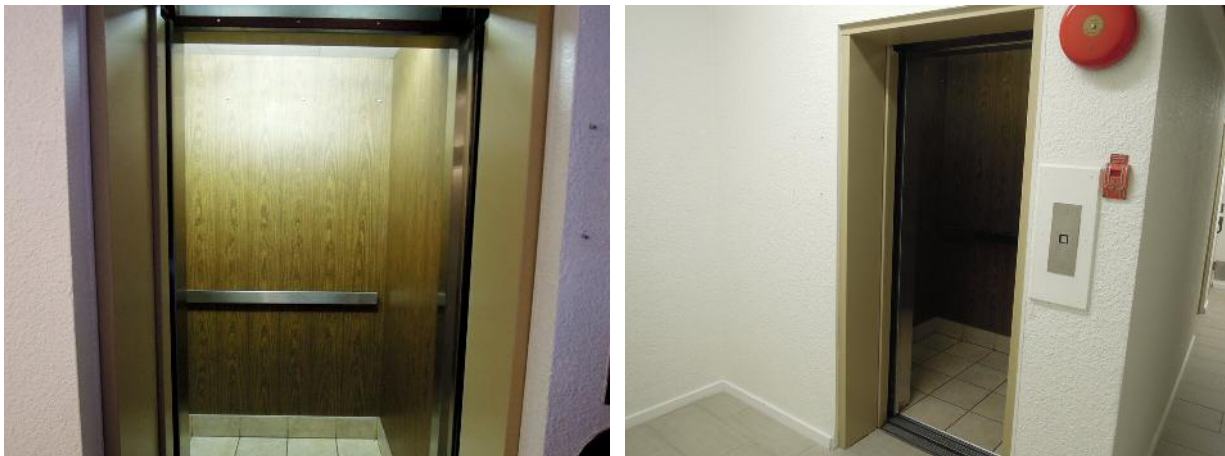
Each building has a hydraulic elevator. They are maintained monthly by West Coast Elevator. The elevators were built in 1979 and are thirty-five years old. In general hydraulic elevators have approximately thirty years of reliable operation. Both usage levels and the regularity of maintenance will affect the actual lifespan. After thirty years full modernization is recommended. West Coast Elevator noted that the cylinder for each elevator is past the end of life. See the Costs section for a budget estimate.

Fig 43. A view of the cab of one of the elevators (left). A view of an elevator call station in a basement hallway (right).

We recommend the strata budget for the cylinder replacement and modernization over the next ten years. However there is no way to predict when a failure may occur. For more detailed information, contact West Coast Elevator.

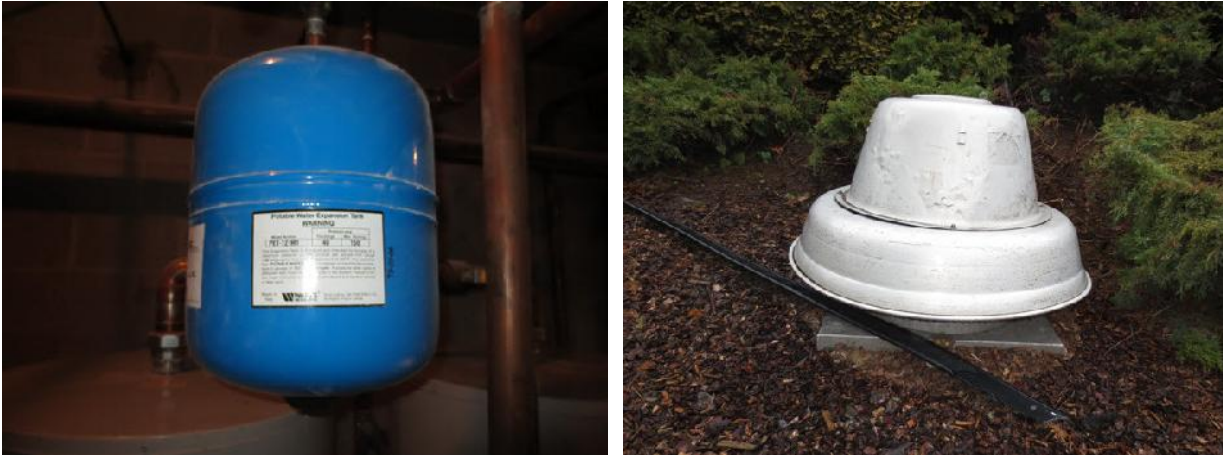
Exhaust fans maintain a negative airflow to ensure no noxious gasses are present. They also help keep the air fresh and prevent moisture build up. Two belt driven exhaust fans service each parkade. The fans have dome exteriors and are situated on the west sides of the grounds. A Delhi exhaust fan is also in the electrical room in Building A. There are generic extractor fans in the storage rooms and bathrooms. These fans were not functional at the time of the site visit.

Fig 44. A water pressure expansion tank (left). A domed parkade exhaust fan situated on the grounds (right).

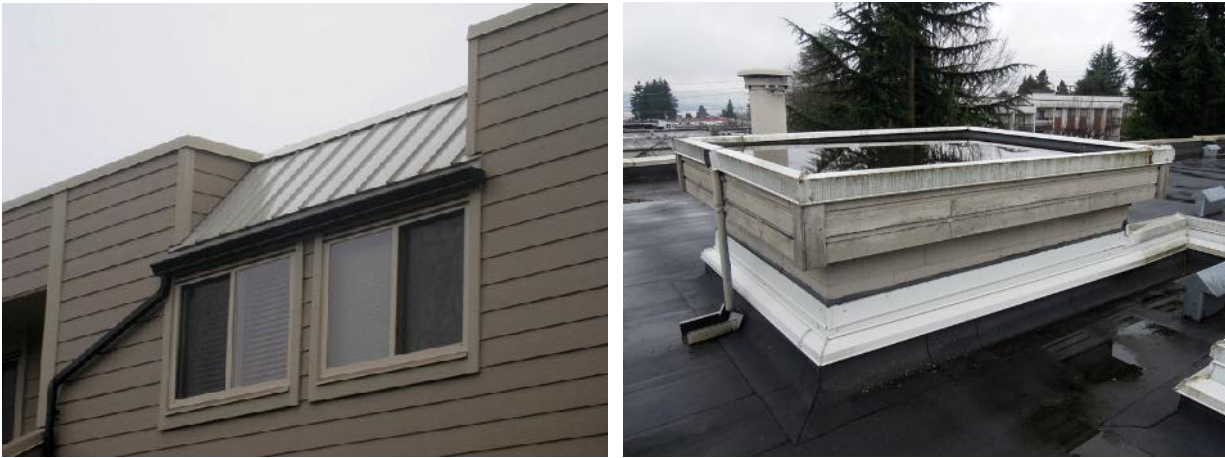
Fig 53. Gutters under a metal panel sloped roof (left). An elevator penthouse (right).

There is an elevator penthouse on the roof of each building. The penthouses have concrete block and cedar siding exterior walls. There is a flat roof system with a scupper drain and downspout. Pooling was observed on both roofs.

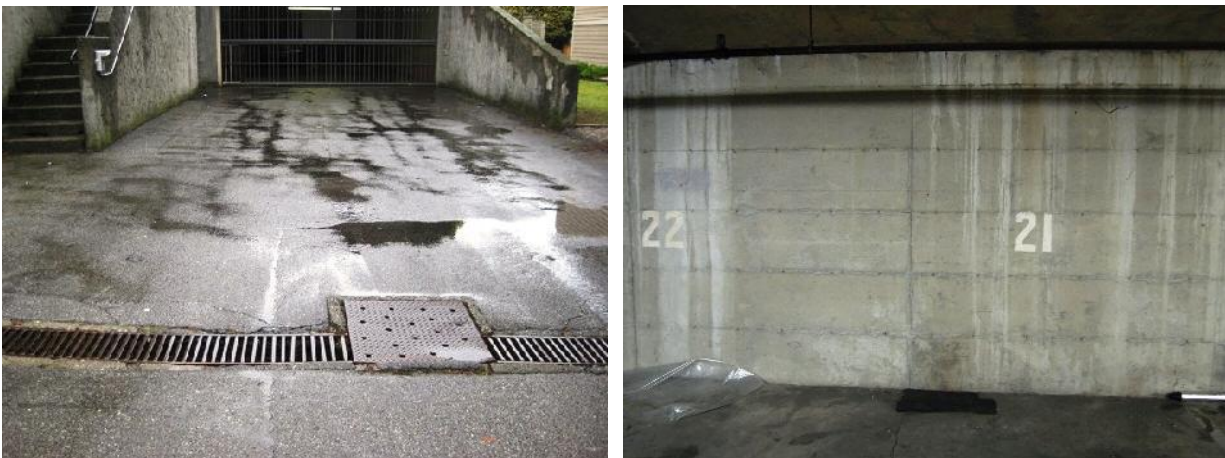
Fig 59. An asphalt driveway (left). Cast in place concrete foundation walls (right).

Foundation walls in the parkades are cast in place reinforced concrete. Some active leaks were observed along the north walls at Building A. Repairs are recommended. For a detailed

assessment with a breakdown of recommended repairs, see the Sealright Concrete Restoration budget estimate in Appendix C.

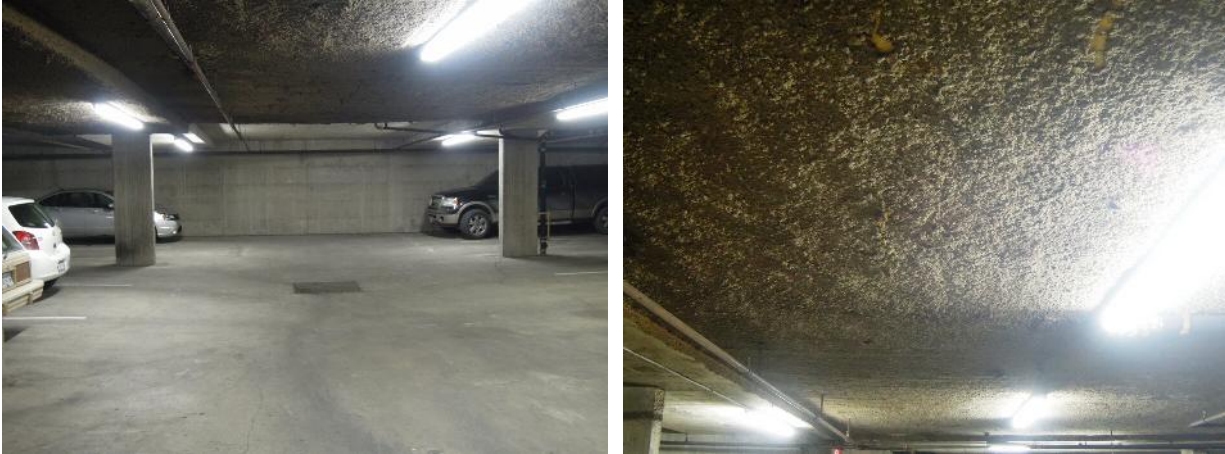
Fig 62. Another view of the slab on grade (left). An insulated section of the suspended slab (right).

There are a few active leaks including a leaking vent stack at Building B. A budget estimate for repairs is included in the Costs section. For a detailed assessment with a breakdown of recommended repairs, see the Sealright Concrete Restoration budget estimate in Appendix C.

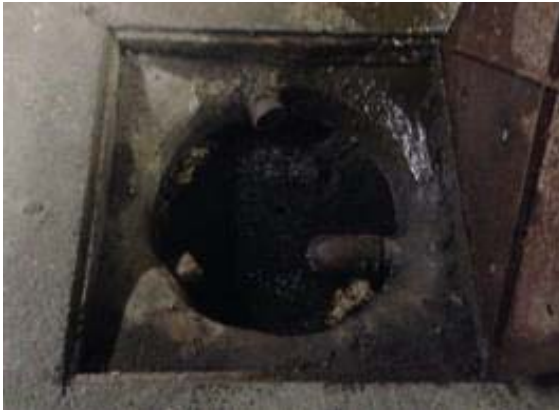
11. Sump Drain A on the west side of the building. We suggest scoping the associated drain pipes to verify their condition.

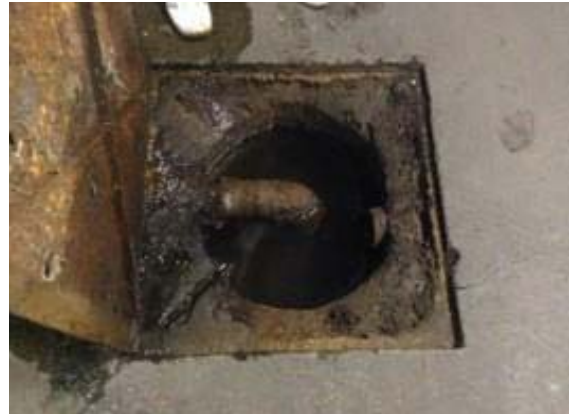
12. Sump Drain B on the east side of the building. We suggest scoping the associated drain pipes to verify their condition.

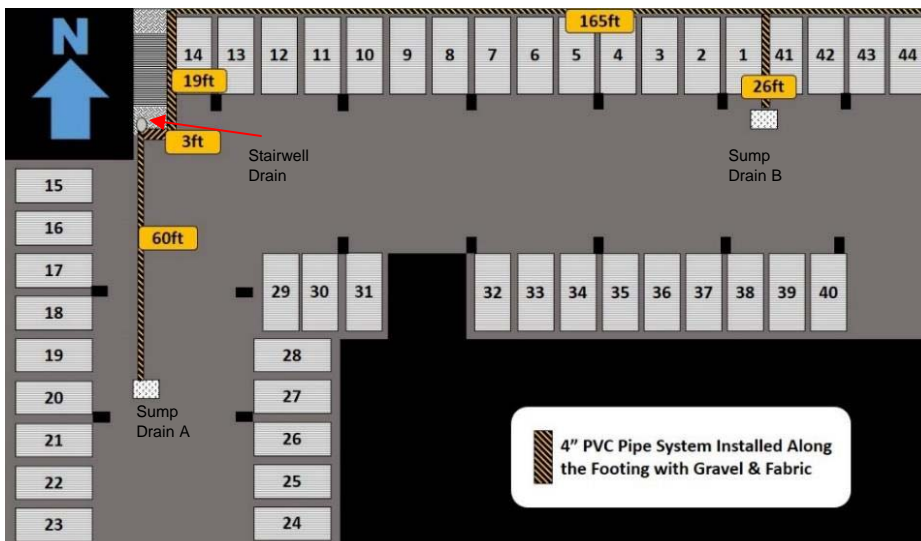
13. Drainage map proposal installing perforated weeping drain pipe to relieve hydrostatic water pressure beneath the parkade slab. will effectively move ground water from the areas in question to the associated sump drains.

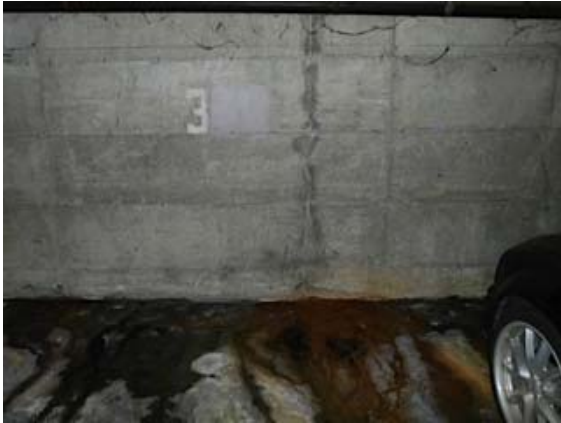
14.Item B. Water ingress along north facing slab to wall interface. Water seeping up through cold joint from below the floor slab.

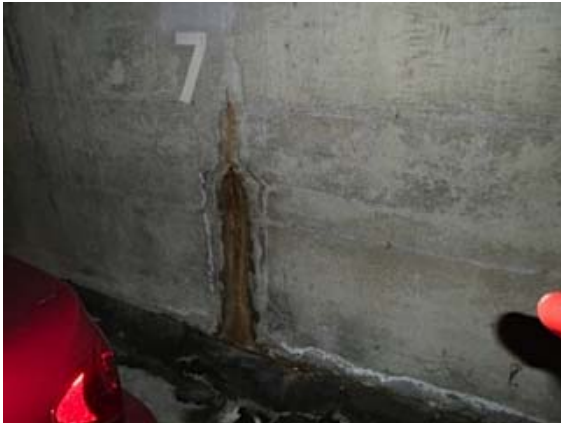
15.Item C stall #7 Water seeping up through cold joint crack void in wall.

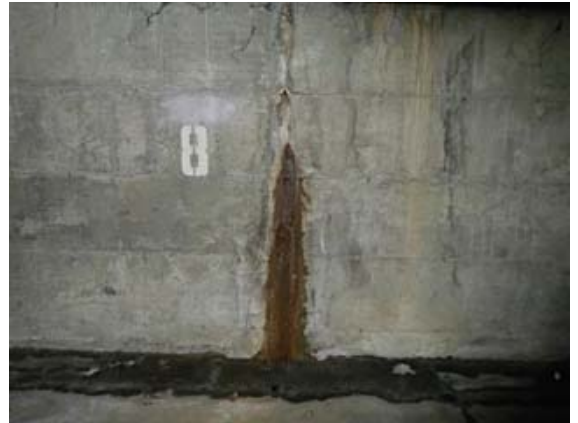
16.Item C stall #8 Water seeping up through cold joint crack and concrete tie void in wall.

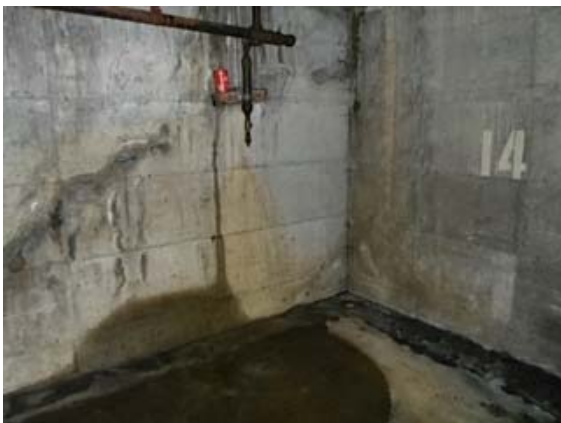
17.Item C stall #14 Water seeping up through crack and concrete honeycomb void in wall. Note crack contours staircase adjacent to exterior wall

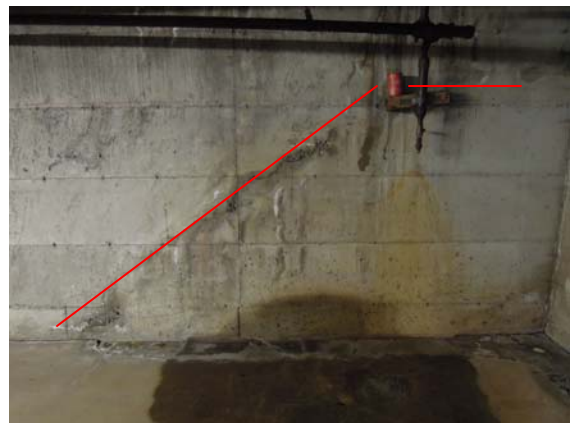
18.Item C stall #14 west wall Water seeping up through crack and concrete honeycomb void in wall. Note crack contours staircase adjacent to exterior wall

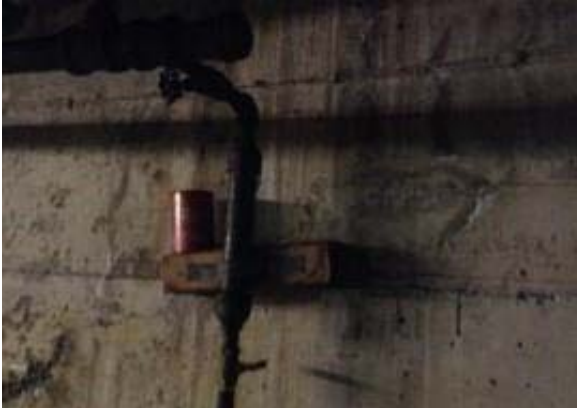
19.Item C stall #14 Water seeping up through crack. A 1ft crack is also apparent behind the wood frame supporting the piping adjacent to the wall.

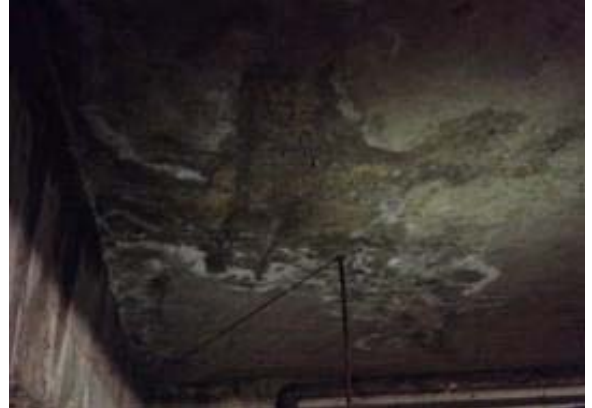
20.Item C stall #14 Water seeping down through ceiling crack. A 10ft crack expanding in diagonal from the West wall of the stall to the Northern Wall and a few branching cracks.

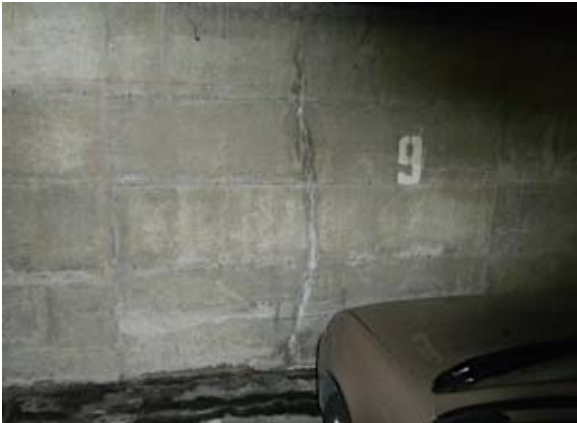
21.Item C-1 stall #9 Additional non active cracks.

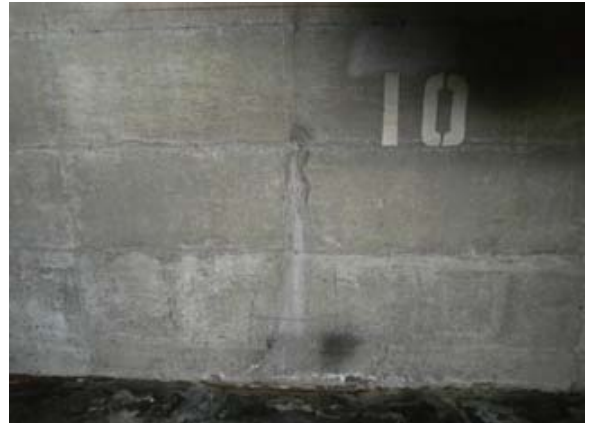
22.Item C-1 stall #10 Additional non active cracks.

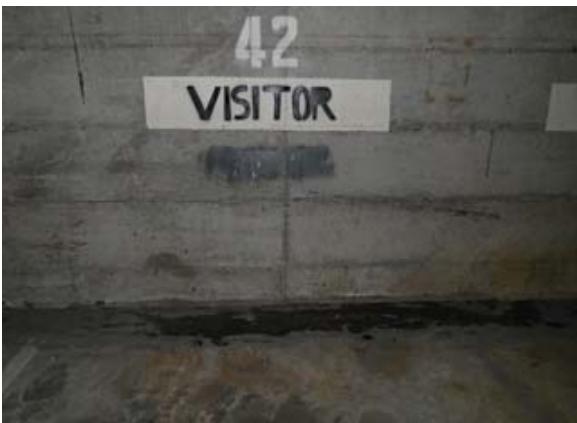
23.Item C-1 stall #42 Additional non active cracks.

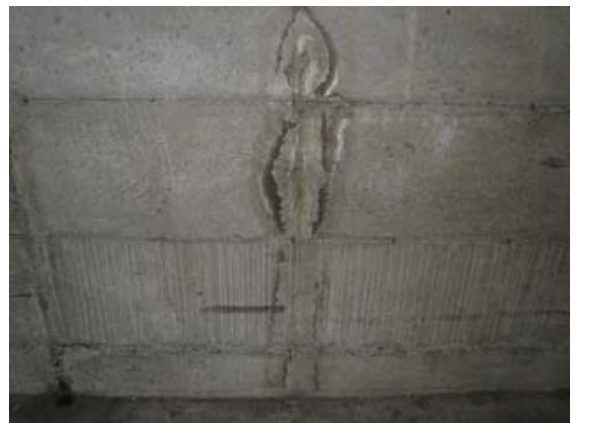
24.Item C-1 stall # Additional non active cracks.

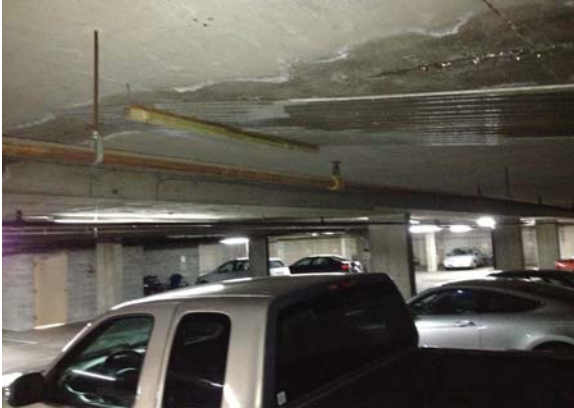
01. Item A Stall # 4-5 15ft ceiling crack emanating from the north wall and ceiling joint expanding outward. We can assume this crack has been leaking for a long period of time as calcite nodules have built up along the

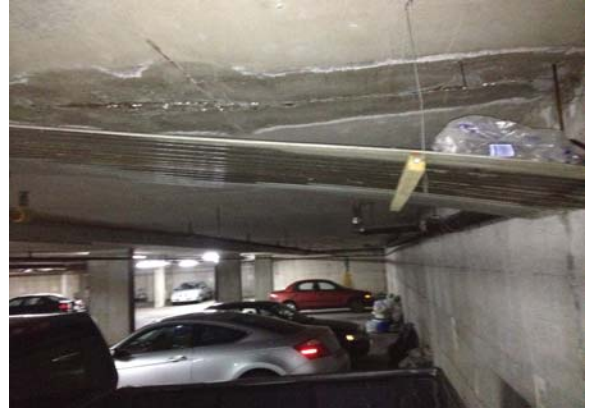
02. Item A stall # 4-5 01. Stall # 4-5 15ft ceiling crack a corrugated panel has been installed below the leaking area of the crack to divert the leaking water away from the parking stall.

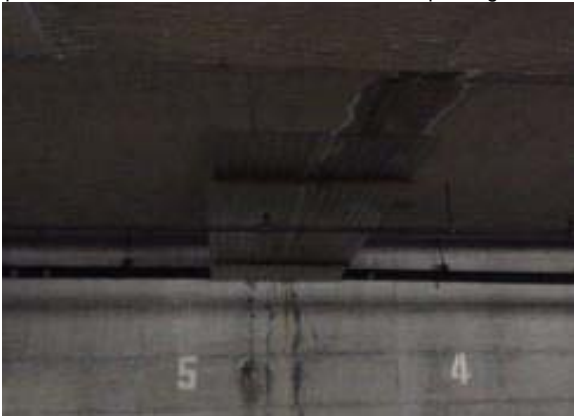
03. Item A Stall # 4-5 15ft ceiling crack emanating from the north wall and ceiling joint expanding outward.

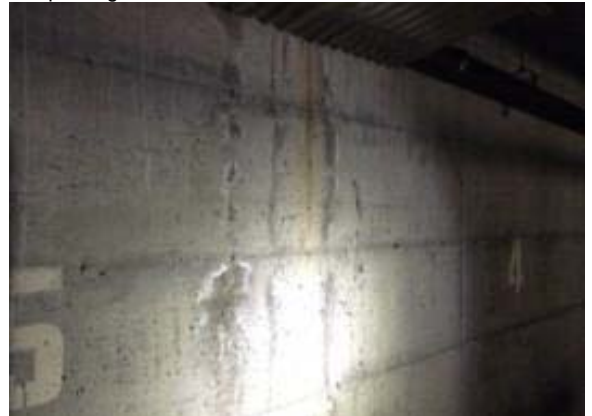
04. Item A Stall # 4-5 8ft wall crack from base to the upper end of the wall. The crack is actively leaking from the mid wall.

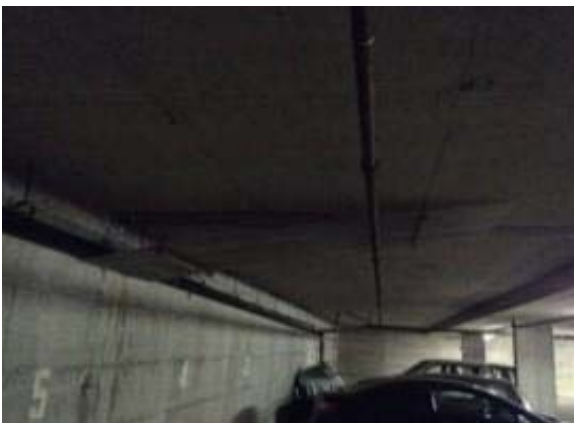
05. Item A Stall # 4-5 15ft ceiling crack emanating from the north wall and ceiling joint expanding outward.

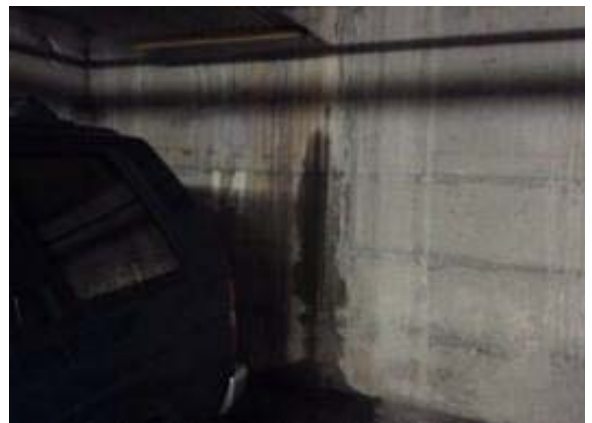
06. Item A Stall # 14 (Active) 5 lf of wall cracks Crack from base to the upper end of the wall. The crack is actively leaking from the mid wall.

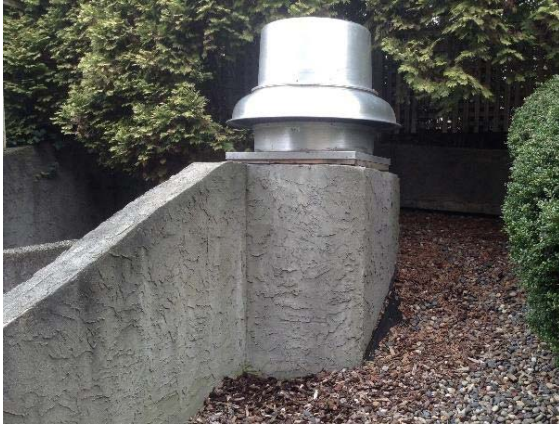
07.Item B topside of vent stack and surrounding landscaping. Location of sump drain A west side of building
