Engineering Investigation

Parking Garage Condition Assessment

The Willows

Strata Plan NWS1389
The Willows
1121 & 1103 Howie Avenue,
Coquitlam, BC V3J 1T9

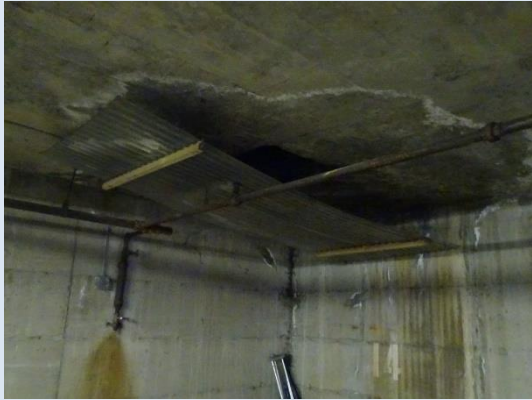
<p><u>Location:</u> East building garage – Around an exhaust penetration.</p> <p><u>Defect:</u> Widespread moisture staining and efflorescence.</p> <p><u>Remarks:</u> The waterproofing around the penetration has failed.</p>

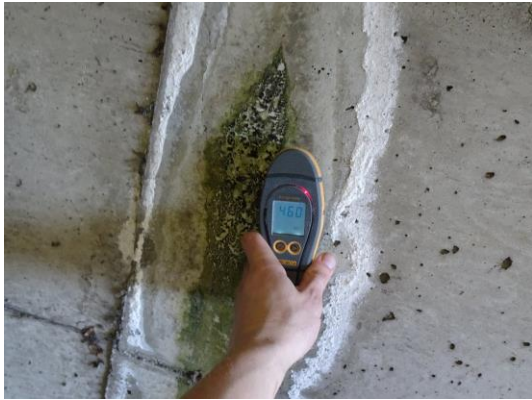
<p><u>Location:</u> East building garage - East wall near the entrance.</p> <p><u>Defect:</u> Efflorescence and elevated moisture readings around a hairline crack.</p> <p><u>Remarks:</u> The waterproofing for the foundation wall has failed.</p>

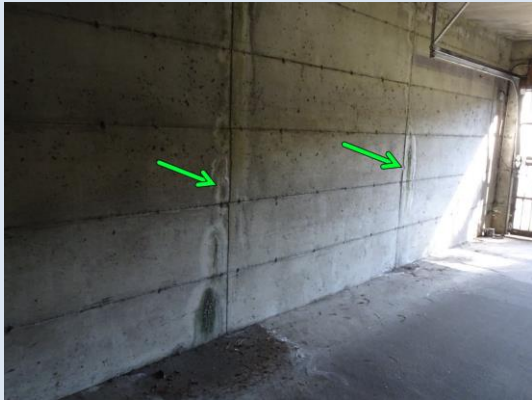
<p><u>Location:</u> East building garage - East wall near the entrance.</p> <p><u>Defect:</u> Efflorescence and staining around hairline cracks.</p> <p><u>Remarks:</u> The waterproofing for the foundation wall has failed.</p>

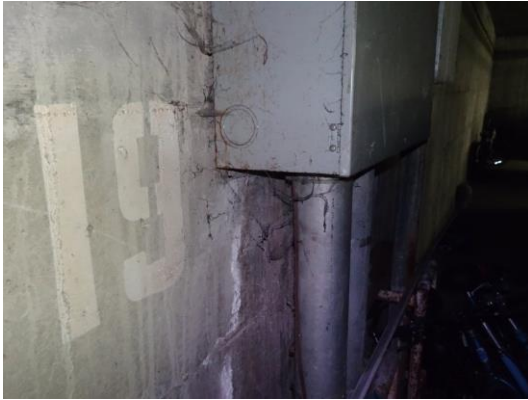
Figure 4

Location: East building garage - Electrical utility boxes at parking stall 19.

Defect: Efflorescence.

Remarks: The waterproofing for the foundation wall has failed.

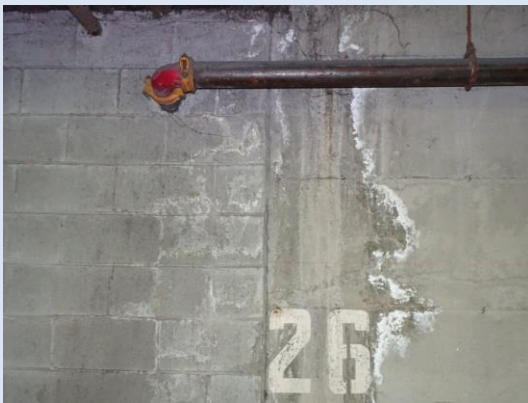
Figure 5

Location: East building garage – Wall by the parking stall #26.

Defect: Efflorescence and moisture staining.

Remarks: The waterproofing around the fresh air intake may have failed.

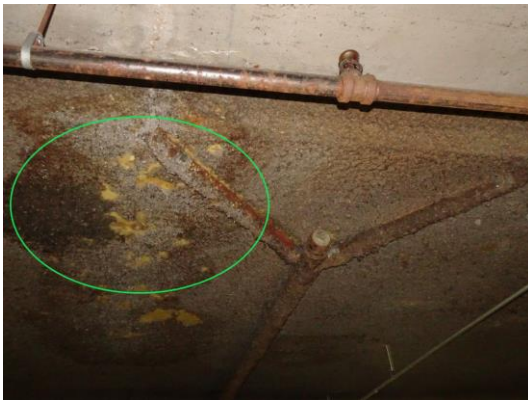
Figure 6

Location: East building garage - Storm drain penetration.

Defect: Moisture staining surrounding a storm drain penetration through the slab.

Remarks: The waterproofing has failed around the exterior of the drain.

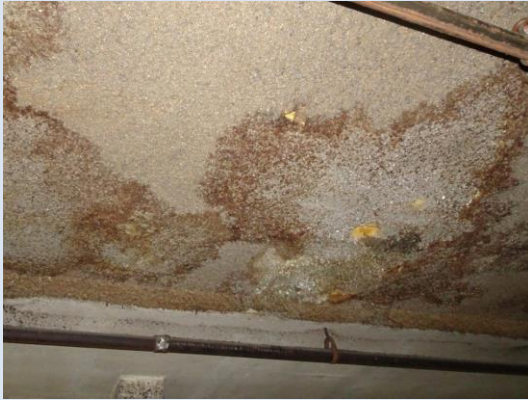
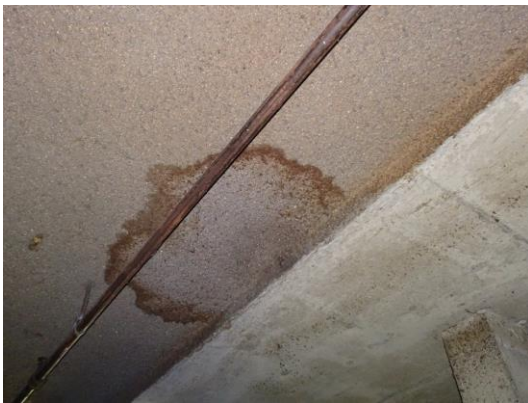
Figure 7

Location: East building garage - Suspended ceiling slab.

Defect: Widespread moisture staining on the ceiling.

Remarks: The moisture ingress is likely occurring at the exterior (non-insulated side) and migrating to the interior (insulated side) due to various waterproofing defects.

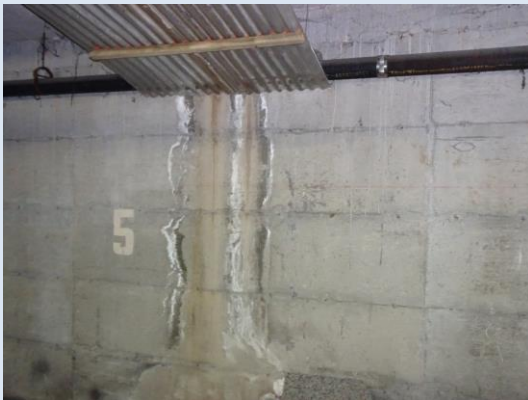
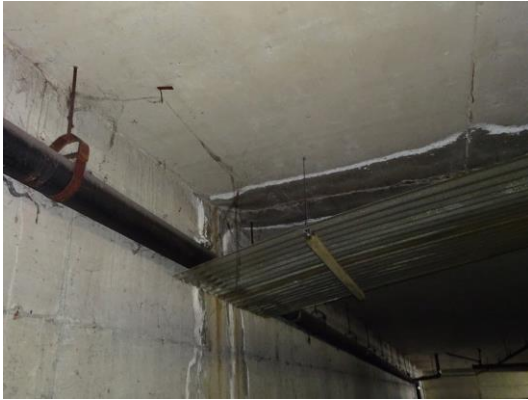
Figure 9

Location: East building garage – ceiling by the parking stall #5.

Defect: Efflorescence and moisture staining.

Remarks: The water ingress is originating at the ceiling slab.

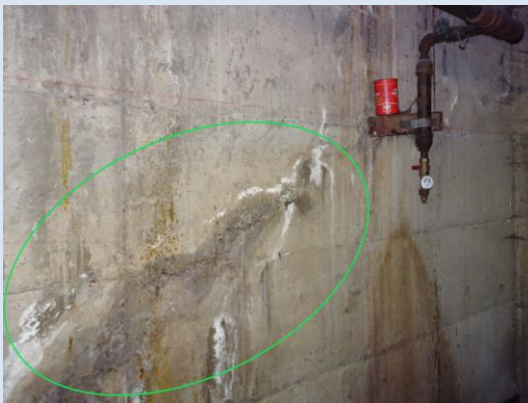
Figure 11

Location: West building garage - Wall beside the west exit stairwell.

Defect: Evidence of water ingress.

Remarks: Based on the pattern of the staining, the waterproofing for the concrete stairs has likely failed.

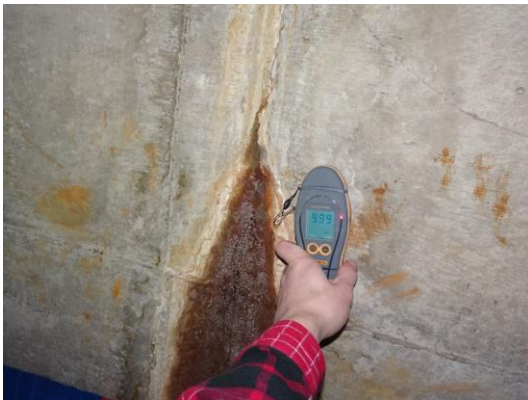
Figure 12

Location: West building garage - Parking stall 8.

Defect: High moisture reading and rusty moisture staining around a hairline crack.

Remarks: The waterproofing for the foundation wall has failed.

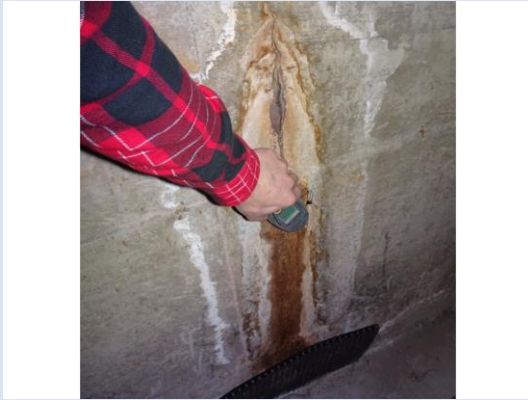
Figure 13

Location: West building garage - Parking stall 7.

Defect: High moisture reading and rusty moisture staining around a hairline crack.

Remarks: The waterproofing for the foundation wall has failed.

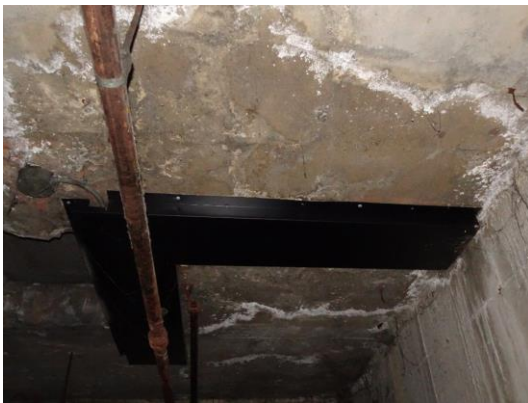
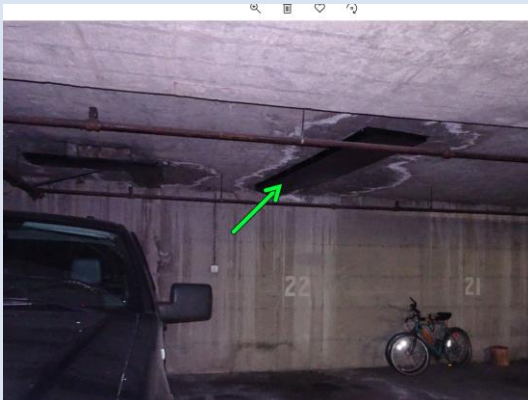
Figure 14

Location: East building garage - Ceiling at parking stall 22.

Defect: Widespread efflorescence in the ceiling slab.

Remarks: The waterproofing membrane has failed.

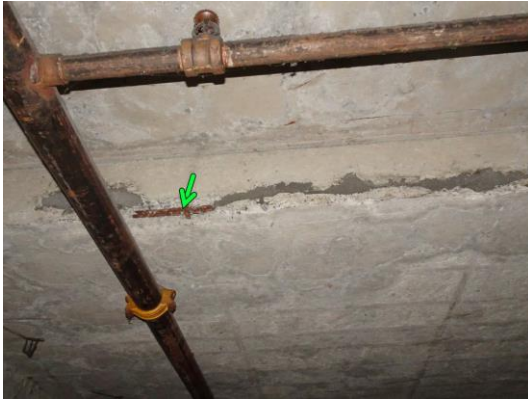
Figure 16

Location: East building garage - South west parking area.

Defect: Exposed, corroding rebar, and spalling concrete.

Remarks: The exposed rebar is resulting in spalling damage to the surrounding concrete.

- **Exposed and corroding rebar in the ceiling slab.** This is a casting defect which has worsened over time due to insufficient concrete cover and environmental conditions in the parking garage. This condition will result in continued structural deterioration and weakening of the concrete structure.

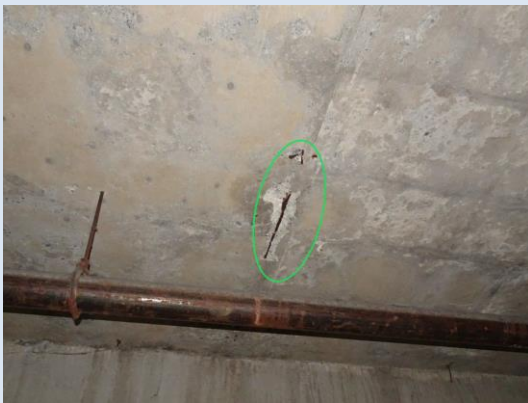
Figure 17

Location: East building garage - South west parking area.

Defect: Exposed, corroding rebar, and spalling concrete.

Remarks: The exposed rebar is resulting in spalling damage to the surrounding concrete.

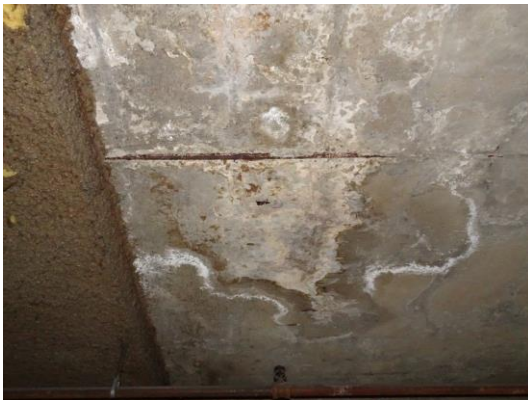
Figure 18

Location: East building garage - South west parking area.

Defect: Exposed, corroding rebar, and spalling concrete.

Remarks: The exposed rebar is resulting in damage to the surrounding concrete.

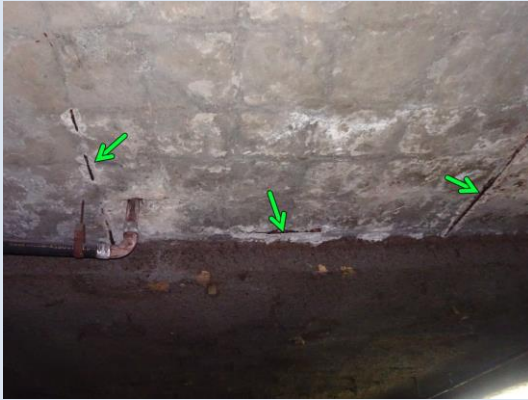
Figure 19

Location: East building garage - South west parking area.

Defect: Exposed, corroding rebar, and spalling concrete.

Remarks: The exposed rebar is resulting in damage to the surrounding concrete.

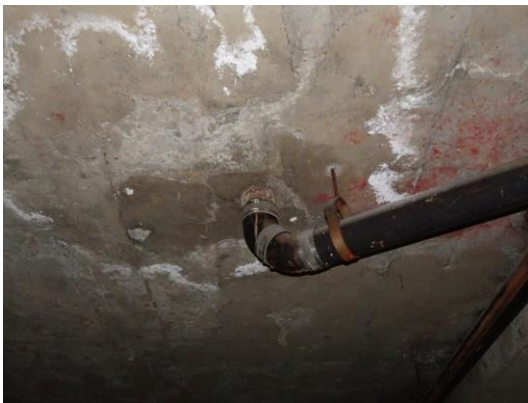
Figure 20

Location: East building garage - Storm drain penetration through the ceiling slab.

Defect: Efflorescence around the penetration.

Remarks: Waterproofing around the exterior drain has failed.

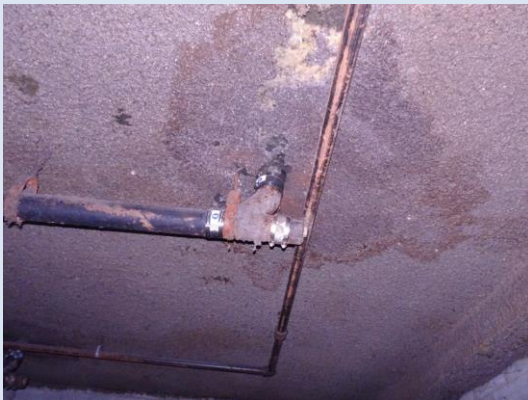
Figure 21

Location: East building garage - drain penetration through the ceiling slab.

Defect: Efflorescence around the penetration.

Remarks: This drain appears to be under the building's footprint, further investigation is required to determine the source of this leak.

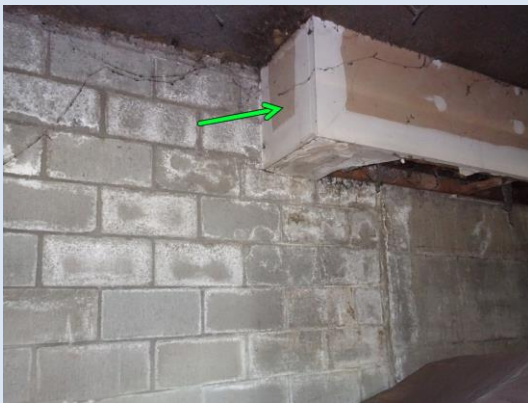
Figure 23

Location: West building garage - Bulkhead for the fresh air intake.

Defect: Efflorescence and moisture staining surrounding the bulkhead.

Remarks: Rainwater may be leaking into the ductwork, further investigation is required.

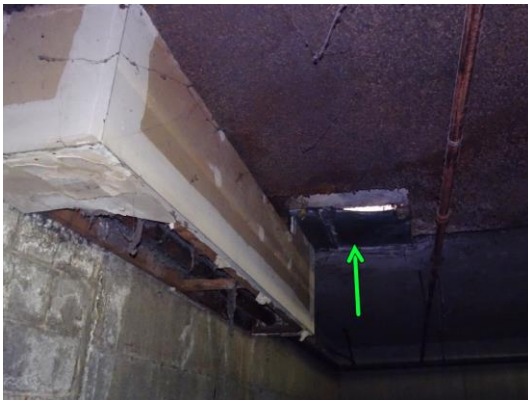
Figure 24

Location: West building garage - Bulkhead for the fresh air intake.

Defect: Efflorescence and moisture staining surrounding the bulkhead.

Remarks: Rainwater may be leaking into the ductwork, further investigation is required.

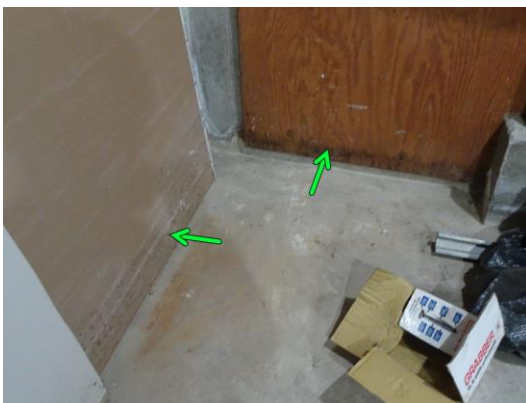
Figure 26

Location: East building garage - Electrical room.

Defect: Mildew on the drywall and plywood.

Remarks: Reportedly, there is flooding in this room during heavy rainfall. This is most likely related to a failed foundation waterproofing or deficient foundation drainage system.

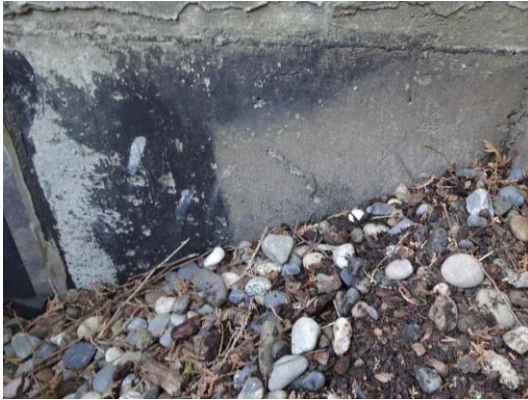
Figure 28

Defect: Previous waterproofing repairs were observed. However, the adjacent damp-proofing is weathered.

Remarks: Waterproofing for this area is inconsistent.

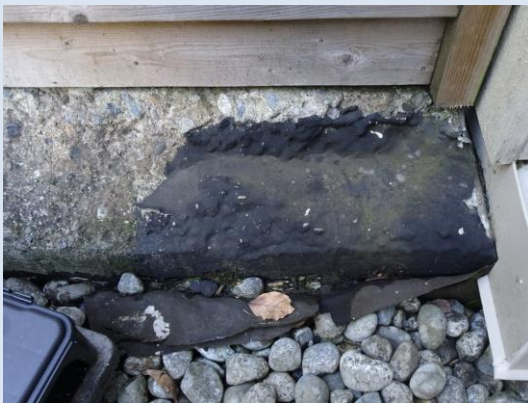
Figure 29

Location: East building exterior -
Throughout.

Defect: Weathered and inconsistent
waterproofing.

Remarks: The waterproofing is in poor
condition.

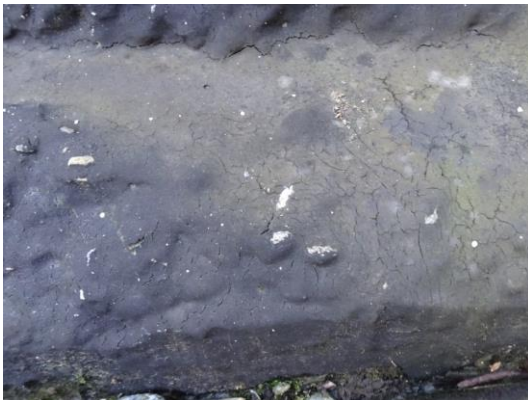
Figure 30

Location: East building exterior -
Throughout.

Defect: Weathered waterproofing.

Remarks: The waterproofing is in poor
condition.

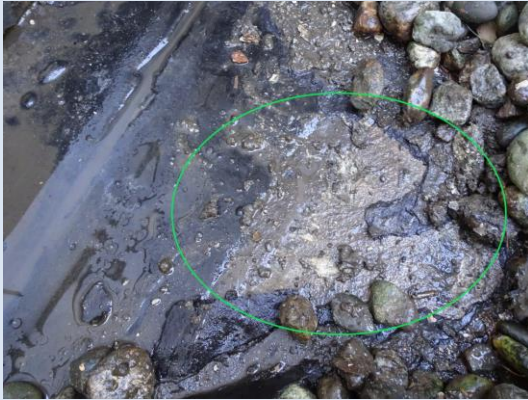
Figure 31

Location: East building exterior - North elevation perimeter.

Defect: Exposed concrete slab.

Remarks: Poor coverage of waterproofing.

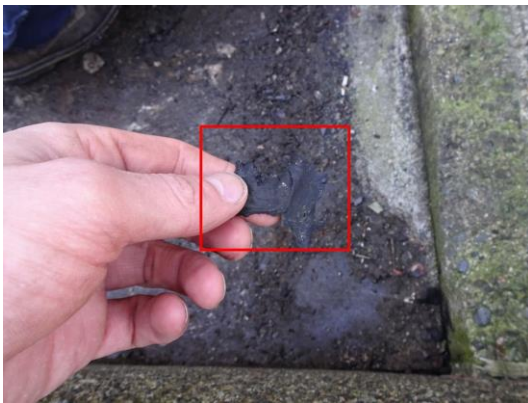
Figure 32

Location: East building exterior - North elevation perimeter.

Defect: The membrane is easily removed.

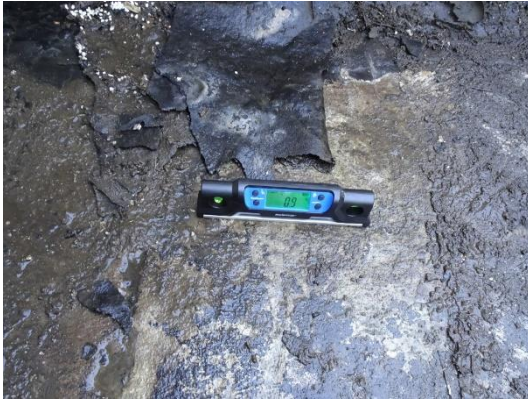
Figure 34

Location: East building exterior - North elevation perimeter.

Defect: Exposed concrete slab and marginal sloping.

Remarks: Poor coverage of waterproofing.

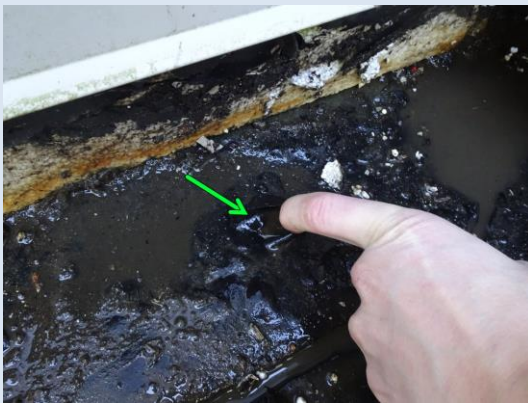
Figure 35

Location: East building exterior - North elevation perimeter.

Defect: Various water filled blisters.

Remarks: The waterproofing membrane has failed.

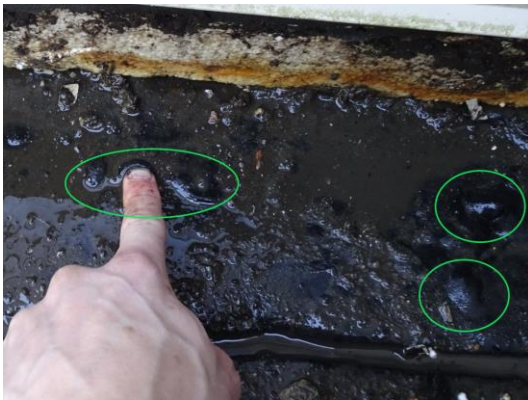
Figure 36

Location: East building exterior - North elevation perimeter.

Defect: Various water filled blisters.

Remarks: The waterproofing membrane has failed.

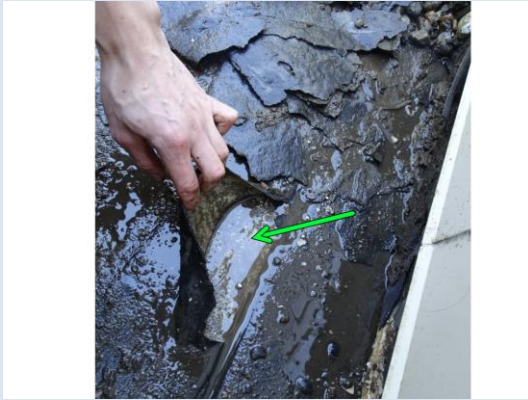
Figure 37

Location: East building exterior - North elevation perimeter.

Defect: The waterproofing membrane is removed with little effort.

Remarks: The waterproofing membrane has failed.

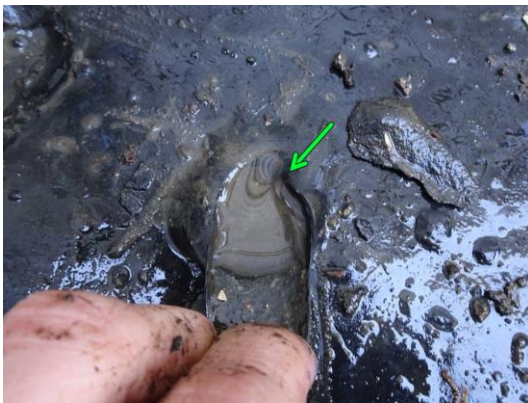
Figure 38

Location: East building exterior - North elevation perimeter.

Defect: Water filled blister.

Remarks: The waterproofing membrane has failed.

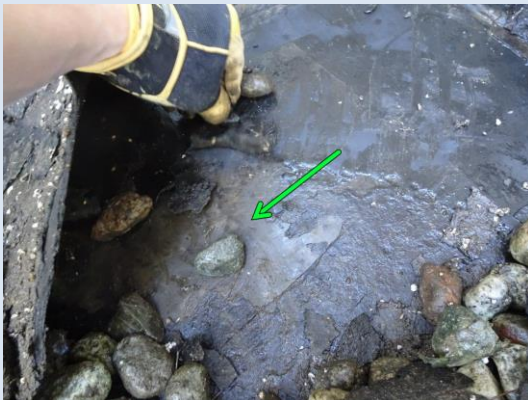
Figure 39

Location: East building exterior - North elevation perimeter.

Defect: Inconsistent layering of the waterproofing.

Remarks: Poor coverage of the waterproofing membrane.

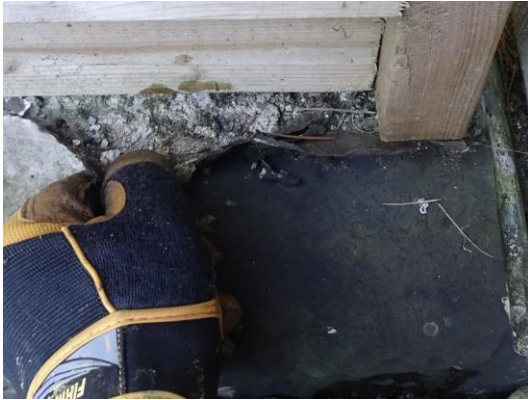
Figure 40

Location: East building exterior - Throughout.

Defect: The waterproofing is removed with little effort.

Remarks: The waterproofing has failed.

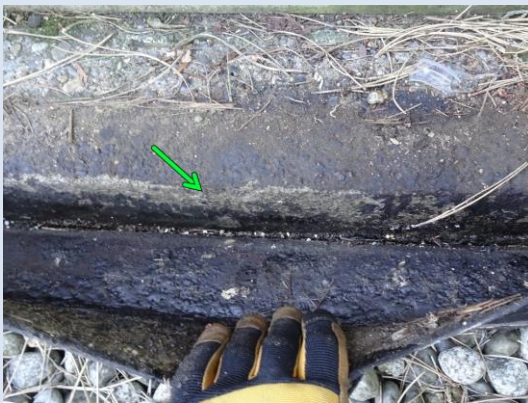
Figure 41

Location: East building exterior - Throughout.

Defect: Weathered waterproofing membrane.

Remarks: The waterproofing membrane has failed.

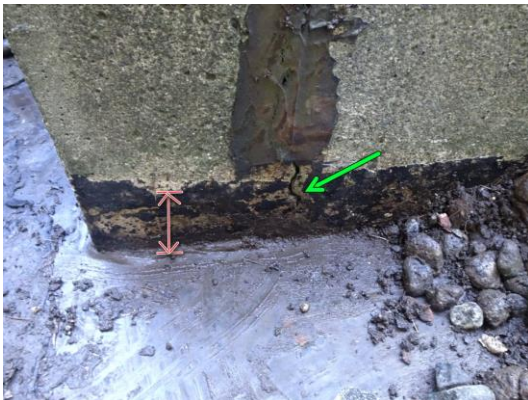
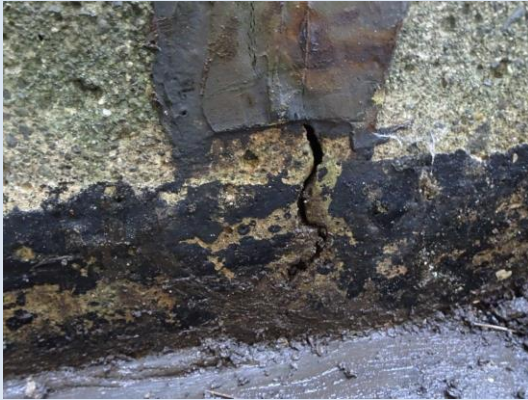
Figure 42

Location: East building exterior - Various concrete curb areas.

Defect: Minimal waterproofing upturn and cracking in the concrete curb.

Remarks: This area is at a high risk for water ingress.

- **Marginal membrane upturns at concrete curbs.** Membrane upturns at the concrete curbs were observed to be roughly two inches high in some locations, pooling water exceeding this upturn height can migrate into the concrete ceiling slab of the parking garage.

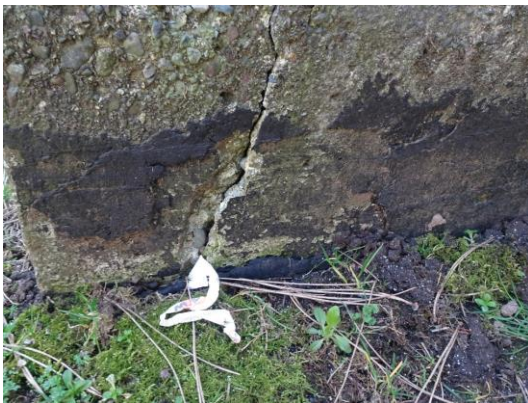
Figure 44

Location: East building exterior - Various concrete curb areas.

Defect: Weathered waterproofing and cracking in the concrete curb.

Remarks: This area is at a high risk for water ingress.

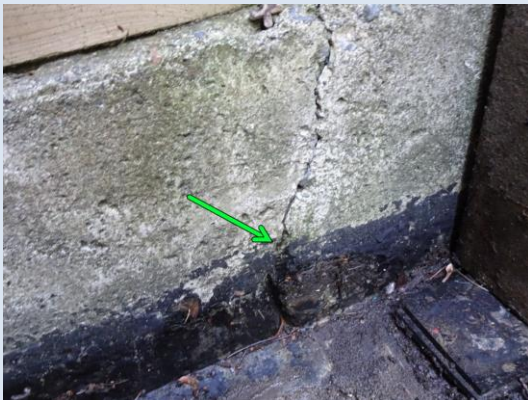
Figure 45

Location: East building exterior - Various concrete curb areas.

Defect: Weathered waterproofing and cracking in the concrete curb.

Remarks: This area is at a high risk for water ingress.

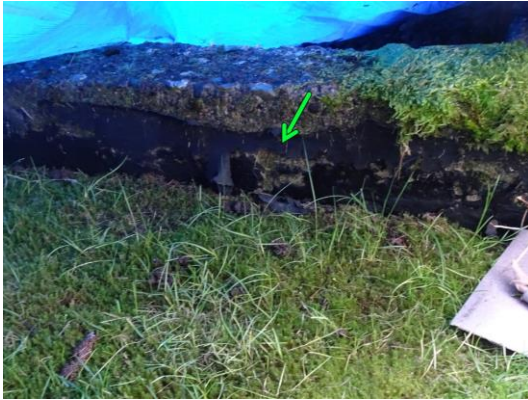
Figure 46

Location: East building exterior - Various concrete curb areas.

Defect: Weathered waterproofing.

Remarks: This area is at a high risk for water ingress.

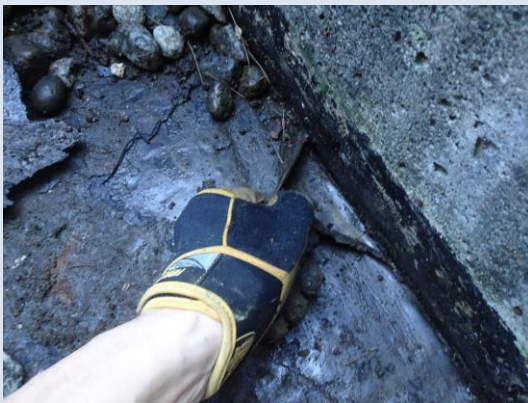
Figure 47

Location: East building exterior - North elevation perimeter.

Defect: Weathered waterproofing.

Remarks: This area is at a high risk for water ingress.

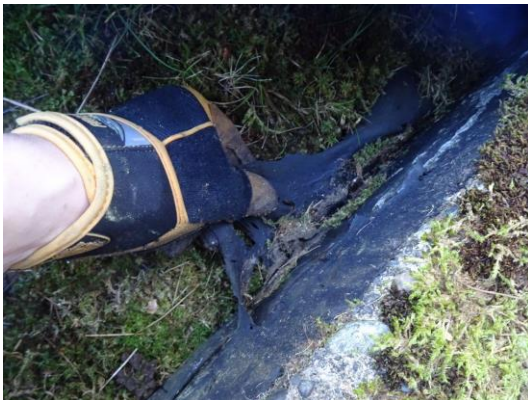
Figure 48

Location: East building exterior - North elevation perimeter.

Defect: Weathered waterproofing.

Remarks: This area is at a high risk for water ingress.

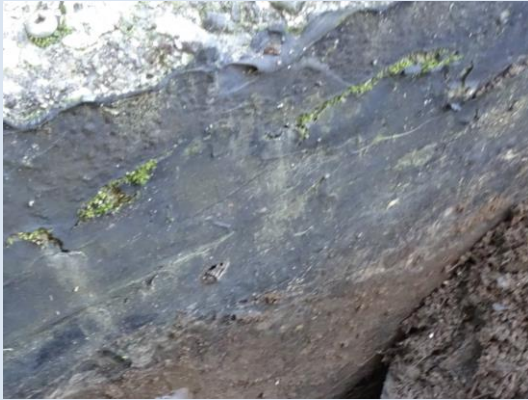
Figure 49

Location: East building exterior - North elevation perimeter.

Defect: Weathered waterproofing.

Remarks: This area is at a high risk for water ingress.

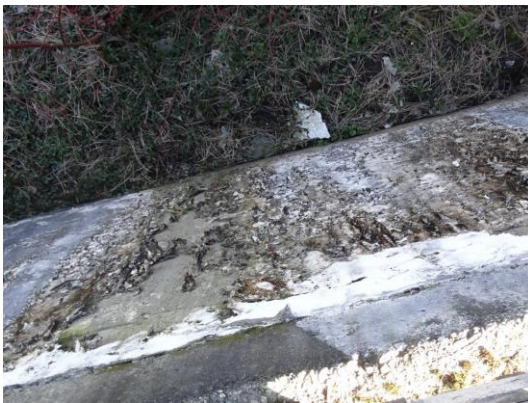
Figure 50

Location: East building - East parking garage wall (exterior).

Defect: Widespread failure of the waterproofing membrane.

Remarks: Replacements are required.

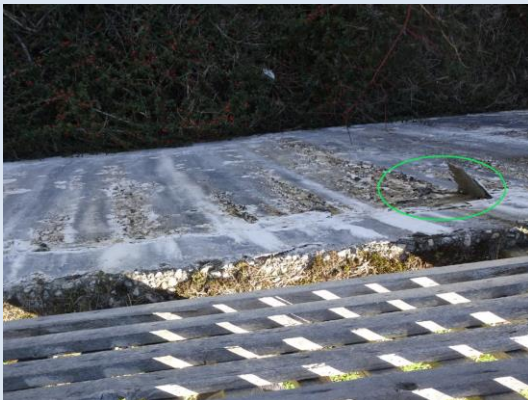
Figure 51

Location: East building - East parking garage wall (exterior).

Defect: Widespread failure of the waterproofing membrane.

Remarks: Replacements are required.

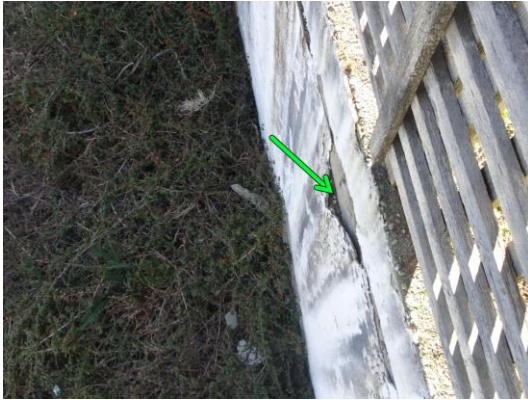
Figure 52

Location: East building - East parking garage wall (exterior).

Defect: Widespread failure of the waterproofing membrane.

Remarks: Replacements are required.

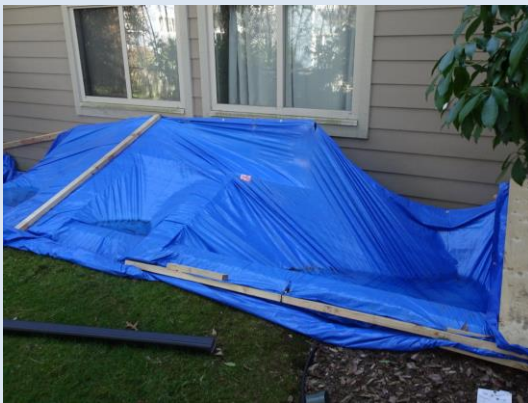
Figure 53

Location: East building exterior - North elevation.

Defect: Various areas are tarped in an attempt to stop water ponding.

Remarks: Drainage will need to be revised for a permanent solution.

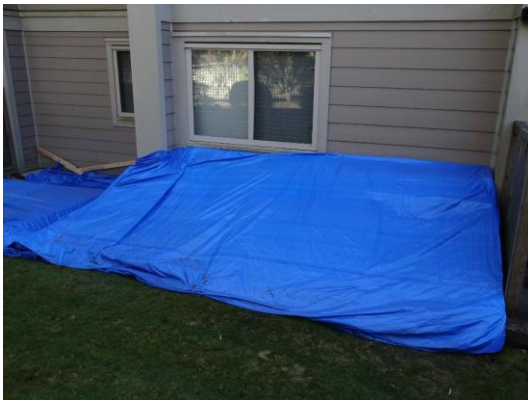
Figure 54

Location: East building exterior - North elevation.

Defect: Various areas are tarped in an attempt to stop water ponding.

Remarks: Drainage will need to be revised for a permanent solution.

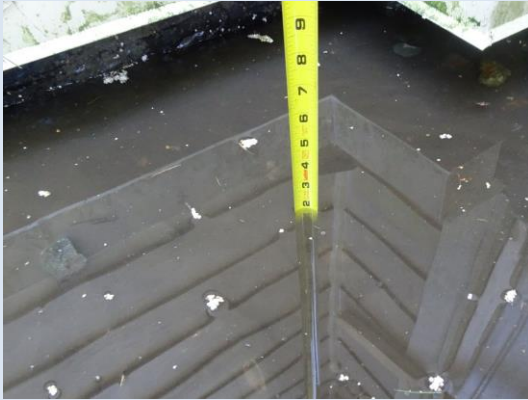
Figure 55

Location: East building exterior - North elevation.

Defect: Roughly two inches of standing water at areas around the building perimeter.

Remarks: Drainage will need to be revised.

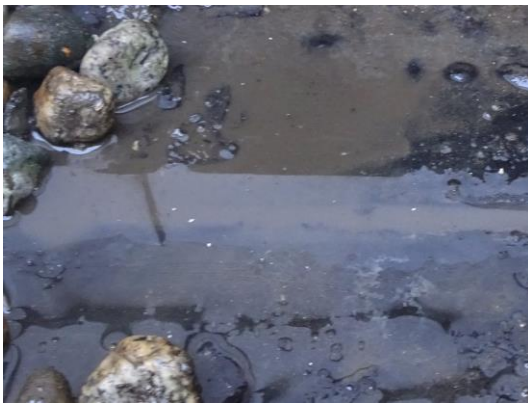
Figure 56

Location: East building exterior - North elevation.

Defect: Standing water.

Remarks: Drainage will need to be revised.

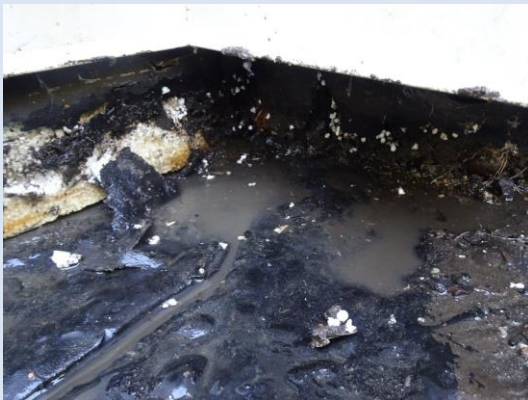
Figure 57

Location: East building exterior - North elevation.

Defect: Standing water.

Remarks: Drainage will need to be revised.

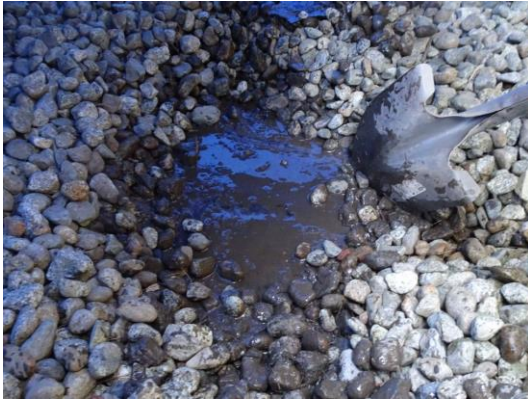
Figure 58

Location: East building exterior - North elevation.

Defect: Standing water.

Remarks: Drainage will need to be revised.

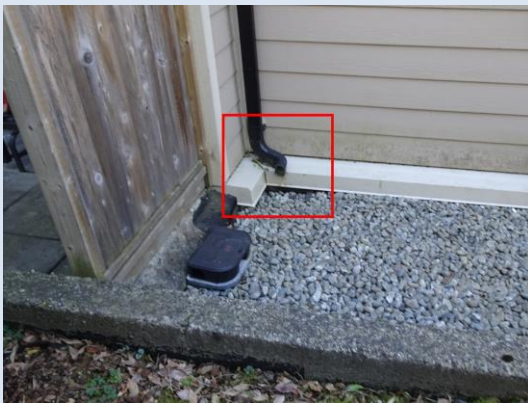
Figure 59

Location: Throughout both buildings.

Defect: Downspouts for the balconies are draining directly into areas surrounding the building perimeter.

Remarks: This condition is contributing to the standing water. Improved storm water management is required.

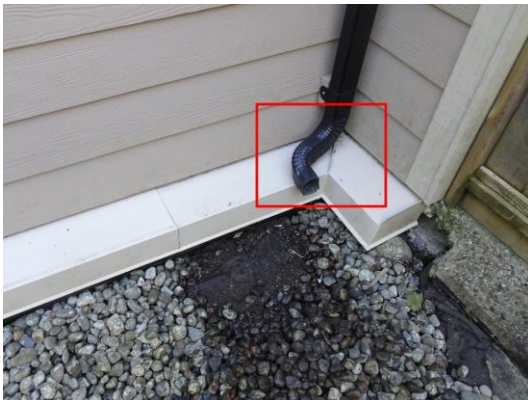
Figure 60

Location: Throughout both buildings.

Defect: Downspouts for the balconies are draining directly into areas surrounding the building perimeter.

Remarks: This condition is contributing to the standing water. Improved storm water management is required.

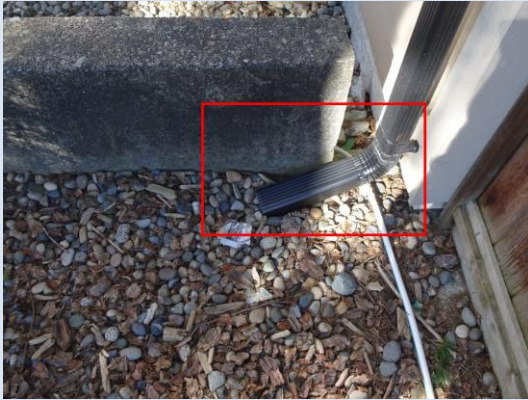
Figure 61

Location: Throughout both buildings.

Defect: Downspouts for the balconies are draining directly into areas surrounding the building perimeter.

Remarks: This condition is contributing to the standing water. Improved storm water management is required.

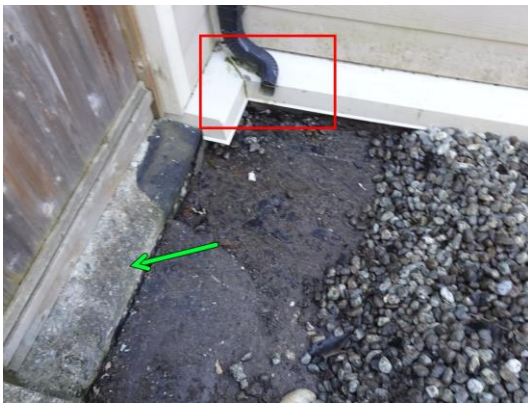
Figure 62

Location: Throughout both buildings.

Defect: Downspouts for the balconies are draining directly into areas surrounding the building perimeter.

Remarks: This condition is contributing to the standing water. Improved storm water management is required.

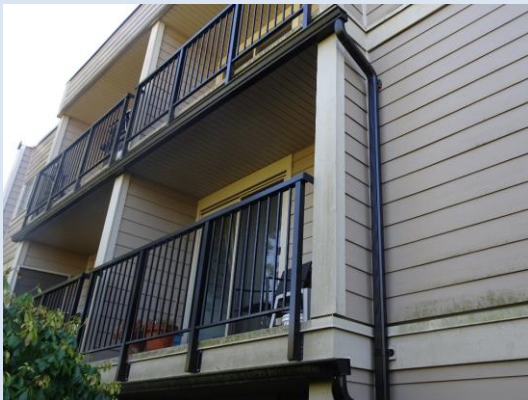
Figure 63

Location: Throughout both buildings.

Defect: Downspouts for the balconies are draining directly into areas surrounding the building perimeter.

Remarks: This condition is contributing to the standing water. Improved storm water management is required.

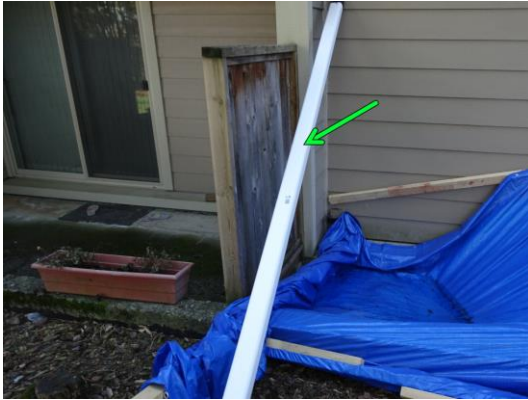
Figure 64

Location: East building exterior - North elevation.

Defect: N/A.

Remarks: The downspout has been temporarily redirected. Improved storm water management is required for a long term solution.

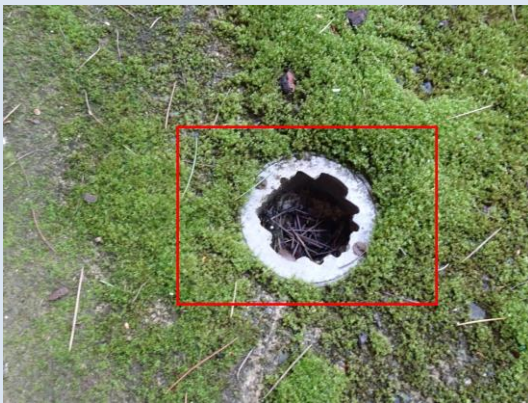
Figure 65

Location: East building exterior - Patio drain.

Defect: The drain is completely clogged with debris.

Remarks: Improved storm water management and maintenance is required.

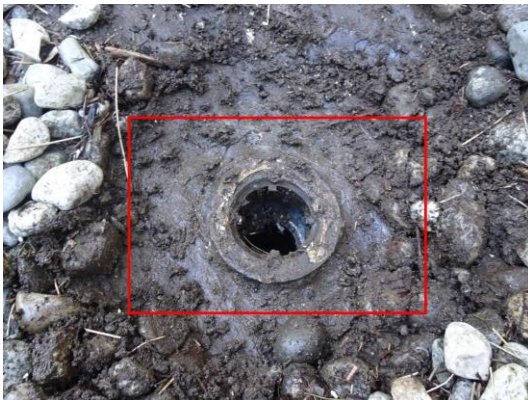
Figure 66

Location: East building exterior - East elevation.

Defect: Missing drain cap and debris in drain.

Remarks: Improved storm water management and maintenance is required.

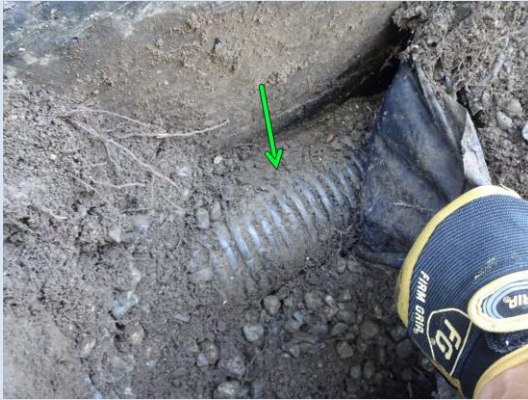
Figure 67

Location: East building exterior - North elevation.

Defect: Poorly protected drainage pipe.

Remarks: The pipe should be fully enclosed in a filter fabric. The perimeter drainage may be clogged with debris.

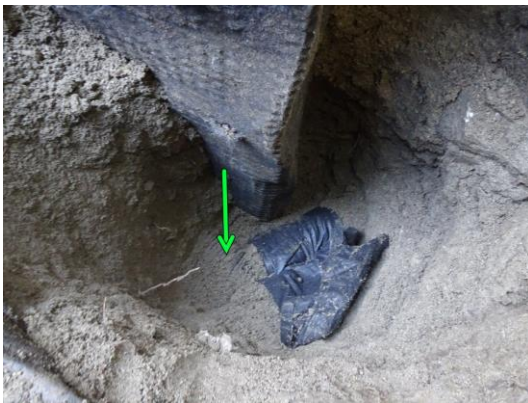
Figure 68

Location: East building exterior - North elevation.

Defect: Poorly protected drainage pipe and missing drain rock.

Remarks: The pipe should be fully enclosed in a filter fabric. The perimeter drainage may be clogged with debris.

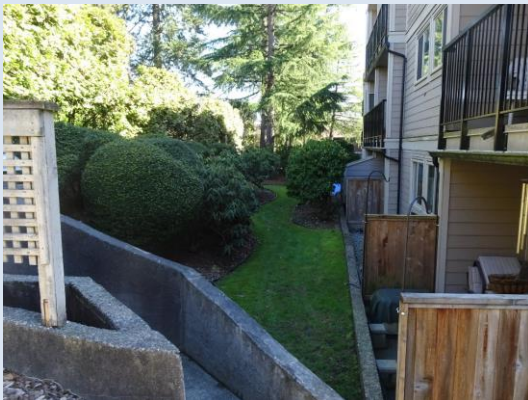
Figure 69

Location: East building exterior - North elevation.

Defect: Various large trees may have potentially damaging roots.

Remarks: The larger trees' roots may be damaging the waterproofing membrane.

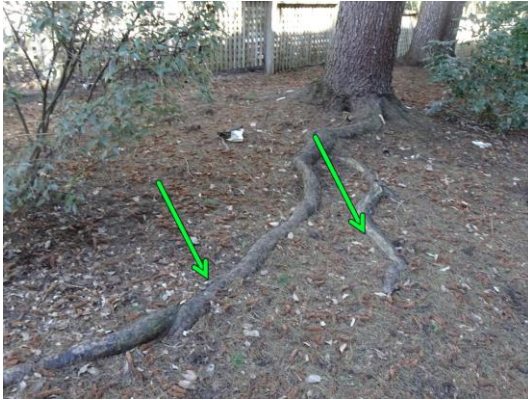
Figure 70

Location: East building exterior - North elevation.

Defect: Various large trees may have potentially damaging roots.

Remarks: The larger trees' roots may be damaging the waterproofing membrane.

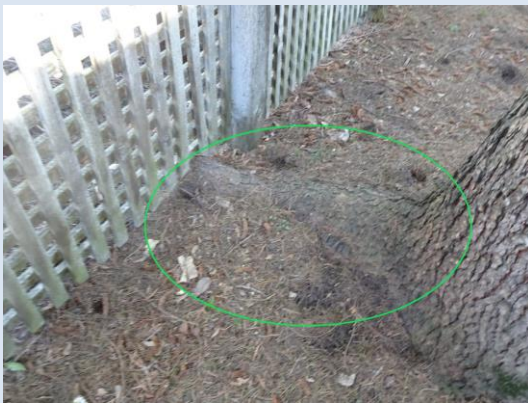
Figure 71

Location: East building exterior - North elevation.

Defect: Various large trees may have potentially damaging roots.

Remarks: The larger trees' roots may be damaging the waterproofing membrane.

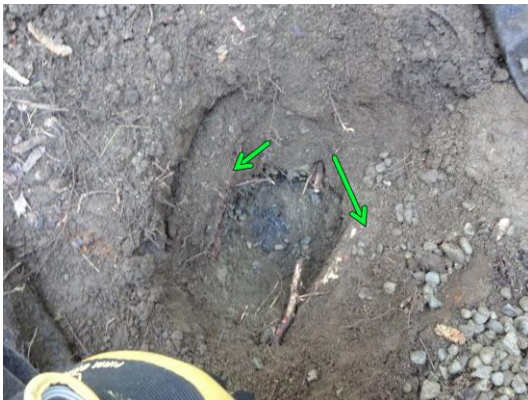
Figure 72

Location: East building exterior - North elevation.

Defect: Various large trees may have potentially damaging roots.
