DEPRECIATION REPORT

**Strata Corporation NWS3119
Queens Gate**

Located at
8500-8580 General Currie Road, BC

June 9, 2014

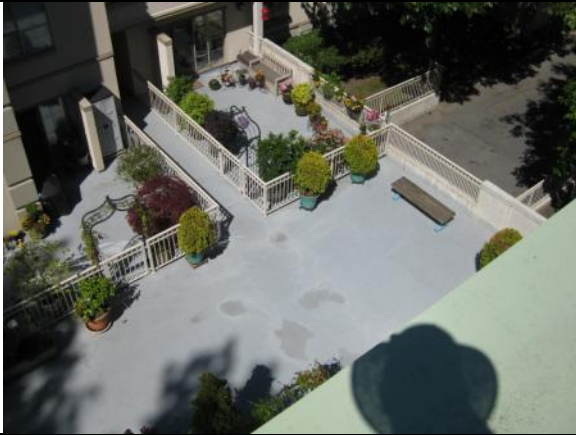
| Reserve Component: A2010 - Parkade Membrane | |

| Reserve Component: A2010 - Parkade Membrane | |
|---|---|
| Physical Description | This component includes the parkade ceiling and the parkade roof membrane which is the exposed area outside of the superstructure. This prevents moisture penetration into the roof slab and into the parkade. The membrane consists of a mix of vinyl and liquid applied membrane the 1st floor, above the parkade. The above ground parkade in the complex means the the membrane doubles as a deck flooring for many of the open patios. |
| Financial Analysis | Most of the patio membranes appear ot have been replaced in 2002/2005. This is a contingency reserve allowance for the eventual full replacement of the membrane, as well for sealing cracks of the parkade ceiling. We have divided the allowances into 4 cycles, spaced 12 years apart. The 2005 report estimates \$295,000 with a service life of 15 years. Our benchmark estimates for costs are lower than in the report. |

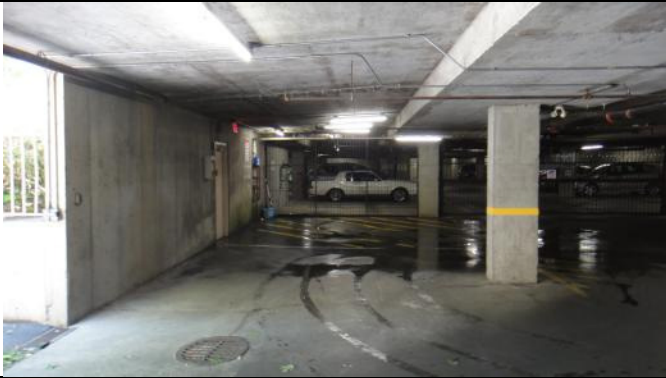
| Reserve Component: A2020 - Parkade Maintenance | |

| Reserve Component: A2020 - Parkade Maintenance | |
|--|---|
| Physical Description | This component may includes painting of lines and possibly walls, sealant re-coating of the floor and sealing of cracks on the floor of the parkade |
| Financial Analysis | This is a reserve allowance for crack leveling and resealing of the parkade floor every 10 years. The allowance also allows for repainting of the parking stall lines. No historical expenditure were reported for resealing. |

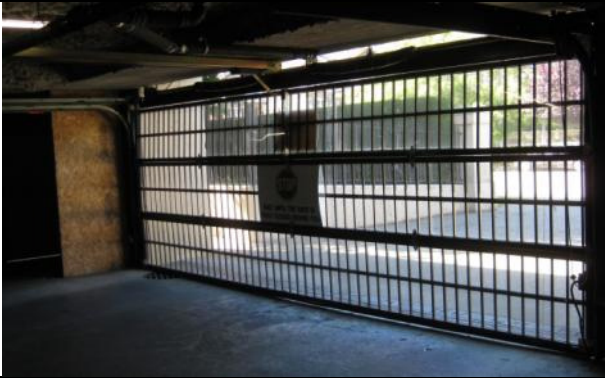
| Reserve Component: A2030 - Garage Doors and Mechanisms | |

| Reserve Component: A2030 - Garage Doors and Mechanisms | |
|--|--|
| Physical Description | This component includes the roll up door, motor, sensors, rails and chain. |
| Financial Analysis | This is a reserve allowance to replace components as they fail. The allowance would mainly be the motor and sensors for the garage doors. No Historical Expenditures were noted. |

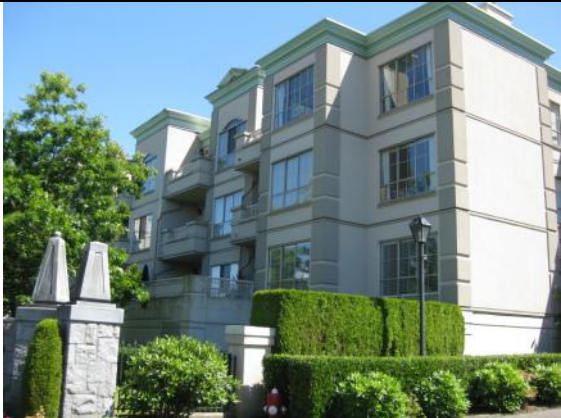
| Reserve Component: B2012 - Exterior Walls, Stucco | | | | | | | | | |

| Reserve Component: B2012 - Exterior Walls, Stucco | | | | | | | | | |
|--|---|---|---|--|---|---|---|---|---|
| Physical Description | The upper floors of the building include an acrylic stucco siding with EIFS trim and rainscreen. | | | | | | | | |
| Financial Analysis | The stucco appears to have been replaced in 2002 by Trow Engineering, although no financials or records were received for that period. The contingency allowance is for the replacement of the stucco on building at the end of its service life. | | | | | | | | |

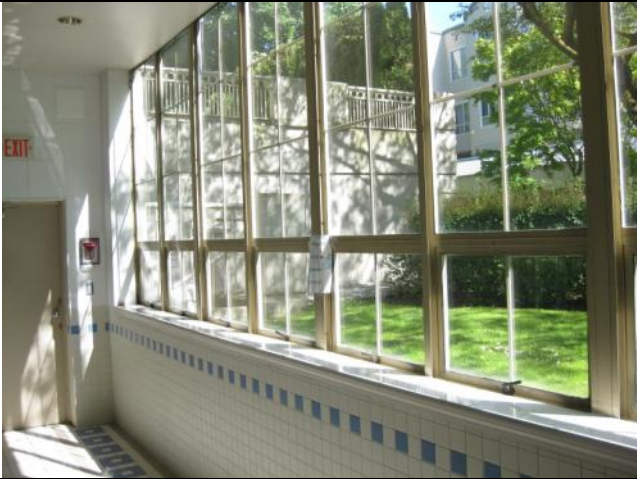
| Reserve Component: B2110 - Exterior, Window Assemblies | | | | | | | | | |

| Reserve Component: B2110 - Exterior, Window Assemblies | | | | | | | | | |
|--|--|---|---|--|---|---|---|---|---|
| Physical Description | The window assemblies are the exterior windows that are installed in living areas of owners' units and are a combination of picture windows and bay windows with double panes with a complete sliding portion or casements. | | | | | | | | |
| Financial Analysis | We have divided the allowances into 4 phases, spaced 5 years apart, allowing for full replacement in a 20 year period. Actual replacement would be as the window seals fail. Costs would be for the sealed units only, not replacement of the entire window frames. The earliest allowance is in 2017, although actual expenditures may begin being incurred as early as 2015. | | | | | | | | |

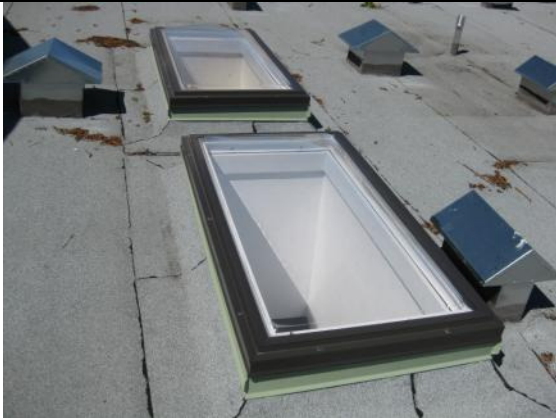
| Reserve Component: B2120 - Exterior, Skylights | |

| Reserve Component: B2120 - Exterior, Skylights | |
|--|--|
| Physical Description | The complex includes skylights on the upper floor units in buildings 2 and 3. |

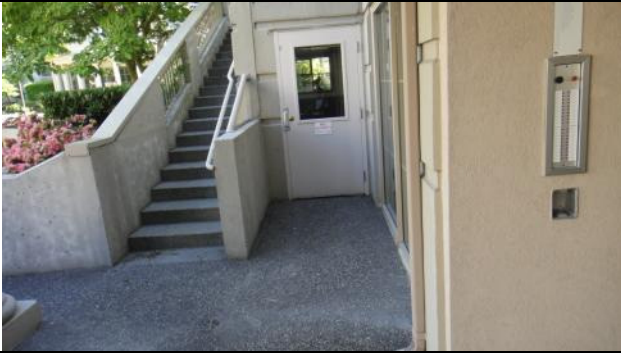
| Reserve Component: B2210 - Exterior Doors | |

| Reserve Component: B2210 - Exterior Doors | |
|--|--|
| Physical Description | This component includes all exterior service doors, patio swing doors, balcony doors. The exterior serviced doors are metal fire rated and insulated. The main lobby doors consist of aluminum and glass double doors with a glass surround. The patio doors consist of aluminum/wood framed units with glass inserts. |

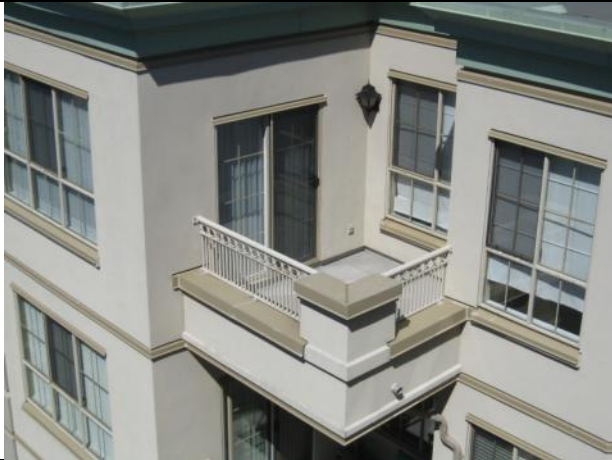
| Reserve Component: B2310 - Balcony Membranes | |

| Reserve Component: B2310 - Balcony Membranes | |
|--|--|
| Physical Description | This reserve item is for the above ground floor balcony membranes. The deck cover is comprised of polyvinyl chloride (PVC) sheets. Majority of exposed membrane assemblies are relatively well protected by the elements by overhead covers with the exception of the upper floor balconies. There are also areas over the ground floor common areas where the membranes are covered with concrete pavers. |
| Financial Analysis | Previous balcony repairs have been done as per need basis. We have allowed for replacement of the balconies at the end of their life cycle. |

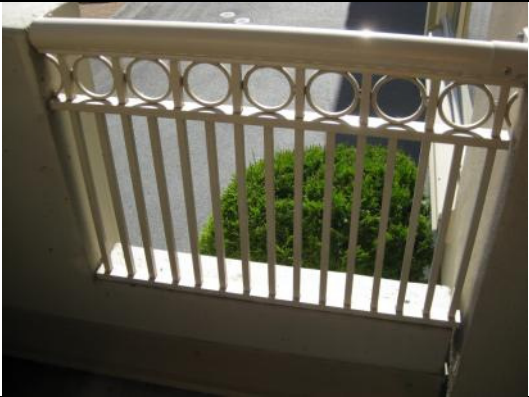
| Reserve Component: B2320 - Balcony Railings | |

| Reserve Component: B2320 - Balcony Railings | |
|---|---|
| Physical Description | This reserve item accounts for the aluminum decorative railings situated above the ground floors. The rails are bolted to supporting walls. |

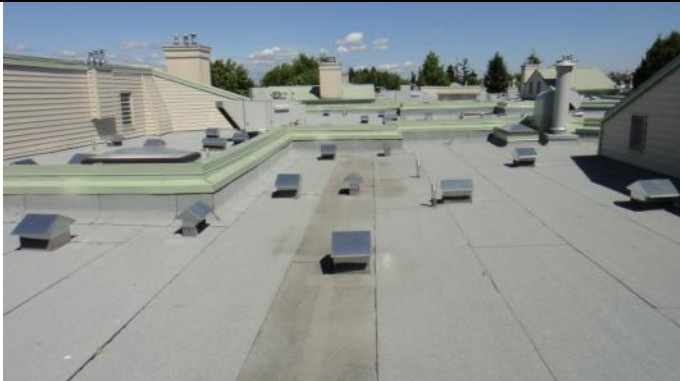
| Reserve Component: | B3010 - Roof - Flat, Membrane | |

| Reserve Component: | B3010 - Roof - Flat, Membrane | |
|--|--|--|
| Physical Description | The roof structures of the three buildings included a two-ply SBS membrane with pitched and flat metal sections. | |

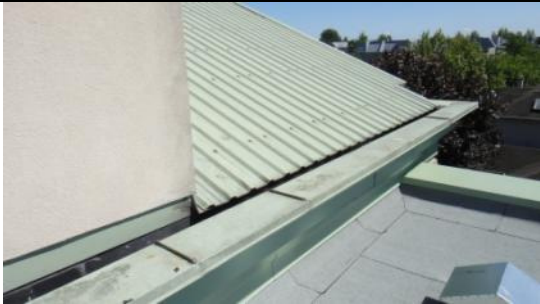
| Reserve Component: B3110 - Eavestroughs and Downspouts | | | | | | | | | |

| Reserve Component: B3110 - Eavestroughs and Downspouts | | | | | | | | | |
|--|---|---|---|--|---|---|---|---|---|
| Physical Description | Aluminum gutters at the sloped roof system, with some in-deck drains, transitioning to exterior downspouts. There are also a number of interior drains emptying through the parkade. | | | | | | | | |

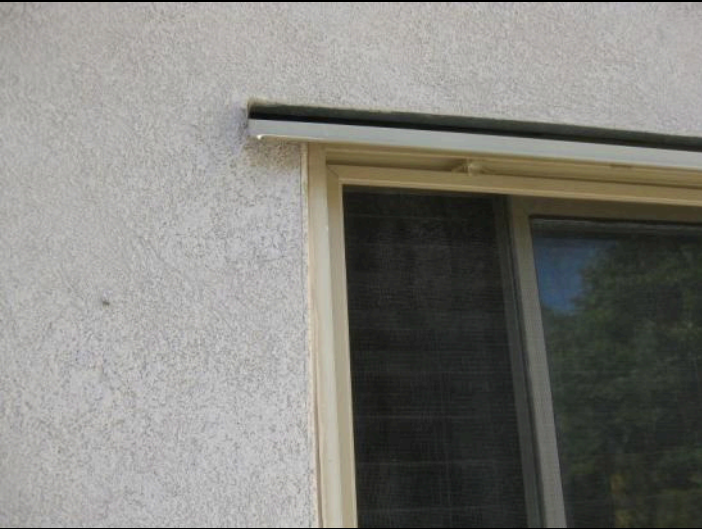
| Reserve Component: B4020 - Caulking and Weatherstripping | | | | | | | | | |

| Reserve Component: B4020 - Caulking and Weatherstripping | | | | | | | | | |
|--|---|---|---|--|---|---|---|---|---|
| Physical Description | Building caulking and silicone sealants would be installed around windows and exterior doors, at interface with wall materials. The primary function of this component is to fill gaps where weather or moisture can penetrate the building envelope. Weatherstripping around moving components of doors, sliders, and opening portions of windows. The primary function of this component is to prevent drafts, heat losses, moisture penetration around door opening. | | | | | | | | |

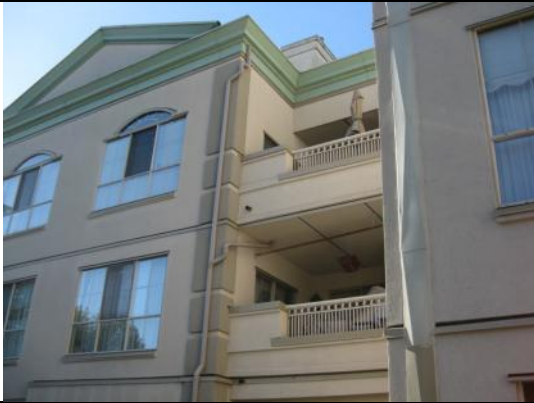
| Reserve Component: B5000 - Exterior Painting | |

| Reserve Component: B5000 - Exterior Painting | |
|--|---|
| Physical Description | Exterior stucco and fencing. The primary function of painting is to enhance the curb appeal of property and to help sustain the life expectancy of the components. Painting is a low cost protective covering over various materials |

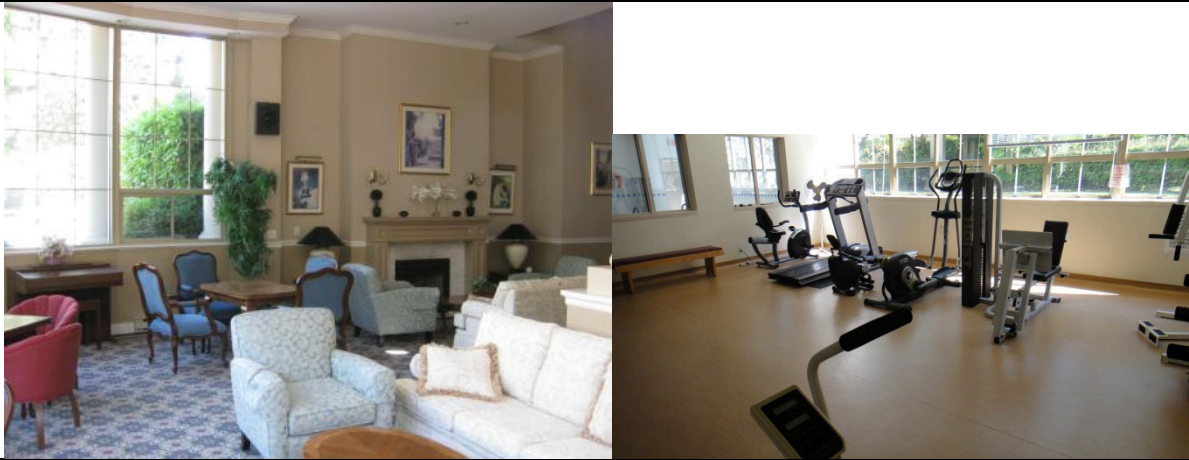
| Reserve Component: C2012 - Common Area Amenity Rooms | | | | | | | | | |

| Reserve Component: C2012 - Common Area Amenity Rooms | | | | | | | | | |
|--|--|---|---|--|---|---|---|---|---|
| Physical Description | There are several common area amenity rooms located throughout the three buildings. These include hobby rooms, rec rooms, guest suites, a large Social/Rec room with a mezzanine, offices, a gym as well as washrooms and change rooms. Plans also show a caretaker suite in Building 1, which has been included. This component does not include the pool or mechanical equipment or the lobby. | | | | | | | | |

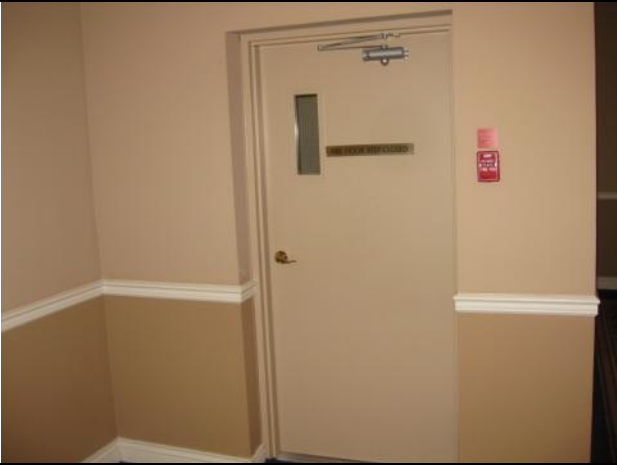
| Reserve Component: C3020 - Interior Doors | | |

| Reserve Component: C3020 - Interior Doors | | |
|--|---|--|
| Physical Description | This component includes the ground level service doors and upper floor stairwell and fire doors. We have not includes individual suite doors. All the doors are fire rated and insulated metal designs. | |

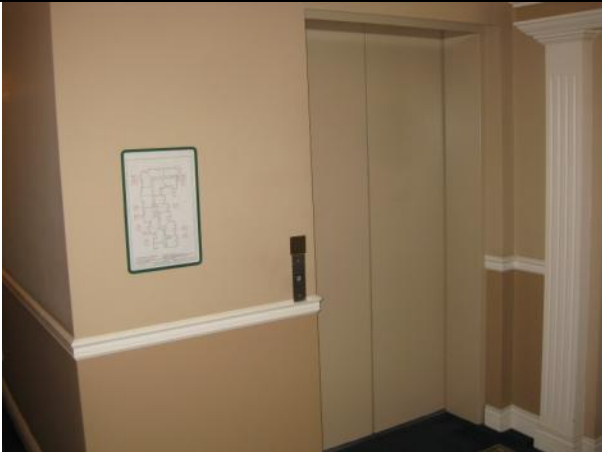
| Reserve Component: D1010 - Elevator Cab | |

| Reserve Component: D1010 - Elevator Cab | |
|--|--|
| Physical Description | This component addresses the periodic, cosmetic updates of elevator cab interior. |

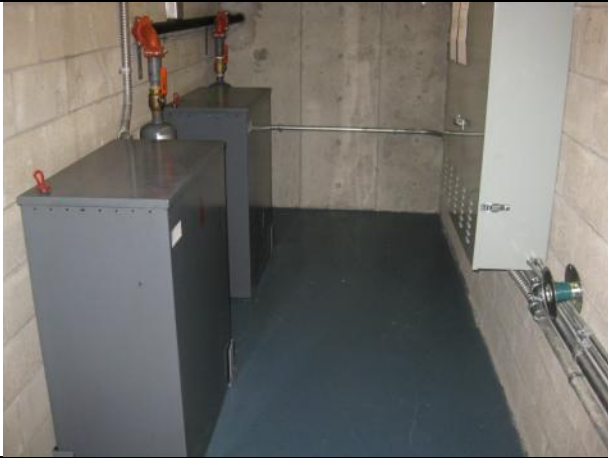
| Reserve Component: D1011 - Elevator Modernization | | | | | | | | | |

| Reserve Component: D1011 - Elevator Modernization | | | | | | | | | |
|--|--|---|---|--|---|---|---|---|---|
| Physical Description | This component is assumed to be comprised of a typical hydraulic elevator system, which includes the elevator cab, rail system, braking system controller, dispatcher, motor, hydraulic fluid holding tank, and hydraulic pump. | | | | | | | | |

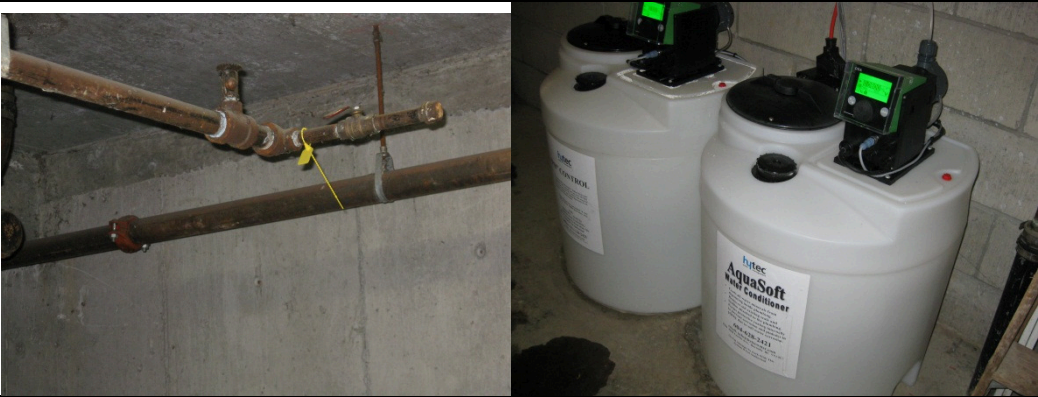
| Reserve Component: D2010 - Piping | | |

| Reserve Component: D2010 - Piping | | |
|--|--|--|
| Physical Description | Components include water distribution lines and vertical stacks running throughout the interior of the three buildings | |

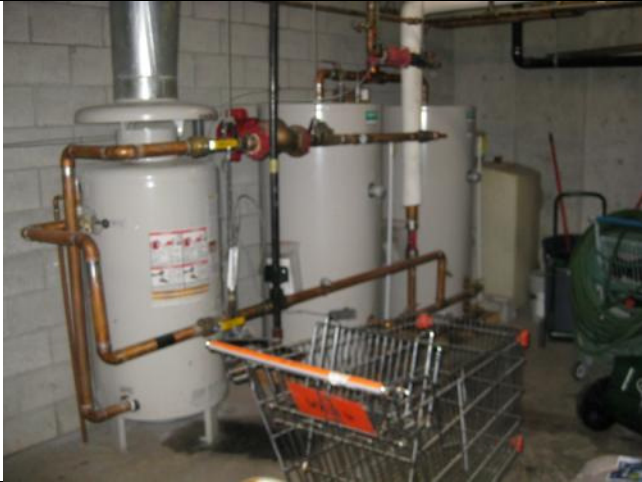
| Reserve Component: D2100 - Boiler & Hot Water Tank | |

| Reserve Component: D2100 - Boiler & Hot Water Tank | |
|--|--|
| Physical Description | This component includes the domestic hot water tanks, water pump, recirculating pump and boilers. |

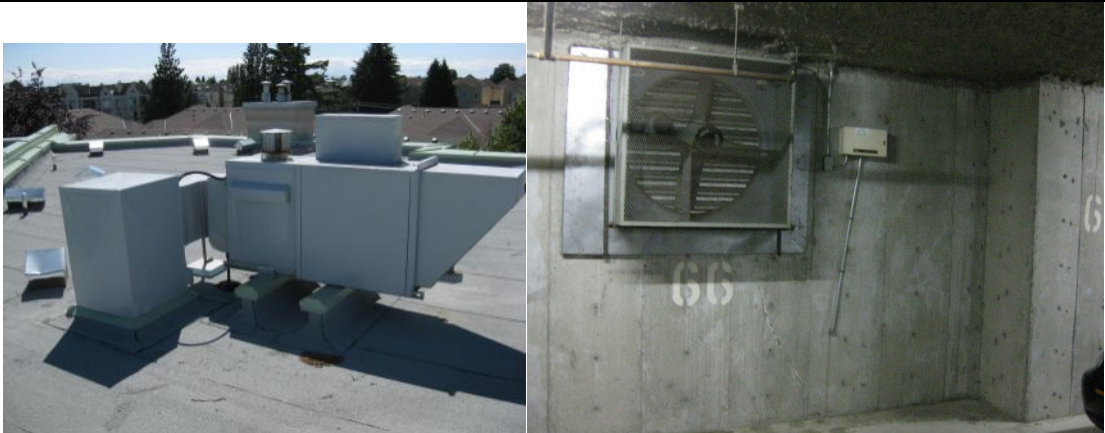
| Reserve Component: D3010 - Makeup Air Units | |

| Reserve Component: D3010 - Makeup Air Units | |
|--|---|
| Physical Description | This component is comprised of the makeup air unit (MAU) supplying heated airflow within the main corridors within the building, as well as the ventilation fans throughout the building. |

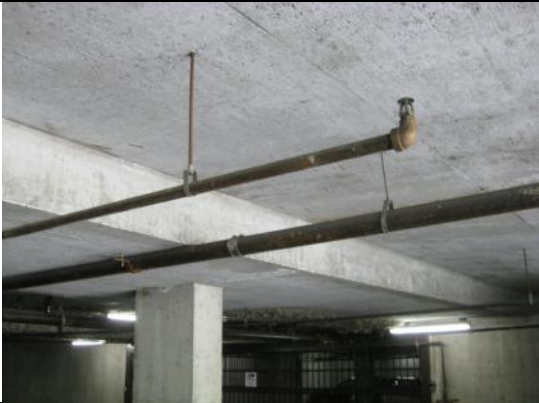
| Reserve Component: D4010 - Sprinklers | |

| Reserve Component: D4010 - Sprinklers | |
|--|---|
| Physical Description | This component is comprised of a dry distribution system which includes standpipes and sprinkler heads. Sprinklers are located in the basement locker areas and parkades, with standpipes located throughout the building; mainly in exit stairwells |

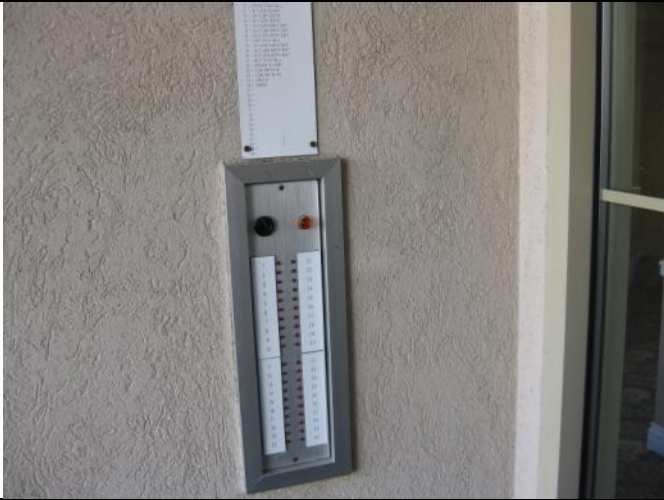
| Reserve Component: D4100 - Fire panel and Emergency Lighting | |

| Reserve Component: D4100 - Fire panel and Emergency Lighting | |
|--|--|
| Physical Description | This item includes the fire annunciator panel, pull stations, smoke and heat detectors and other devices such as public address systems if there is one. Emergency lighting and controls systems are also included. Life safety systems consist of the main panel, sub-panel, wiring and end devices. These end devices include heat detectors, smoke detectors, pull stations and flow switches. For items affecting life safety it activates an alarm within the building to warn occupants to evacuate. |

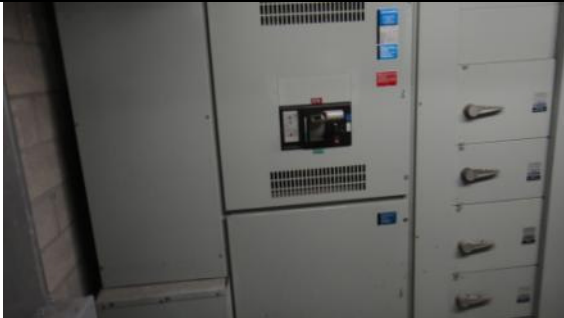
| Reserve Component: D5010 - Electrical Services and Distribution | |

| Reserve Component: D5010 - Electrical Services and Distribution | |
|---|---|
| Physical Description | This reserve includes the incoming electrical service, various distribution panels, electrical cables and wiring, connections in the complex. The distribution to the common element equipment and end devices is included within this component, while the distribution within the individual units is the individual owners' responsibility. |

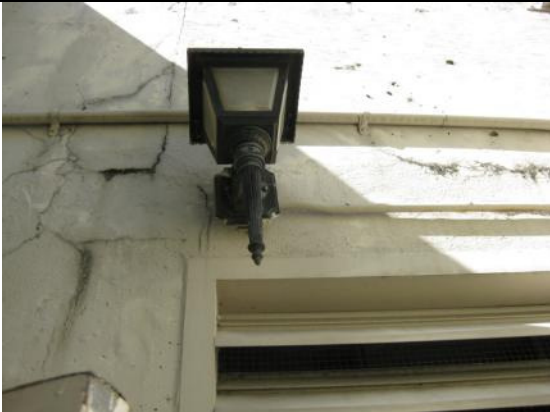
| Reserve Component: D5030 - Exterior Lighting | | | | | | | | | |

| Reserve Component: D5030 - Exterior Lighting | | | | | | | | | |
|--|--|---|---|--|---|---|---|---|---|
| Physical Description | This component includes all the exterior ceiling mounted, wall mounted, and free standing light fixtures found outside the building. | | | | | | | | |

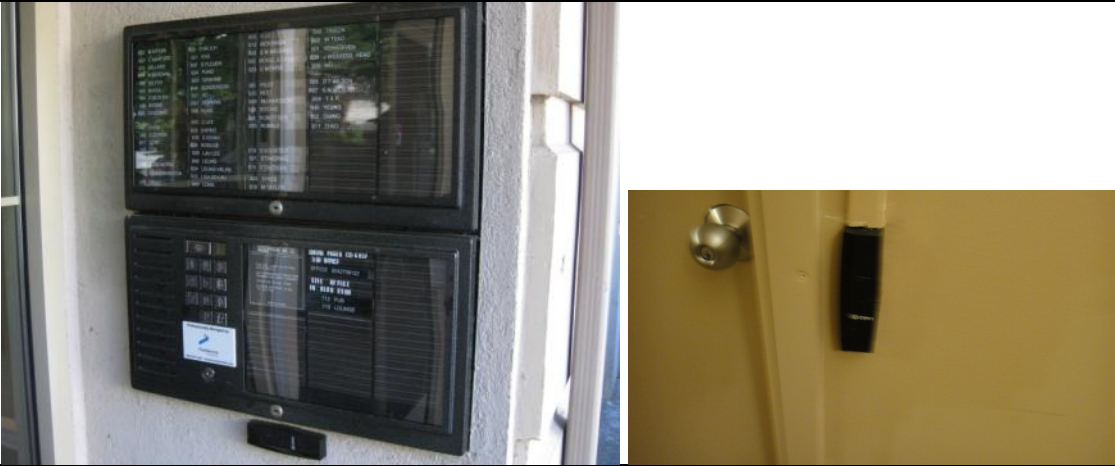
| Reserve Component: D5040 - Access Control and Security | |

| Reserve Component: D5040 - Access Control and Security | |
|--|--|
| Physical Description | This component encompasses the enterphone access systems, the new fob access systems, as well as the CCTV security system. |

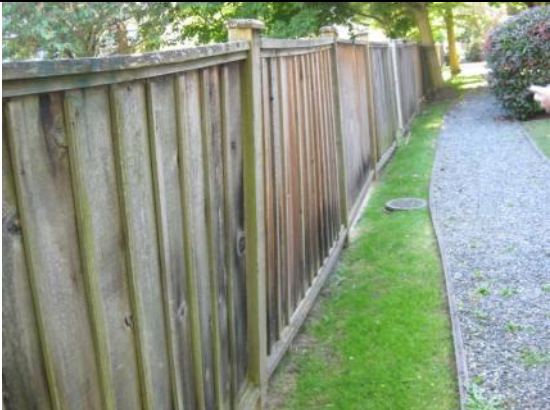
| Reserve Component: E1010 Fencing - Wood | |

| Reserve Component: E1010 Fencing - Wood | |
|--|---|
| Physical Description | Cedar panel perimeter fencing found along the rear and side lot lines of the complex. |

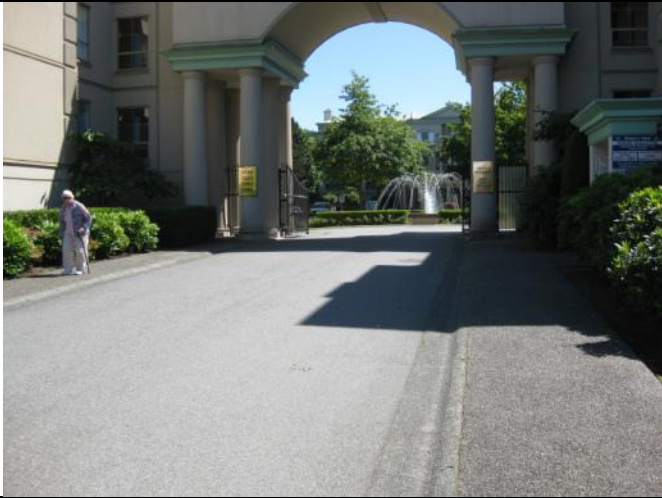
| Reserve Component: E2210 - Pavement Asphalt | |

| Reserve Component: E2210 - Pavement Asphalt | |
|---|--|
| Physical Description | This component is for the asphalt driveways throughout the complex which also includes all concrete curbing. |

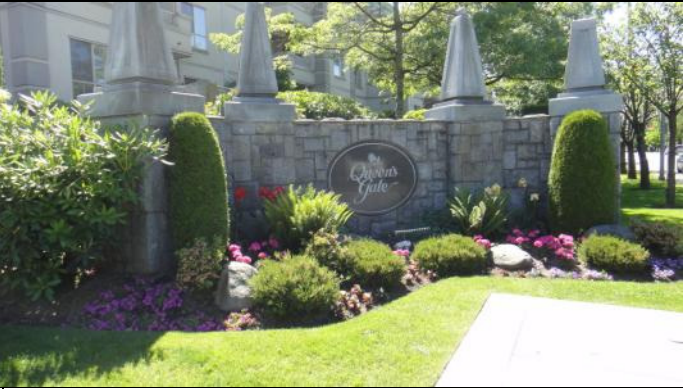
| Reserve Component: | E3020 - Soft Landscaping | |

| Reserve Component: | E3020 - Soft Landscaping | |
|--|--|--|
| Physical Description | This component includes removal of existing greeneries, resodding and reseeding as turf, trees, shrubs and plants die off or become unsightly. | |

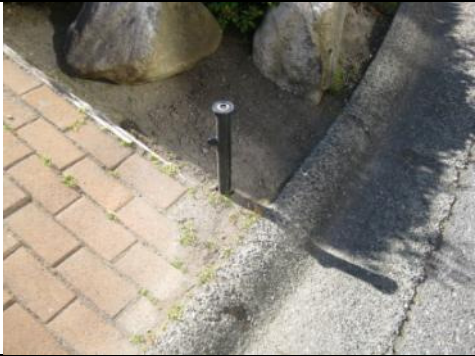
| Reserve Component: E3030 - Irrigation | | | | | | | | | |

| Reserve Component: E3030 - Irrigation | | | | | | | | | |
|--|--|---|---|--|---|---|---|---|---|
| Physical Description | The sprinkler system is situated above ground with comprised of PVC tubing, heads, and assumed PVC fittings. | | | | | | | | |

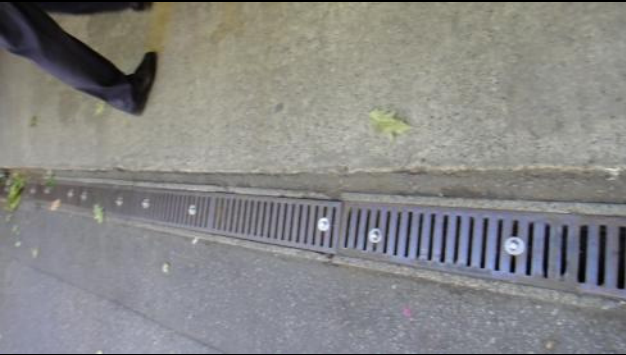
| Reserve Component: E4010 - Perimeter Drains | |

| Reserve Component: E4010 - Perimeter Drains | |
|---|---|
| Physical Description | This reserve includes replacement of perimeter drains around the base of each townhouse units, excluding porches/decks and carports. Plans indicate 6" diameter PVC drain pipe surrounded by drain rock wrapped in filter cloth. |

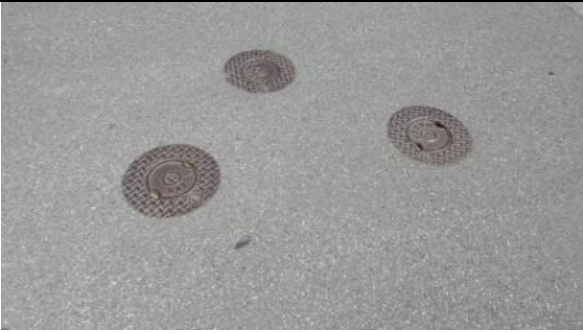
| Reserve Component: E5000 - Services and UG Piping | | | | | | | | | |

| Reserve Component: E5000 - Services and UG Piping | | | | | | | | | |
|---|---|---|---|--|---|---|---|---|---|
| Physical Description | This component consists of main shut offs and associated piping, providing domestic water from the municipal water main to the strata. It also consists of: sanitary and storm sewer piping. | | | | | | | | |
