DEPRECIATION REPORT

**Strata Corporation NWS3119
Queens Gate**

Located at
8500-8580 General Currie Road, BC

June 9, 2014

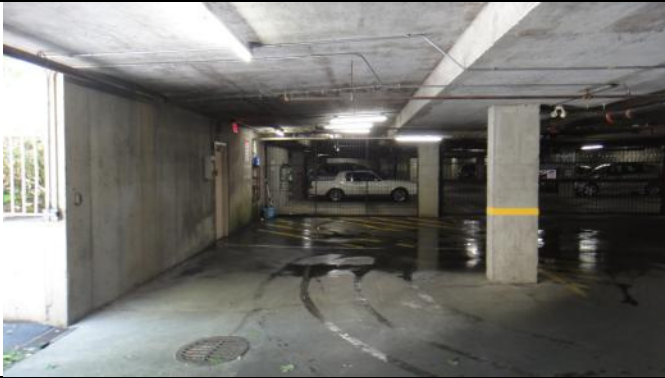
Reserve Component: A2020 - Parkade Maintenance

Physical Description	This component may includes painting of lines and possibly walls, sealant re-coating of the floor and sealing of cracks on the floor of the parkade
Financial Analysis	This is a reserve allowance for crack leveling and resealing of the parkade floor every 10 years. The allowance also allows for repainting of the parking stall lines. No historical expenditure were reported for resealing.
Potential Deterioration	General wear and tear from vehicle traffic, salts and oils will erode the sealant on the floor of the parkade
Condition & Deficiency Analysis	The parkade floor shows minor cracks and typical signs of wear. Periodic power washing was conducted in 2014 at a cost of about \$3000, and is reported to be annual (power washing is a Operations expense). Although this is not as important as the membrane seals above, strata should consider resealing the floors as well sometime in the intermediate future,

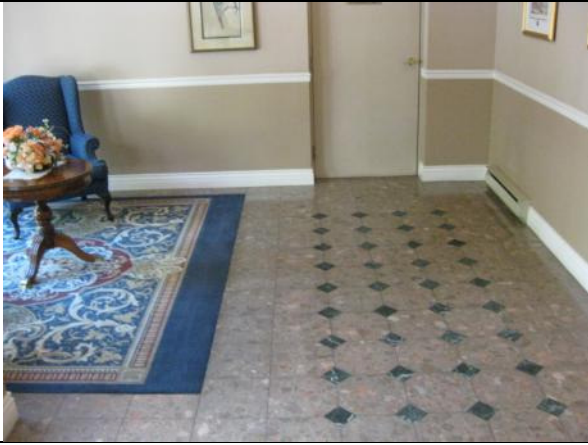
Reserve Component: C2010 - Lobby Redecoration

Physical Description	Each of the common area lobbies in each of the buildings includes basic furnishing and decorations. Flooring consisted of tile and carpets.
Financial Analysis	No significant expenditures were reported for the lobbies. The interior of the each lobby is original. Typically, the interior furnishings and décor is update to suite the residents, and the life cycle can vary widely. We have used a replacement cycle of 15 years for redecoration.
Potential Deterioration	The entry lobby flooring is subject to high traffic volumes on a daily basis; therefore, susceptible to wear at a greater rate than most other common areas.
Condition & Deficiency Analysis	The lobby areas viewed appeared well maintained and in good condition.
Life Cycle Analysis	<div> Date of Acquisition: Normal Life Span: Effective Age: Estimated Remaining Life Span: </div> <div> 1991 15 years 5 years 10 years </div>

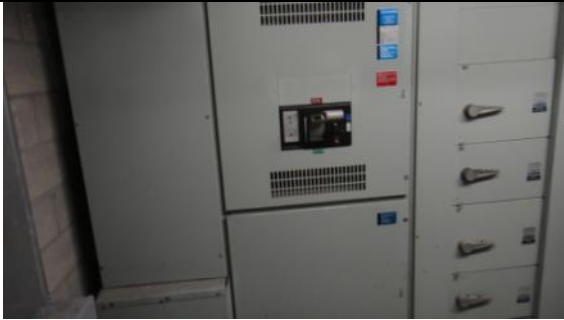
Reserve Component: D5010 - Electrical Services and Distribution

Physical Description	This reserve includes the incoming electrical service, various distribution panels, electrical cables and wiring, connections in the complex. The distribution to the common element equipment and end devices is included within this component, while the distribution within the individual units is the individual owners' responsibility.
Financial Analysis	The reserve is a long-term reserve provision and consists of a contingency estimate for the electrical systems which is deemed to be sufficient for any electrical repairs or electric component replacements. It is not a total replacement estimate, as the electrical systems should last the lifetime of the building.
Potential Deterioration	This component requires distribution wiring and connection points which generally last the lifetime of the building. High voltage wiring connections should be tight as over time, due to metal fatigue or corrosion, the screws holding the wire to their terminals can become loose. If electrical current arcs across the resultant gap, fire can result. Loose connections cause heat to build up and also increase the potential for a large scale power failure. The electrical systems should be regularly inspected and thermo-graphically analyzed and any 'hot spots' corrected. End devices such as receptacles and light fixtures are generally affected by electrical component failures, vandalism or misuse.

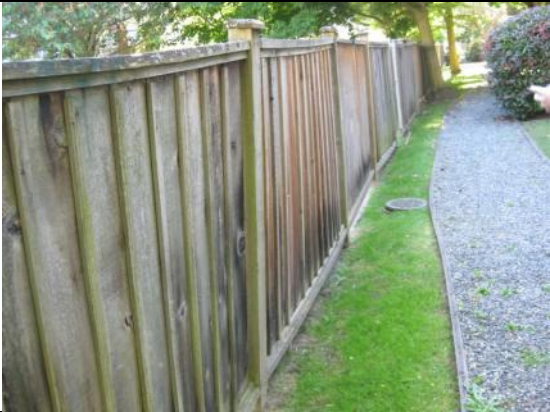
Reserve Component: E1010 Fencing - Wood

Physical Description	Cedar panel perimeter fencing found along the rear and side lot lines of the complex.
Financial Analysis	Periodic painting required to combat weathering. Reserve is for full replacement. Alternatives would be for periodic allowances.
Potential Deterioration	This component is subject to rotting caused by mildew, exposure to moisture and age. Wet/Dry cycle as well as string trimmer use, destroys posts prematurely at ground level. Panels are subject to rot, vandalism, and impact damage. Regular painting or staining. To lengthen the lifespan of this component, it is advisable to regularly stain or paint the wood with a quality outdoor product that provides good protective properties. Protection of post bottoms at grass level will extend the life, aluminum flashing works effectively.
Condition & Deficiency Analysis	The wood perimeter fence appears to be in fair condition. Some of the beams showed visible sagging and some of the posts were leaning significantly. Council reports partial replacement in 2012 at a cost of \$2905. Full fence replacement was proposed in the 2012 minutes but appears to be deferred.

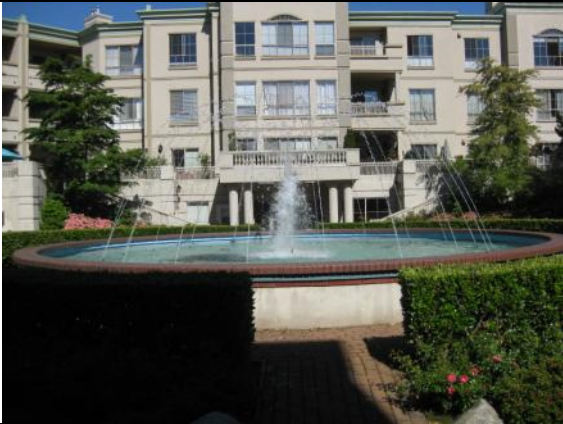
Reserve Component: E3010 - Hard Landscaping

Physical Description	Hard landscaping consists mainly of the rail ties, brick retaining walls, a central fountain, several wood gazebos, and wood benches found throughout the complex. tc
Financial Analysis	This item includes an allowance for replacement of any wood components, and long term repair allowance for the fountain equipment and regrouting of the brickwork.
Potential Deterioration	This component is subject to rotting caused by exposure to moisture and age. The retaining railroad wood ties and wooden of this component are subject to rotting caused by exposure to moisture and age.
Condition & Deficiency Analysis	No expenditures have been reported. The fountain is reported to be in good working condition, and the other components appeared in average condition. Some of the wood may need replacement/resealing earlier.
Life Cycle Analysis	<div> Date of Acquisition: 1991 Normal Life Span: 25 years Effective Age: 15 years Estimated Remaining Life Span: 10 years </div>
