**ROOFING CONDITION ASSESSMENT REPORT  
QUEEN'S GATE  
8500, 8520, 8560 AND 8580 GENERAL CURRIE ROAD  
RICHMOND, BC**

This Roofing Condition Assessment Report pertains to the Queen's Gate residential complex located at 8500, 8520, 8560 and 8580 General Currie Road, Richmond, BC.

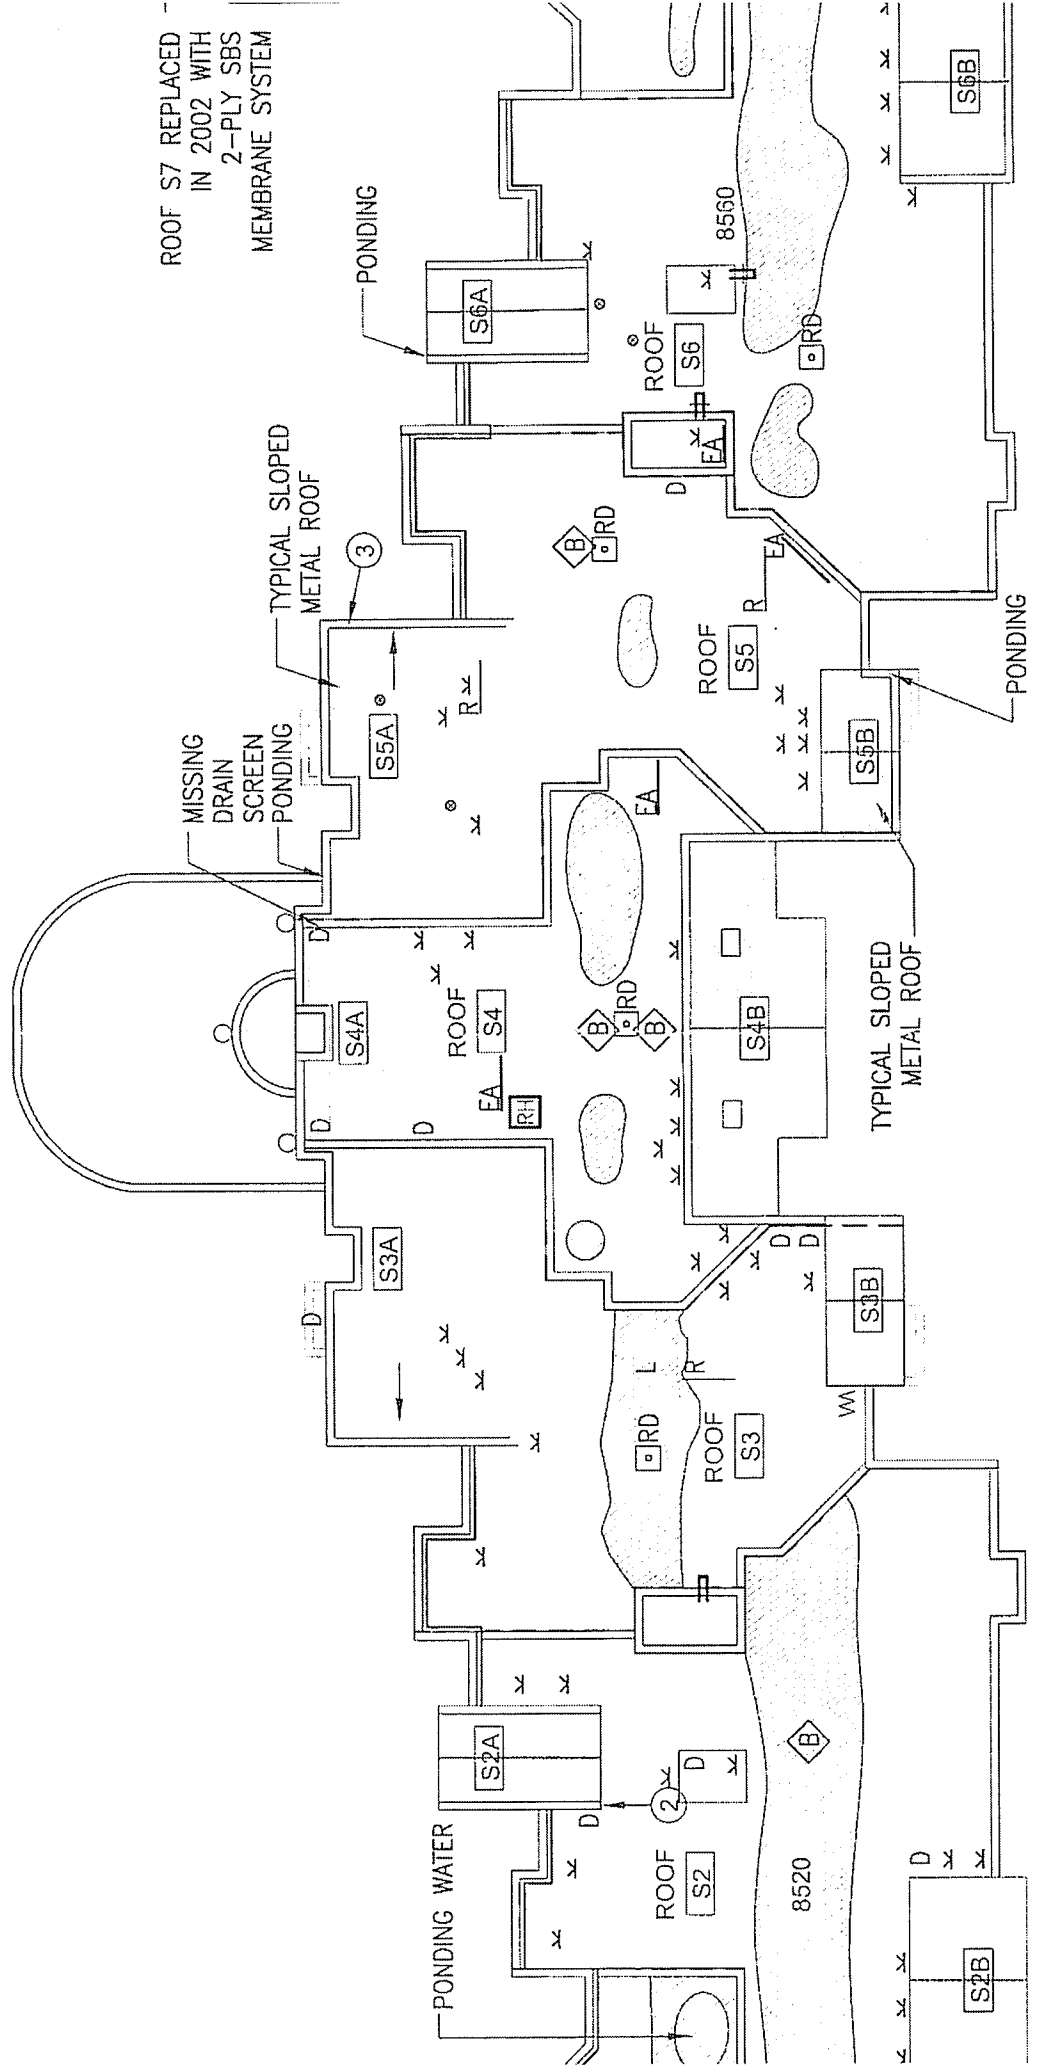
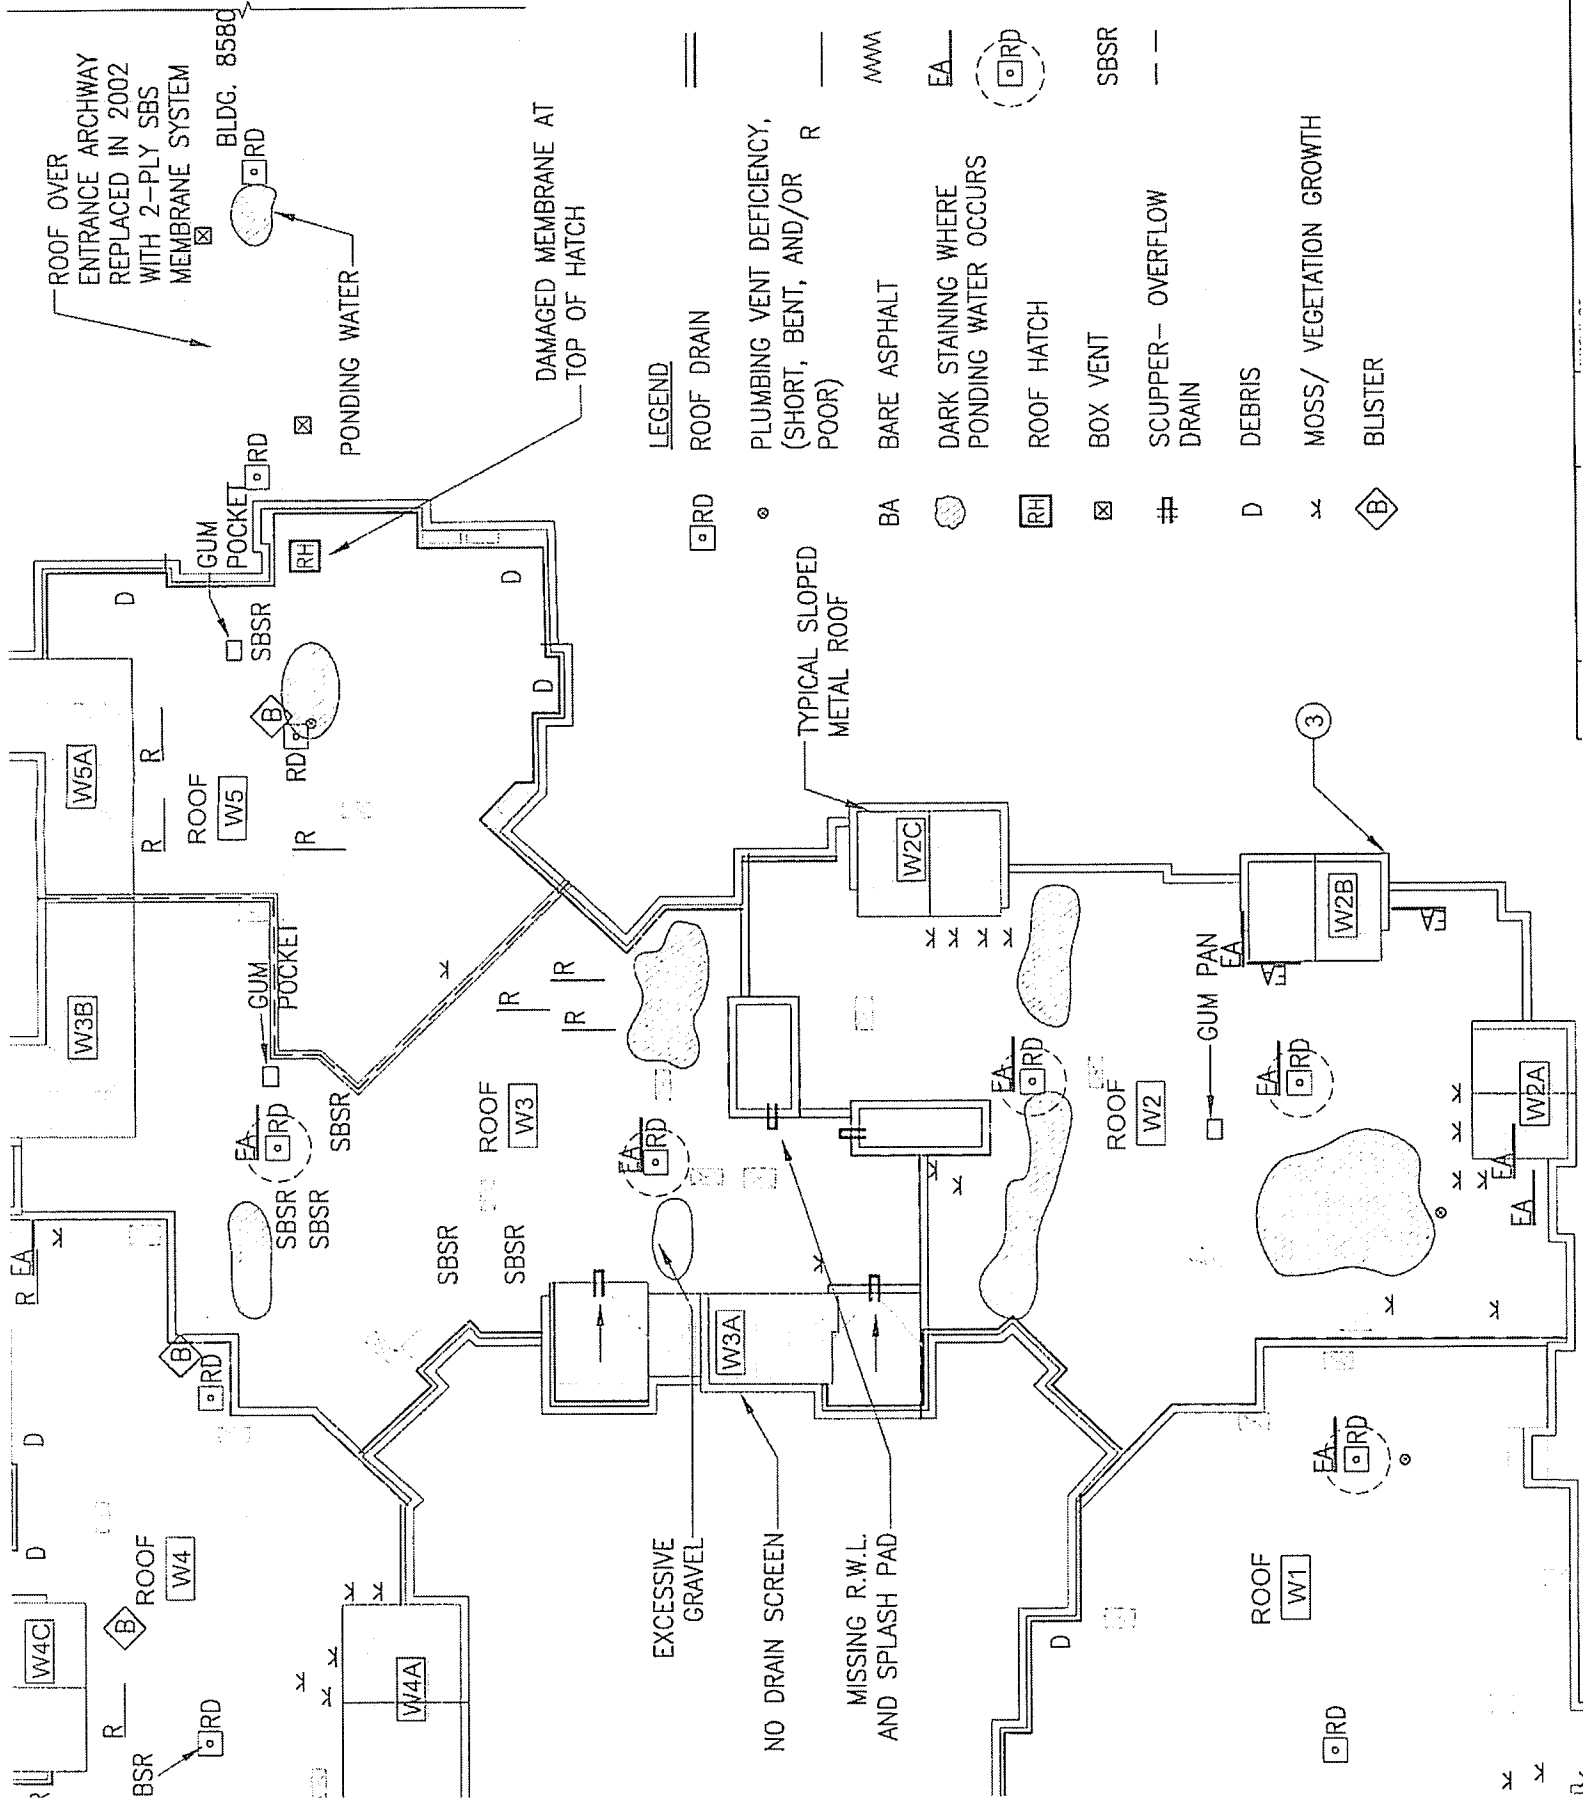
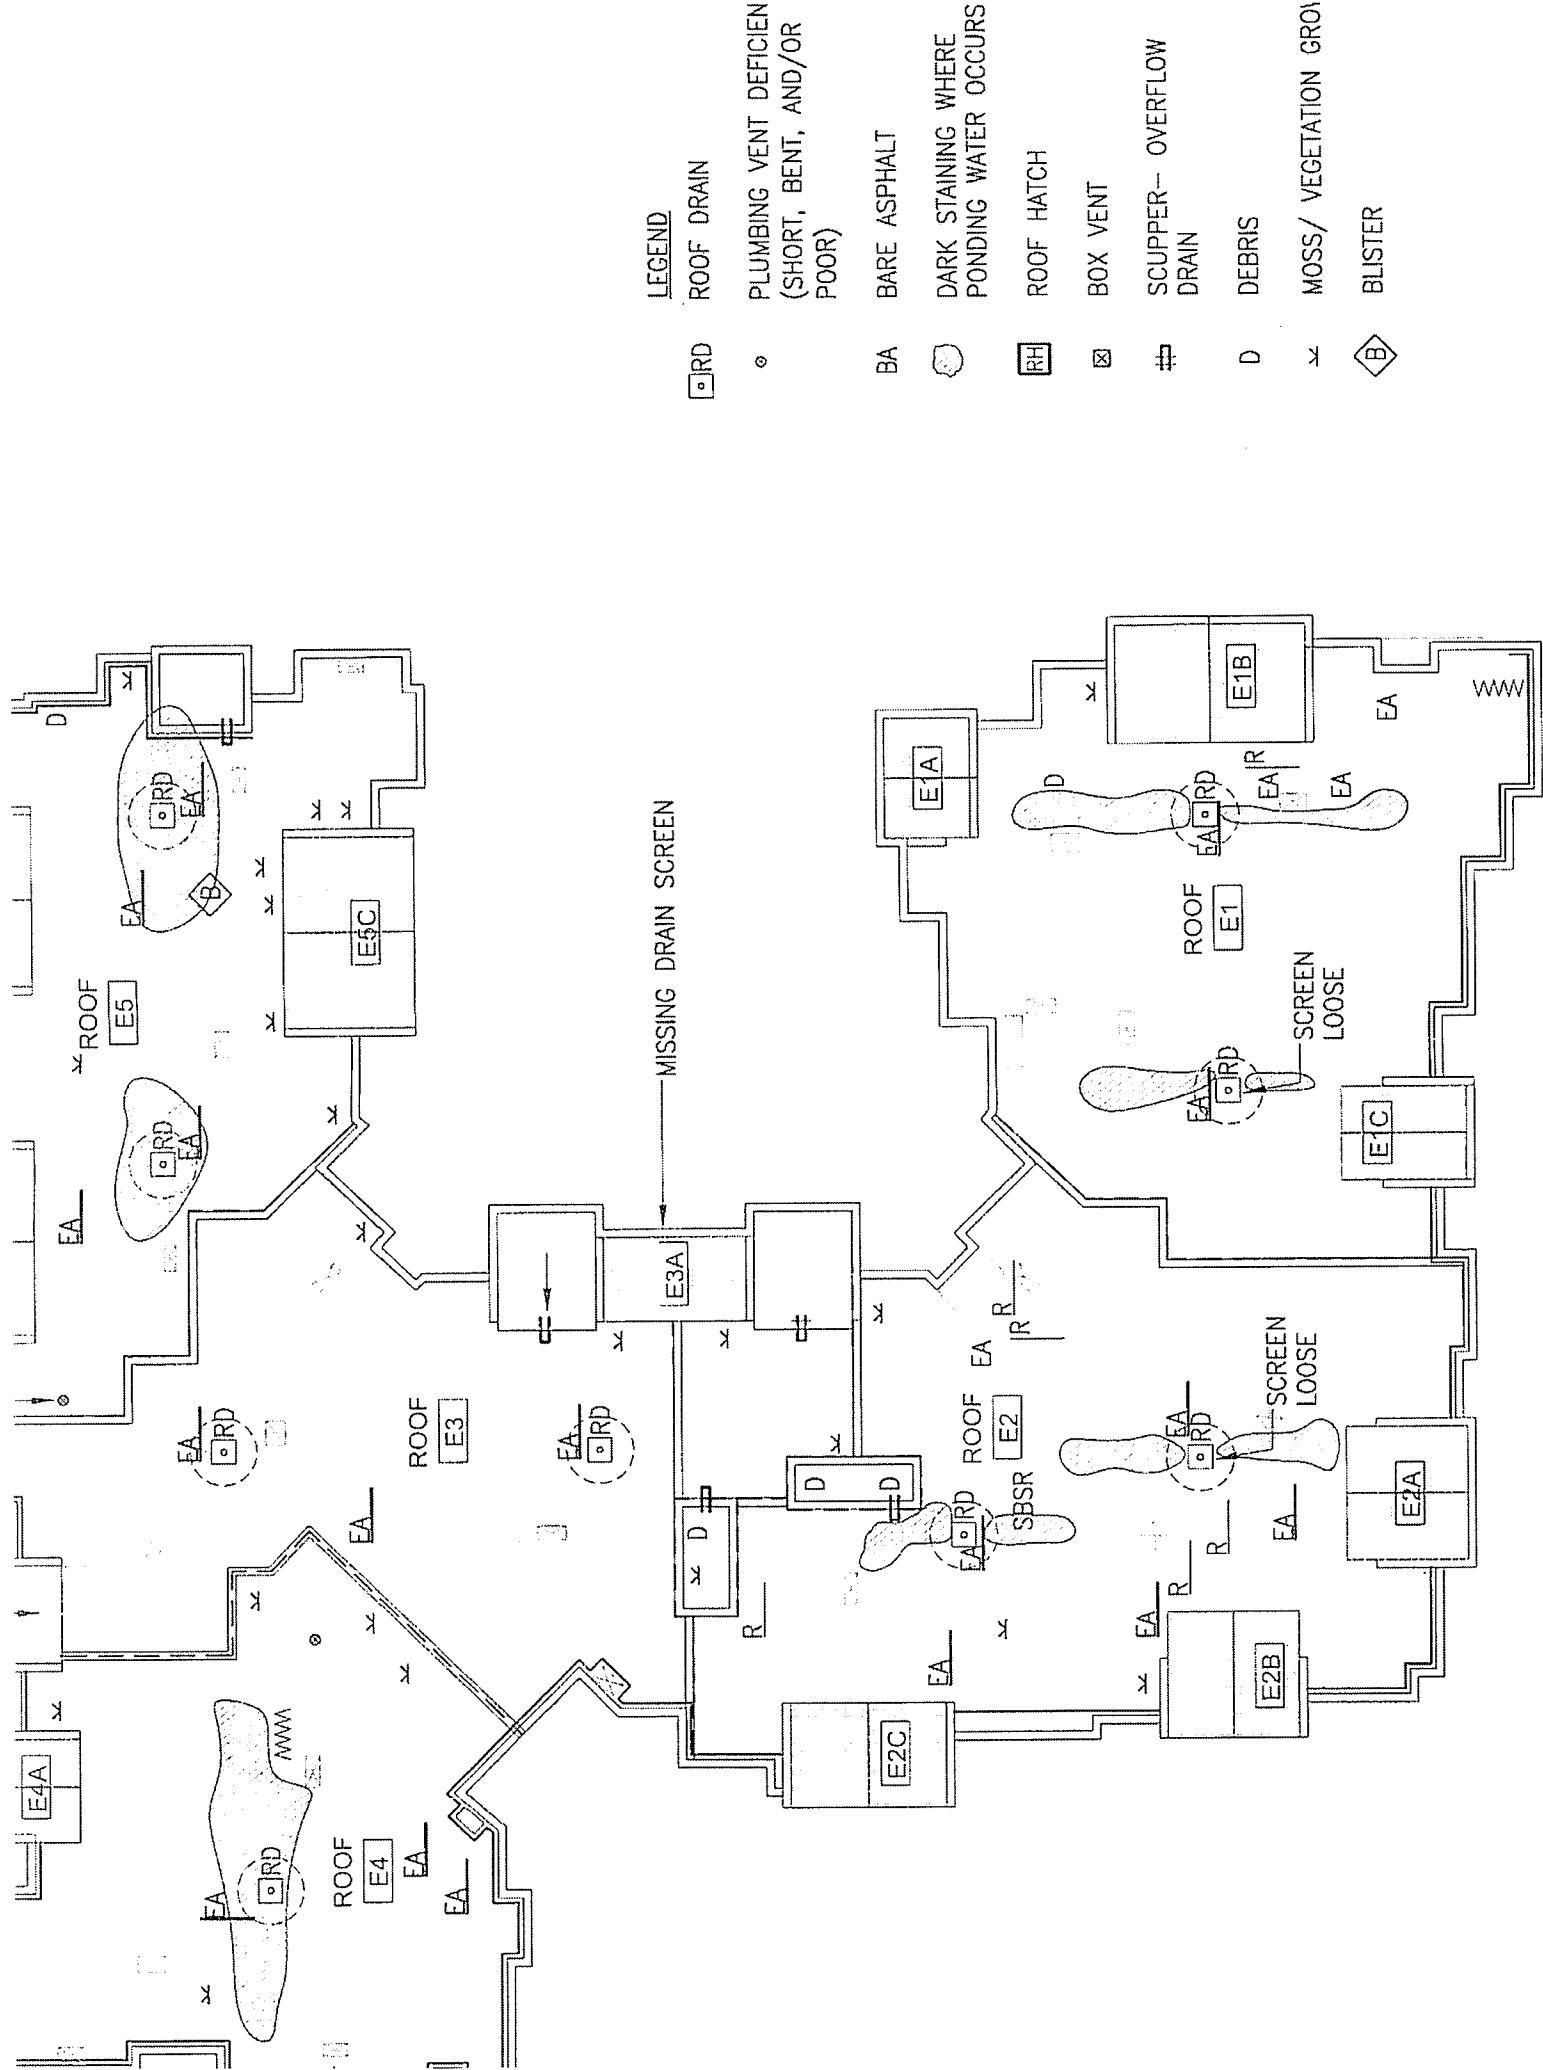
**E1B** LOCATION OF BUILDING (EAST,  
WEST, OR SOUTH)  
SECTION OF FLAT ROOF,  
SECTION OF SLOPED METAL ROOF

ROOF S7 REPLACED  
IN 2002 WITH  
2-PLY SBS  
MEMBRANE SYSTEM
