NW1389 THE WILLOWS

1103 and 1121 Howie Avenue, Coquitlam, BC

**DEPRECIATION REPORT
MAY 2014**

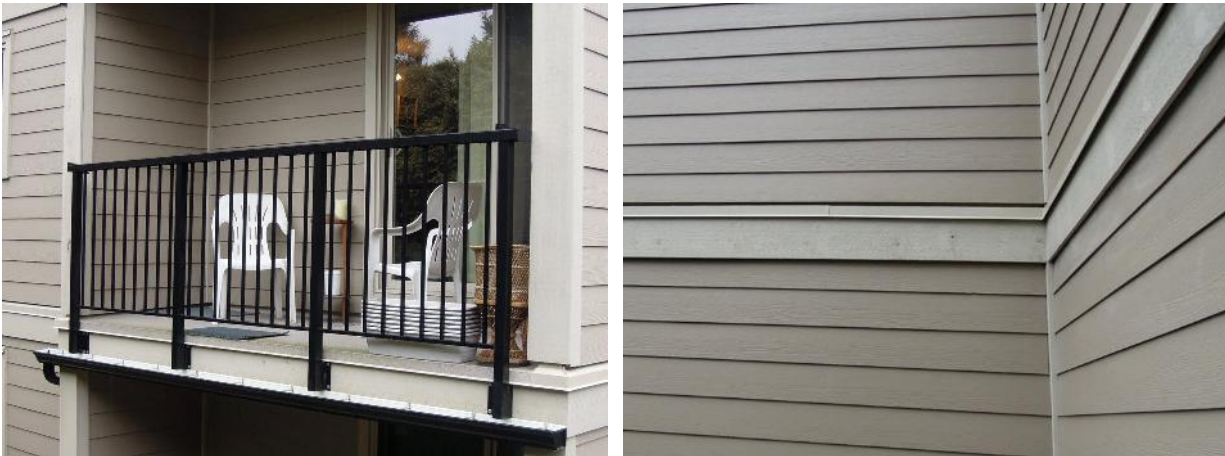
Each building has twenty wood frame balconies. The plywood decks are covered in vinyl membrane. The membrane was replaced in 2012 and has an estimated remaining lifespan of eighteen years.

Painted fir/hem bandboard provides expansion separation between floors. The bandboard was installed in 2012. We recommend painting exterior wood components every ten years to extend the lifespan.

Fig 2. A view of one of the balconies (left). A section of bandboard (right).

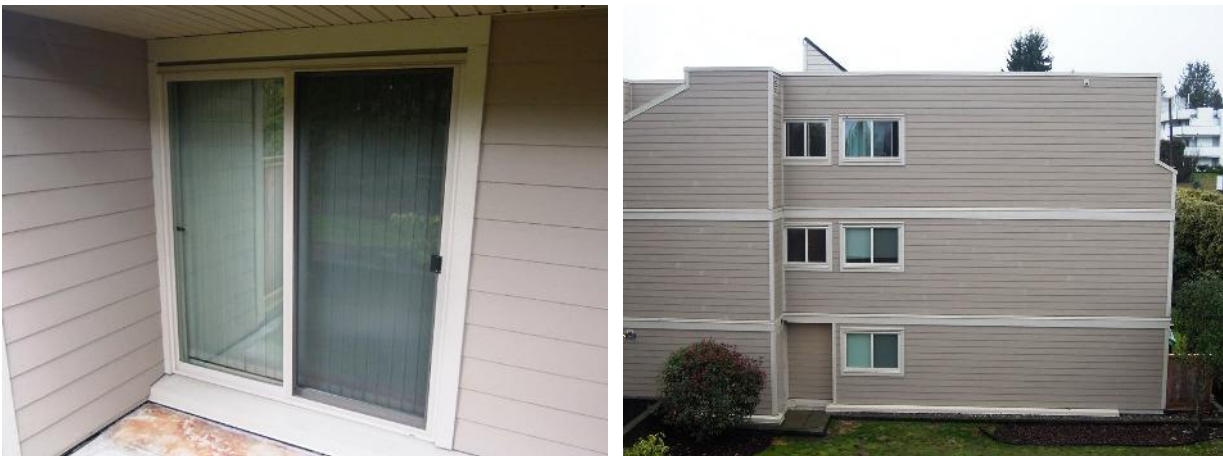
In 2012 all of the exterior walls were clad in HardiePlank® siding installed over a rainscreen assembly. We recommend caulking and painting the siding every twenty years.

Fig 4. A vinyl double glazed sliding glass door (left). HardiePlank® siding covers the exterior walls (right).

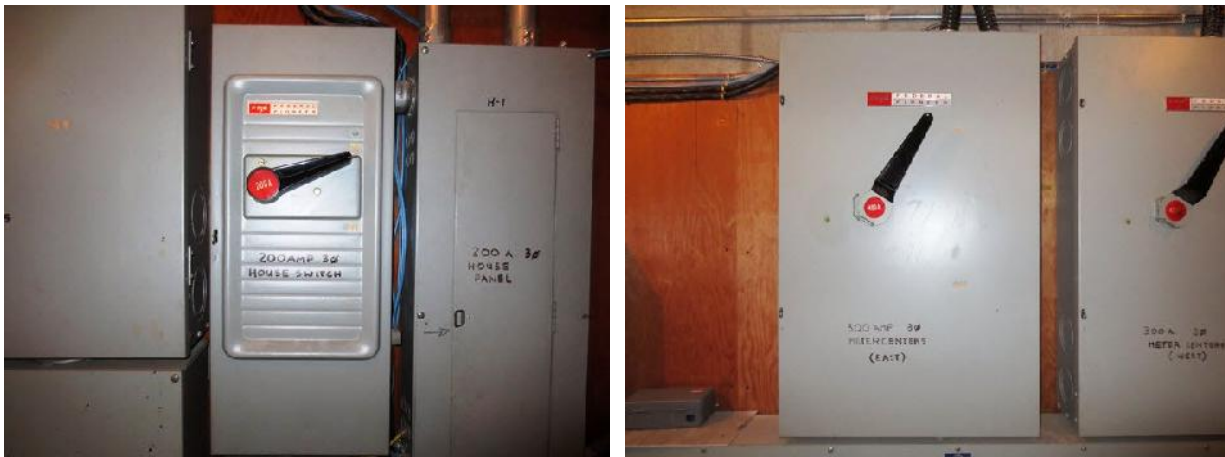
There is a Federal Pioneer 400 amp and 200 amp disconnect in each electrical room. They service the individual unit meter stacks. We recommend annual tightening of all electrical connections.

Fig 18. A 200 amp house disconnect (left). A 400 amp unit meter stack disconnect (right).

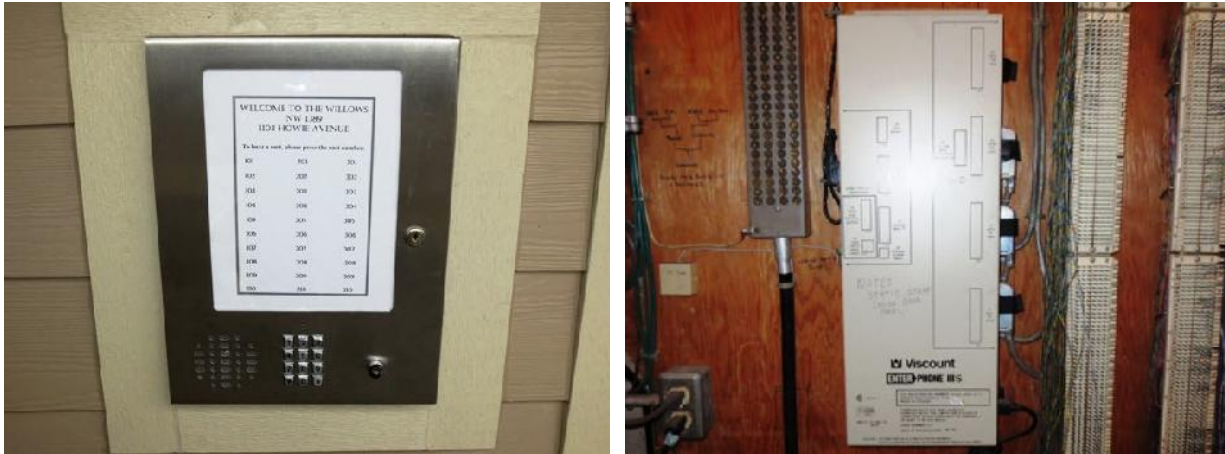
Both buildings have Enterphone IIS panels at the front entrance. They provide communication to in-unit telephones. The enterphone system was replaced in 2012. The control relay modules are in the electrical rooms. These systems have a fifteen year estimated lifespan. See the Costs section for a budget estimate.

Fig 19. The enterphones are outside the main entrance (left). An enterphone control relay (right).

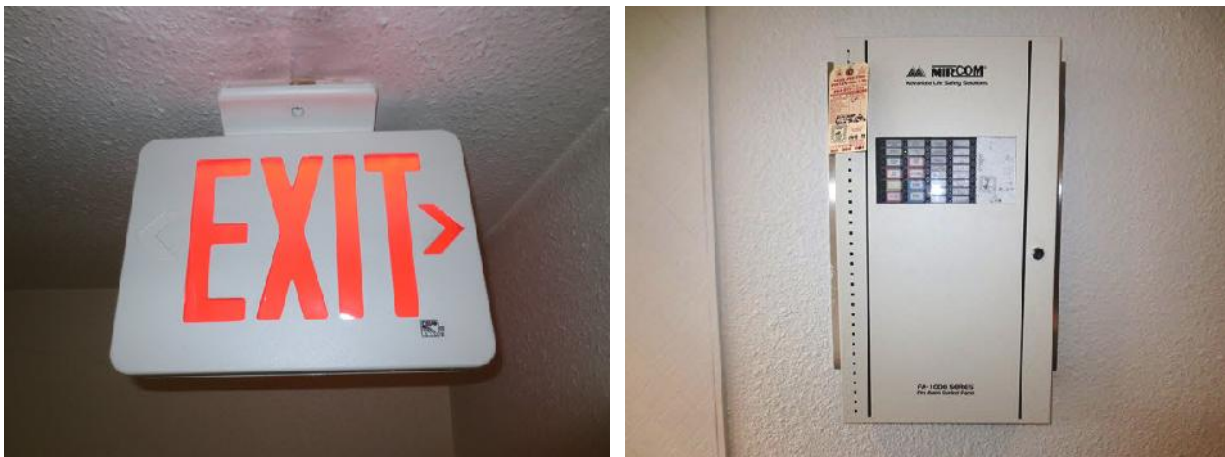
The fire alarm system for the buildings are a Conventional system. It includes the pulls, bells and the annunciator panel. The fire system is maintained regularly by Fairlane Fire Prevention Ltd.

These systems have an estimated lifespan of twenty-five years. The most cost effective way to modernize is to replace the system with another Conventional system. The budget estimate provided in the Costs section is for planning purposes only. For more information about fire safety systems see Appendix B – Fire Safety Systems.

Fig 20. An LED exit sign (left). A fire alarm annunciator panel (right).

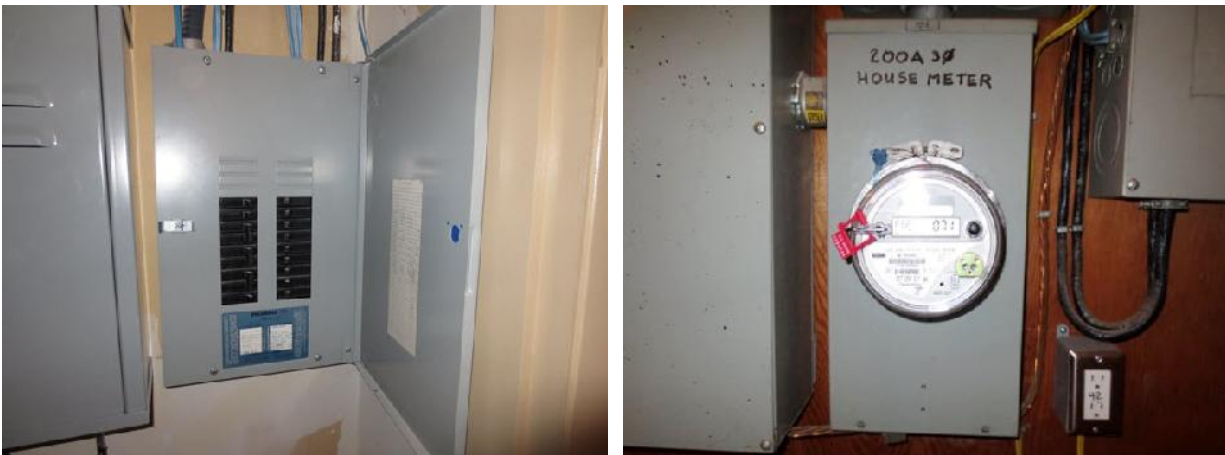
House panels in the electrical rooms and closets serve as a central point for all common use electrical loads. There are no moving parts to this equipment. Wear is commonly caused by loose connections that occur over time from natural expansion and contraction. We recommend annual tightening of all electrical connections.

Fig 22. One of the house panels (left). A house meter in one of the electrical rooms (right).

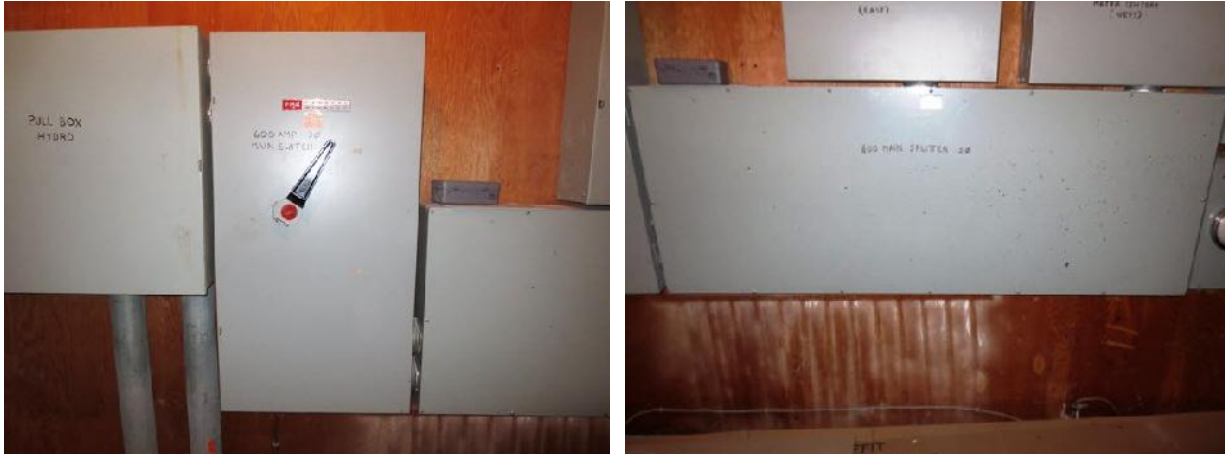
There is a Federal Pioneer 600 amp main building disconnect in each electrical room. This disconnect is the initial point at which electricity enters end-user equipment. We recommend annual tightening of all electrical connections.

There is a BEL 600 amp main splitter in each electrical room. The panels split and distribute power to the house panels and unit meter stacks. We recommend annual tightening of all electrical connections.

Fig 27. One of the main building disconnects (left). A main splitter (right).

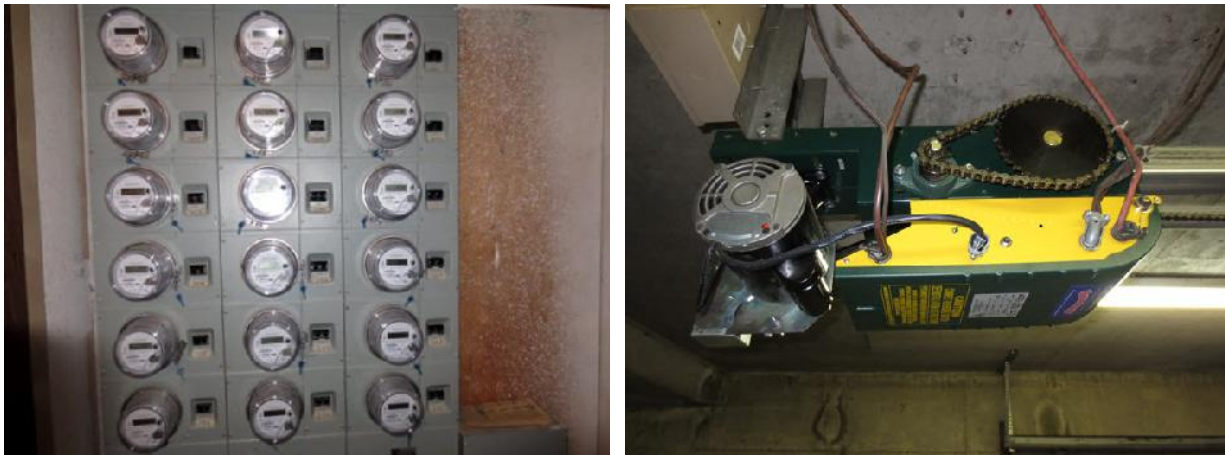
There are ten unit meter stacks with six meters per stack. The stacks are located in the second floor electrical closets. The unit meter stacks are the point at which building power becomes the end users' responsibility. We recommend annual tightening of all electrical connections.

Manaras door openers operate the parkade overhead doors. The opener for Building A was replaced in 2013. These devices are serviced by Overhead Door Co. Overhead door openers have an estimated lifespan of fifteen years. A budget estimate is provided in the Costs section.

Fig 28. A set of unit meter stacks (left). The new overhead door opener in Building A (right).

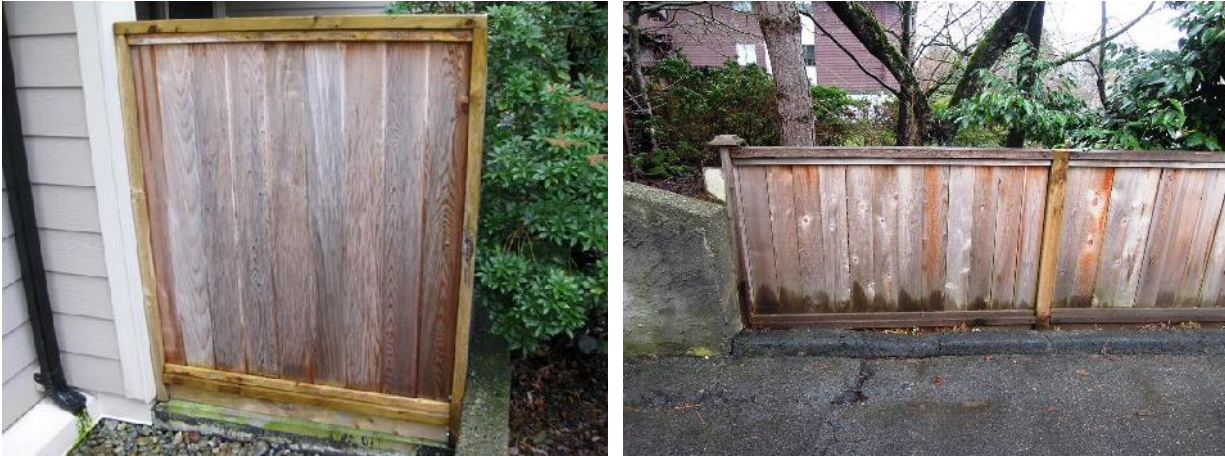
Cedar privacy panels are between the unit patios. The panels appeared to be recently installed. Cedar fencing is also beside the parkade entrance ramp at Building B. This fence was installed in 2011. We recommend all cedar fencing be stained every ten years to extend the lifespan. A budget estimate is provided in the Costs section.

Fig 30. A patio privacy panel (left). The cedar fencing at the parkade entrance ramp to Building B (right).

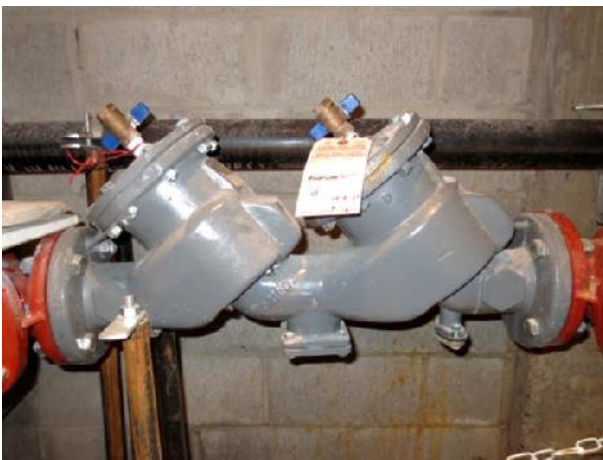
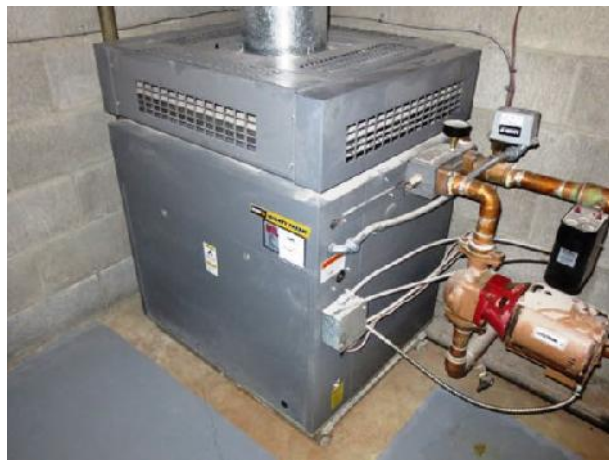
The Laars Mighty Therm boilers service the unit owners' domestic hot water needs. There is one in each mechanical room. The boilers heat and then transfer water to storage tanks for use when needed.

Fig 41. One of the backflow preventers (left). A domestic hot water boiler (right).

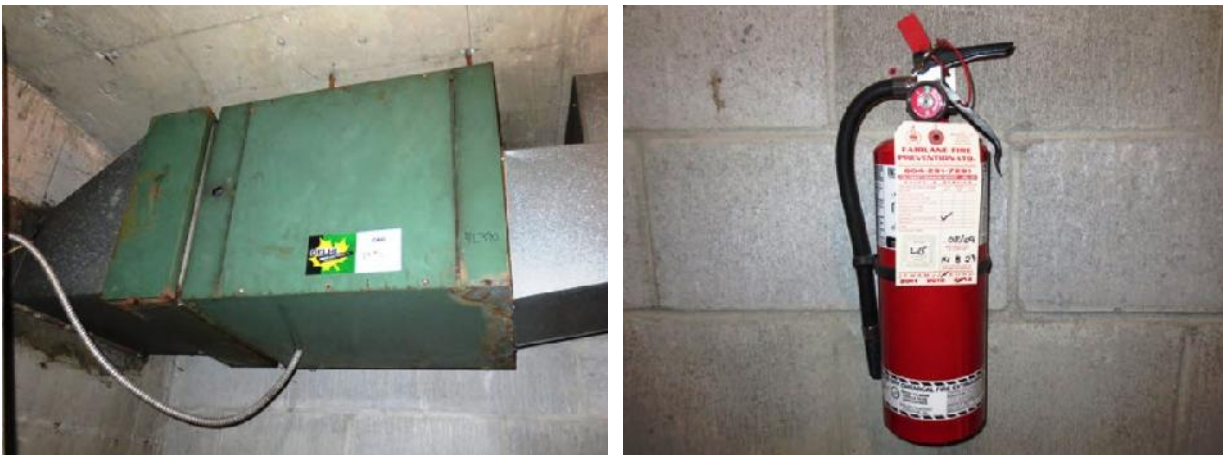
Exhaust fans maintain a negative airflow to ensure no noxious gasses are present. They also help keep the air fresh and prevent moisture build up. Two belt driven exhaust fans service each parkade. The fans have dome exteriors and are situated on the west sides of the grounds. A Delhi exhaust fan is also in the electrical room in Building A. There are generic extractor fans in the storage rooms and bathrooms. These fans were not functional at the time of the site visit.

Fig 45. The Delhi inline exhaust fan (left). One of the fire extinguishers (right).

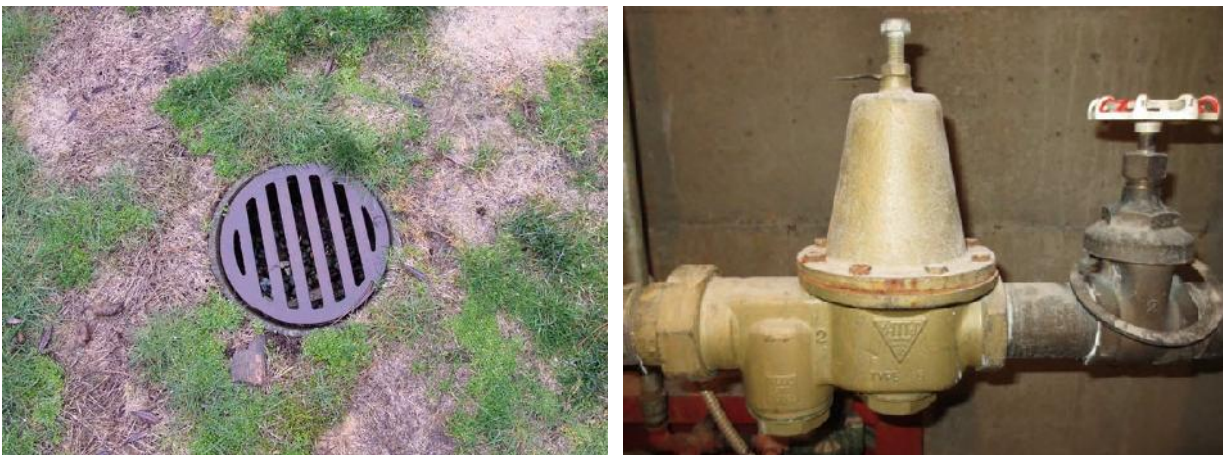
Fig 47. A building perimeter storm drain (left). A pressure reducing valve (right).

Each building has a two-inch Watts Type 5 PRV. They reduce city water pressure from 52 – 100 psi to a more end user friendly pressure. Common set points are 50 – 65 psi depending on build design. PRVs that are rebuilt regularly rarely need replacement. We recommend a full rebuild every three years.

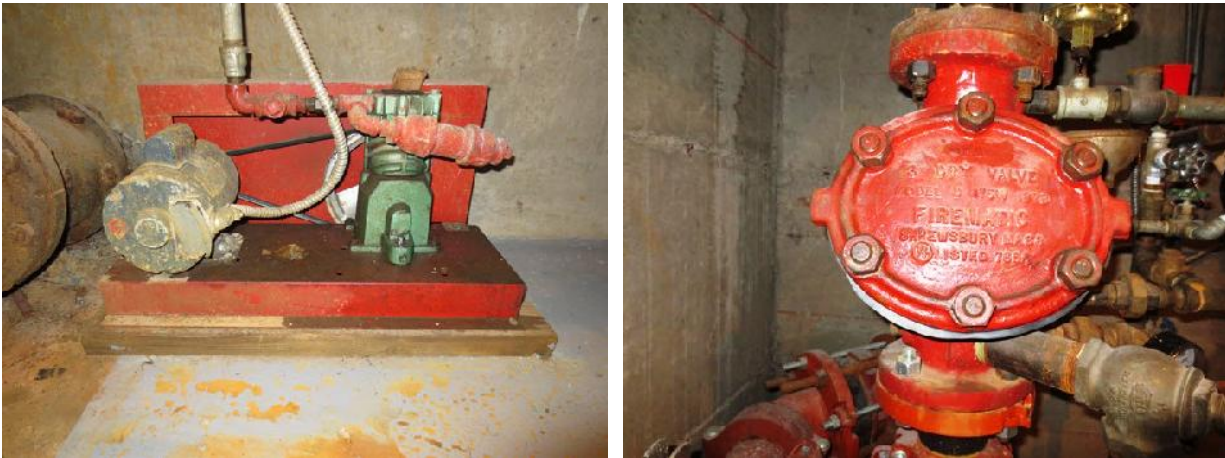
The compressor in Building B was replaced in 2013. The budget estimates provided in the Costs section are for budget planning only. For an assessment of your system, contact Fairlane Fire Prevention Ltd. For more information see Appendix B – Fire Safety Systems.

Fig 49. The compressor in the mechanical room at Building A (left). One of the dry pipe valves (right).

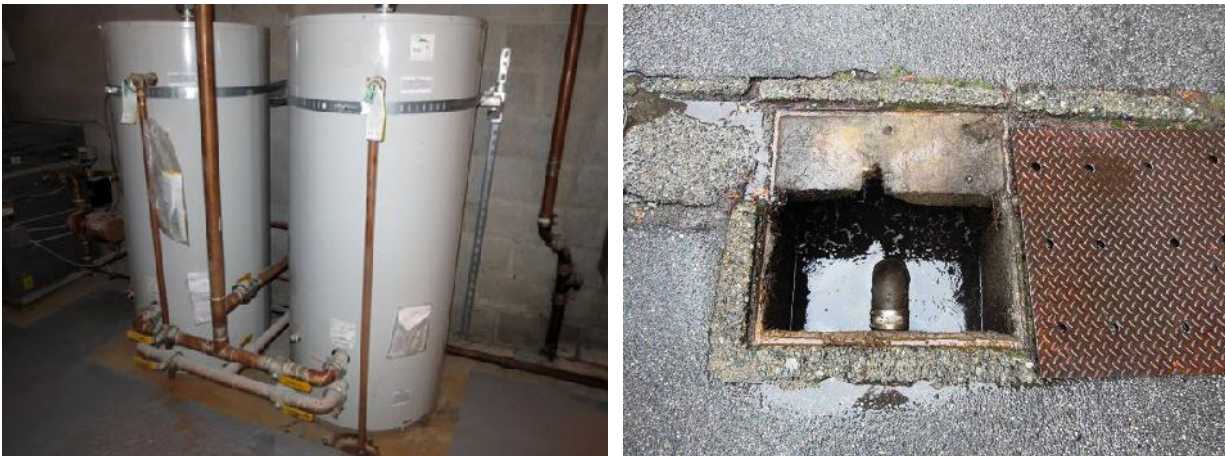
There are gravity sumps for building drainage at the entrance ramps, in the parkades and in storage rooms. The sumps facilitate excess groundwater removal to the city water system through a pipe by gravity. There are no mechanical components or moving parts to these systems. We recommend the sumps be inspected regularly and cleaned at least every two years.

Fig 50. A set of hot water storage tanks (left). This gravity sump is on one of the entrance ramps (right).

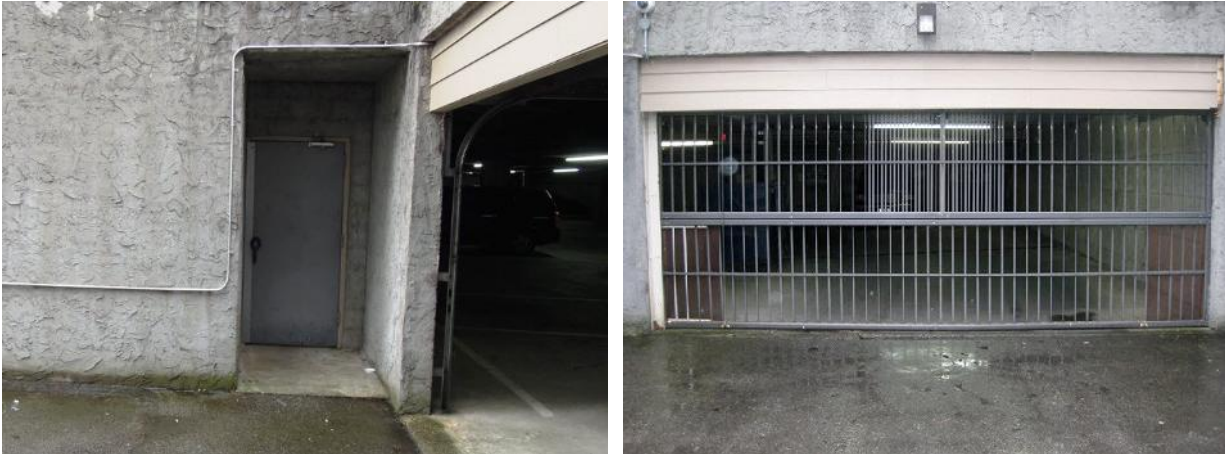
A metal overhead door provides vehicle access into the parkades. This type of door has an estimated lifespan of thirty years. A budget estimate is provided in the Costs section.

Fig 58. A metal exterior exit door from the parkade (left). An overhead door (right).

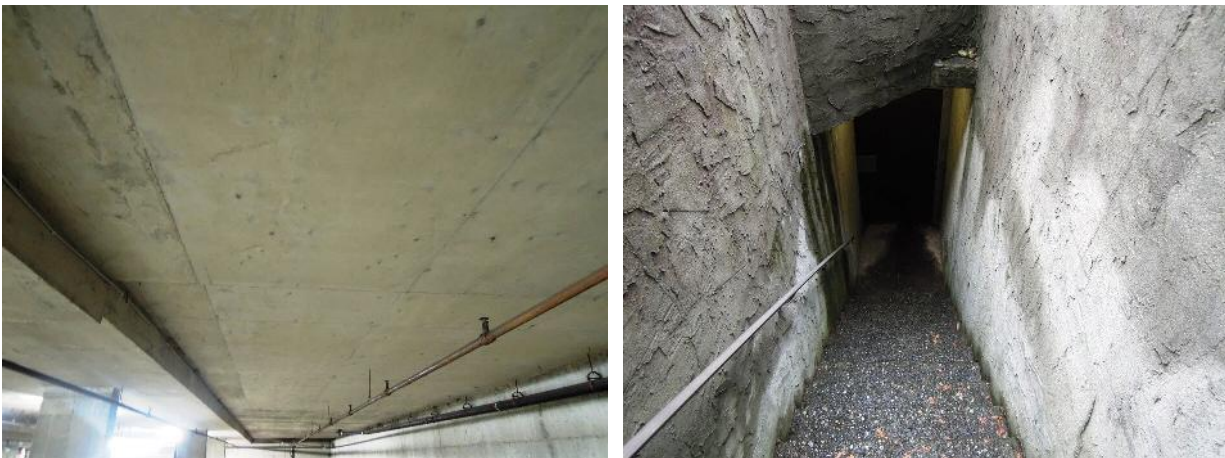
There are a few active leaks including a leaking vent stack at Building B. A budget estimate for repairs is included in the Costs section. For a detailed assessment with a breakdown of recommended repairs, see the Sealright Concrete Restoration budget estimate in Appendix C.

Fig 63. An uninsulated area of suspended slab (left). A view down one of the parkade stairwells (right).

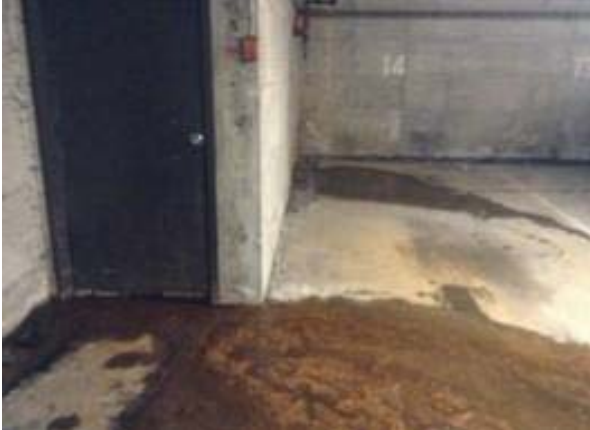
1. Item A.Drainage Problem in Parkade Stairwell. Water pooling in stairwell landing behind door.

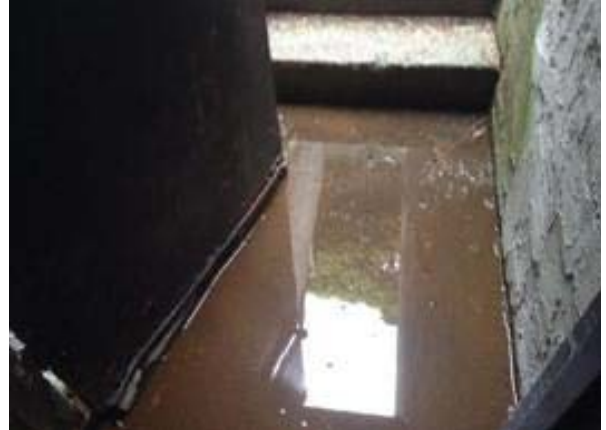
2..Drainage Problem in Parkade Stairwell. Water pooling in stairwell landing is saturated with soil.

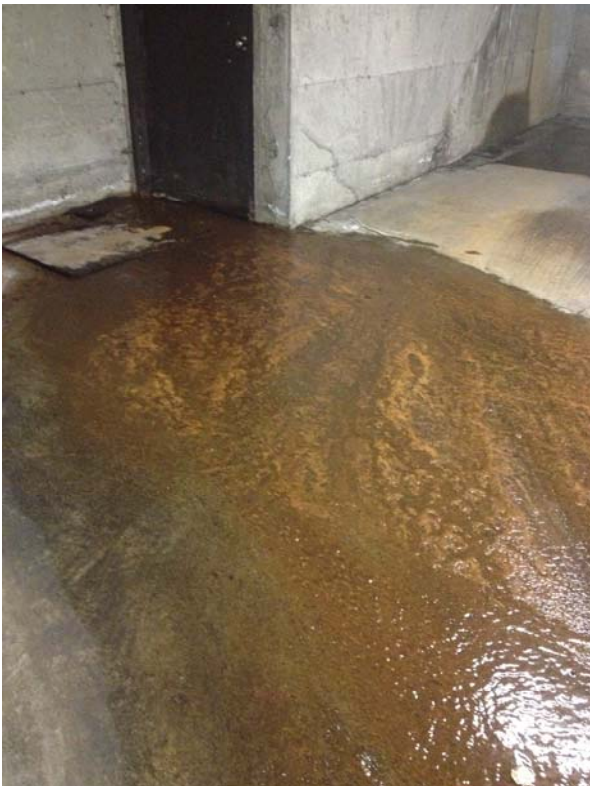
3..Drainage Problem in Parkade Stairwell. Water pooling in stairwell landing behind door and streaming down parkade interior slab to the sump drain.

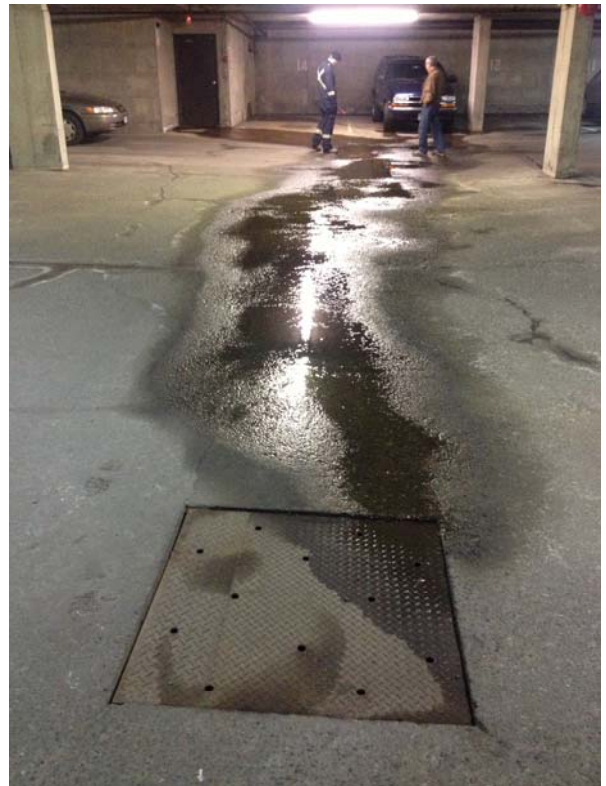
4..Drainage Problem in Parkade Stairwell. Water pooling in stairwell landing behind door and streaming down parkade interior slab to the sump drain. Sump drain cover seen in front.

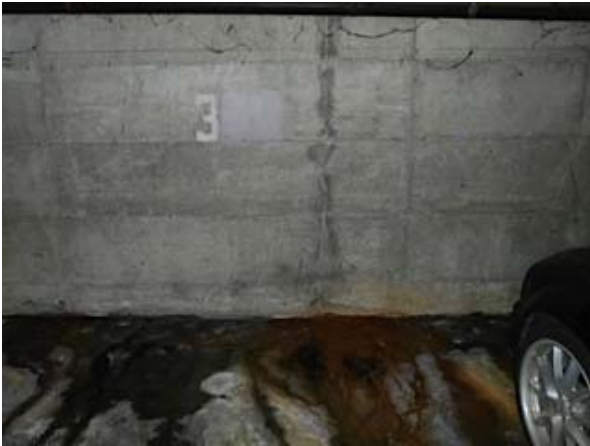
5. Item B. Water ingress along north facing slab to wall interface. Water seeping up through cold joint from below the floor slab.

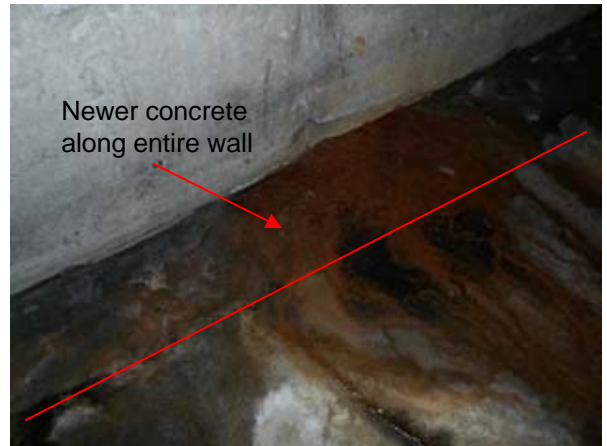
6. Item B. Water ingress along north facing slab to wall interface. Water seeping up through cold joint from below the floor slab. Slight difference in newer concrete installed along wall.

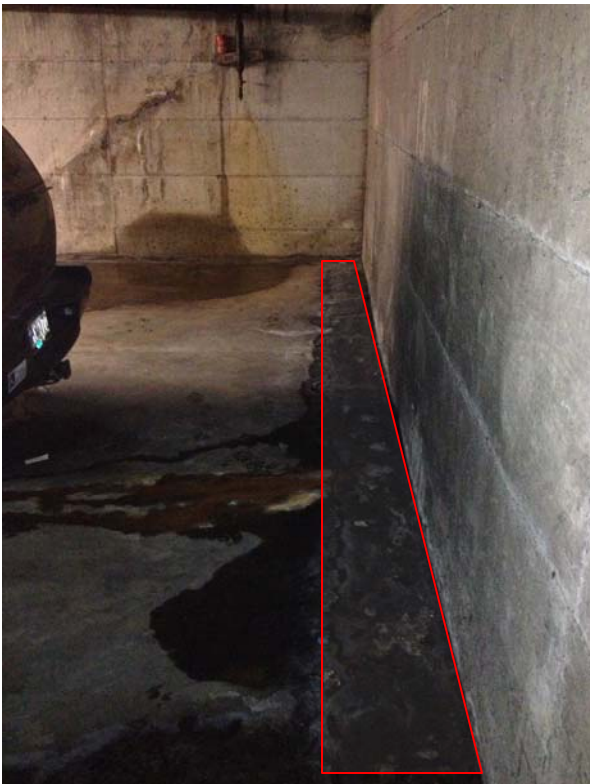
7. Item B. Water ingress along north facing slab to wall interface. Water seeping up through cold joint from below the floor slab. Slight difference in newer concrete installed along wall. Partial length of the wall. Showing the water coming up through the floor.

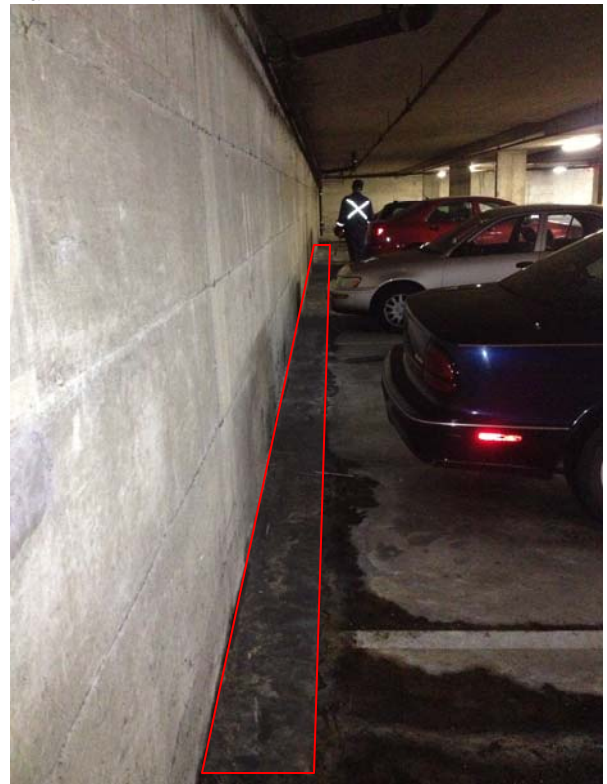
8. The rest of the same wall. It is about 200 feet long. There is evidence that there has been a drain system made along this wall at some point in the past.

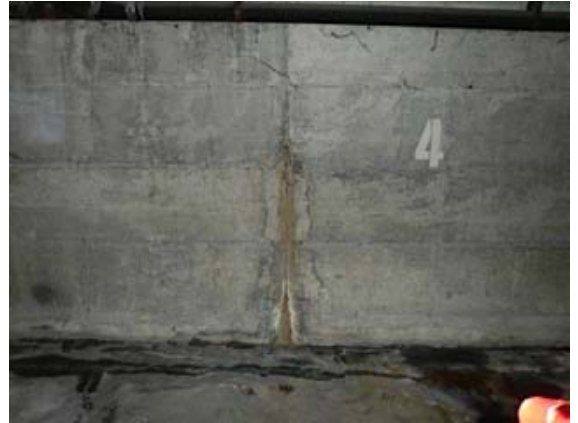
15.Item C stall 4-5. Water seeping up through cold joint void in wall.

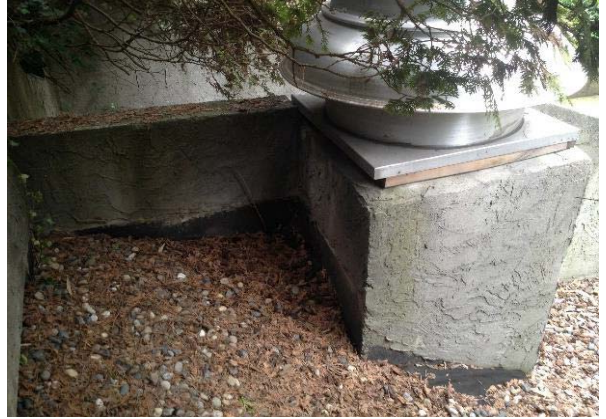
08.Item B topside of vent stack and surrounding landscaping. Location of sump drain A west side of building

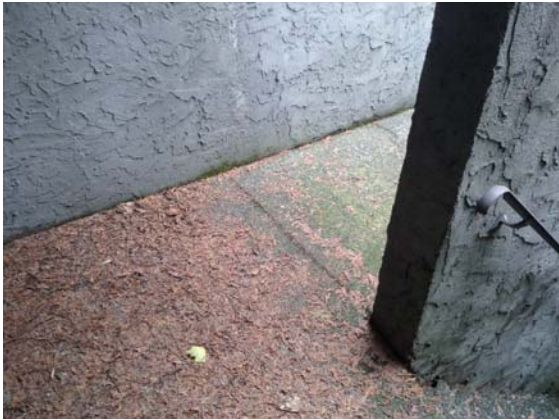
09.Item B topside of vent stack wall and adjacent stairwell corridor.

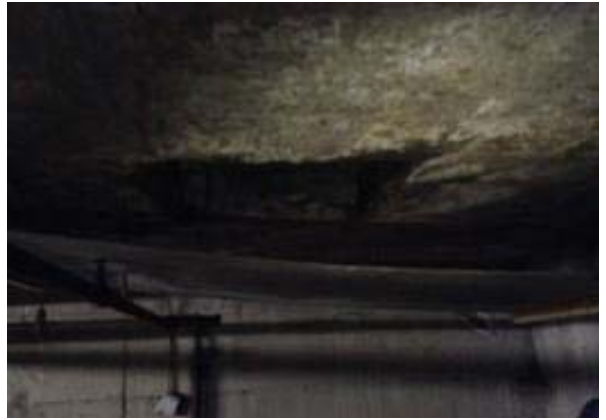
10.Item B underside of vent stack and surrounding insulation.
