Depreciation Report

NW1803 – Blue Mountain Place

RE: Depreciation Report for Strata Plan NW1803
File No. 20160215-DR-NW1803

The subject of this depreciation report consists of “Blue Mountain Place”, a 47-unit apartment complex constructed in 1982 and located at 1177 Howie Avenue in Coquitlam, BC. We are pleased to present you with the enclosed depreciation report, which we believe will serve as the basis of your reserve planning to help better equip your members for future expenditures.

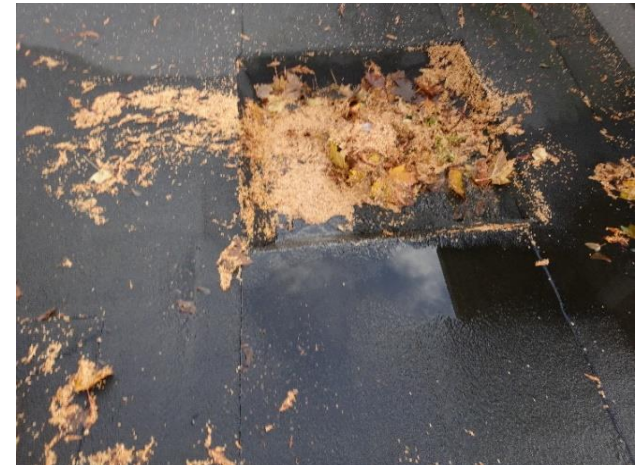
Clogged roof drain

Cost Estimates	Starting Year	Current Cost		Future Cost	
	2036	\$174,300		\$340,180	
Funding Method	Budget for full replacement.				
Preventative Maintenance	Inspect twice a year (spring and fall) and repair/replace any damage. Clear away any debris or dirt, ensuring that drainage is clear. Addressing any splits or tears in flashing or penetrations helps keep leaks from entering the building or soaking the insulation and destroying the system and the roof deck from within.				
Remarks	None.

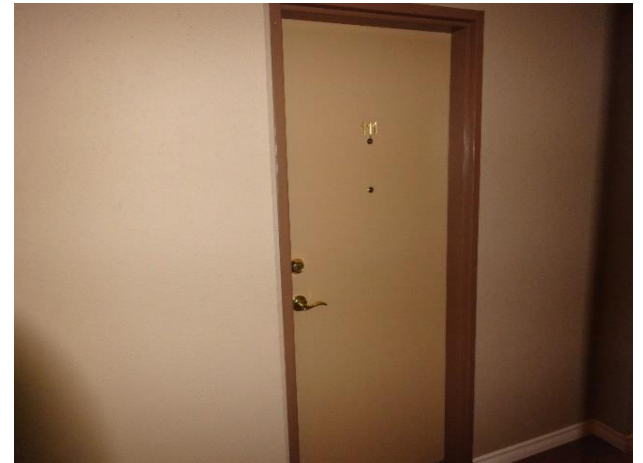
Unit entry door

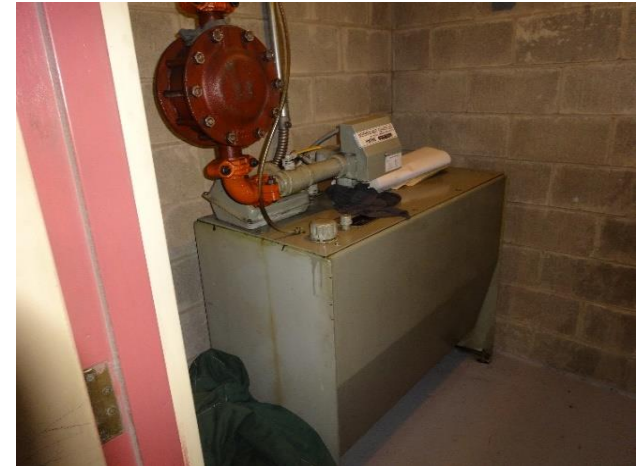
Elevator machinery

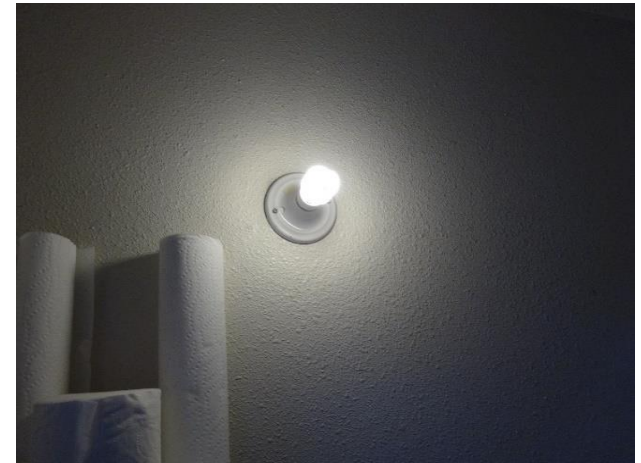
Fluorescent lamp light fixture in service room

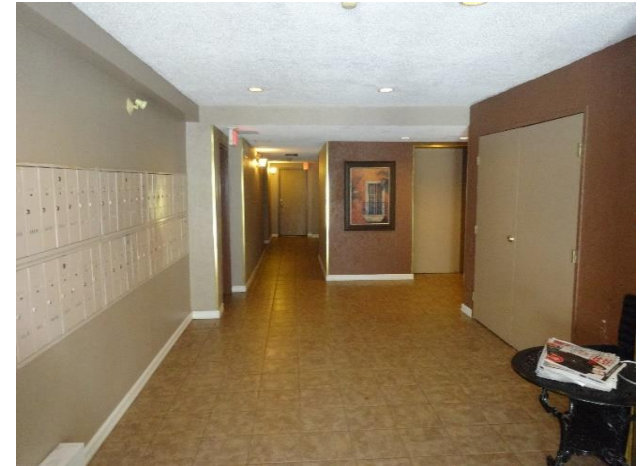
Lobby area

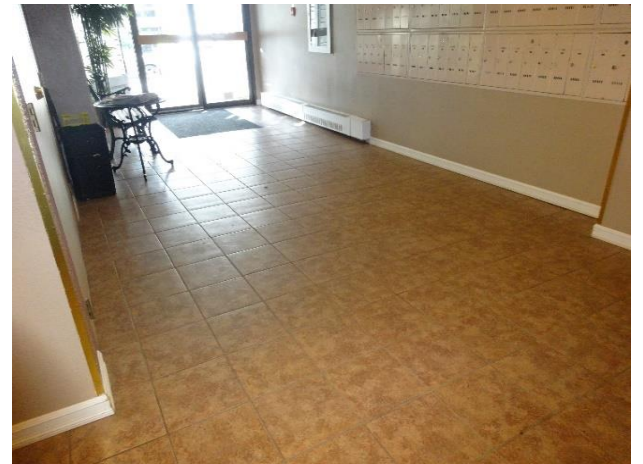
Quarry tiles flooring

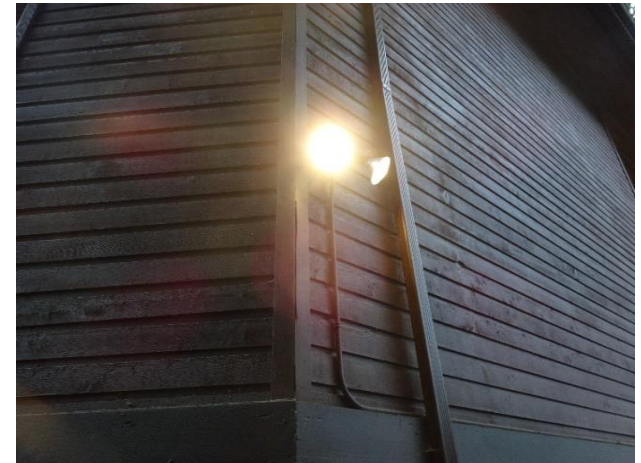
Wall mounted light fixture

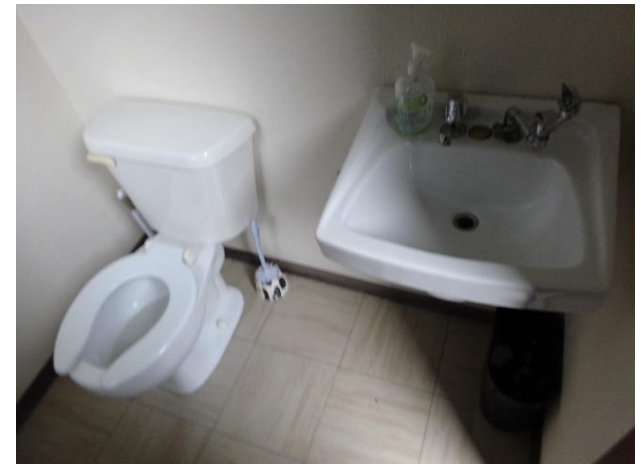
Plumbing fixtures in washroom

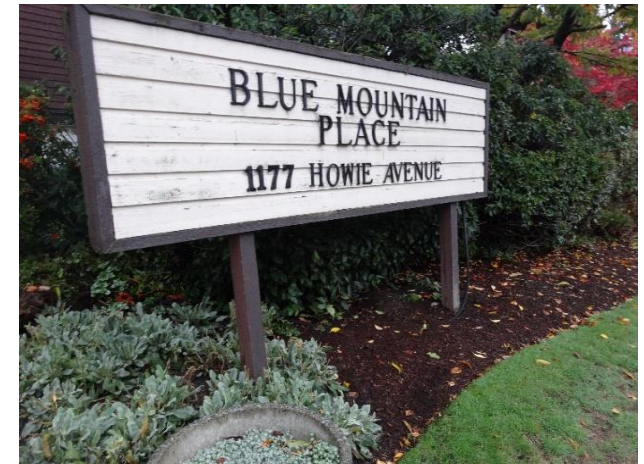
Property sign
