eSH342573-06-Form B - Information Certificate_Strata Engineering - Depreciation Report - NW1803 (revised).pdf

Absolute Building Science
Strata Engineering Inc.
#234 - 5589 Byrne Road
Burnaby, BC V3J 3J4

*NW1803 – Blue Mountain Place
1177 Howie Avenue
Coquitlam, BC*

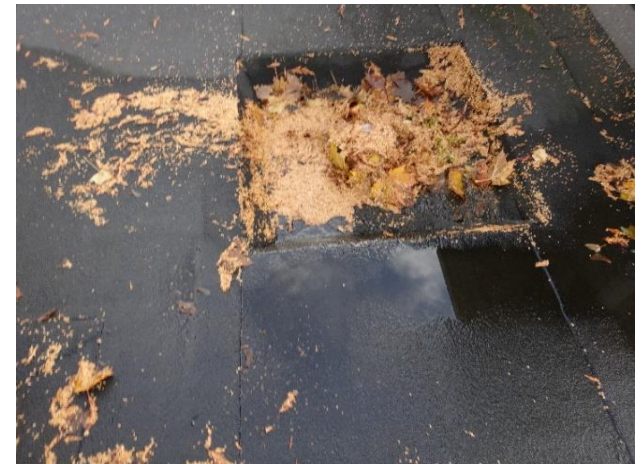
Clogged roof drain

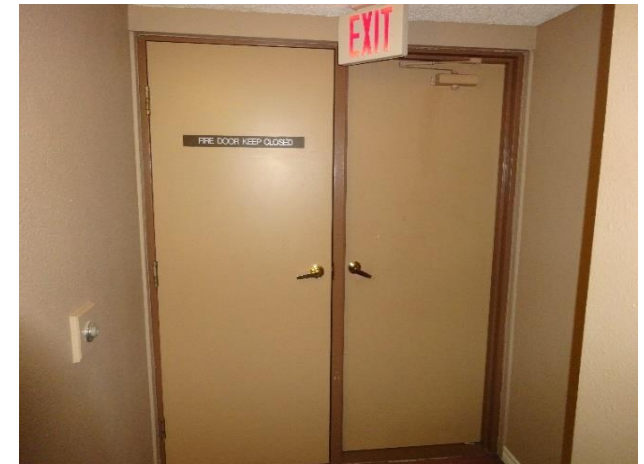
Fire doors on corridor

| Reserve Component C10200103 | Unit entry doors | | | | |
|---|--|---|---|---|---|
| Condition Analysis | Deterioration | None apparent. | | | |
| | Overall Condition | Acceptable. | | | |

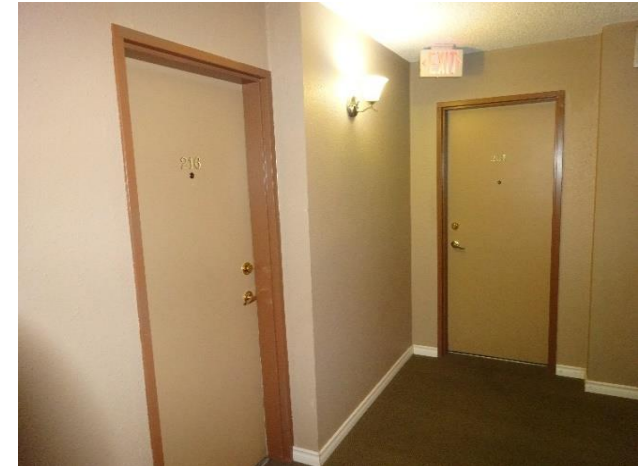
Unit entry doors

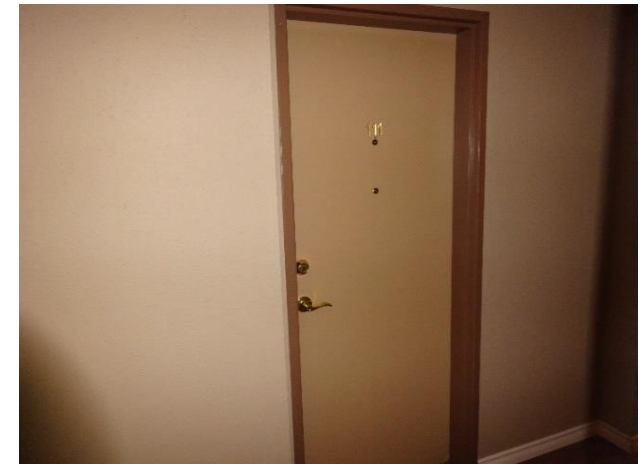
Unit entry door

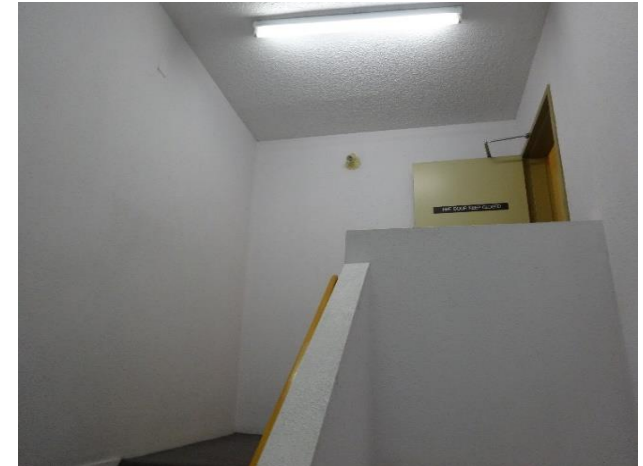
| Condition Analysis | Deterioration | None apparent. | | | |
| | Overall Condition | Acceptable. | | | |

Paint application on walls and ceiling

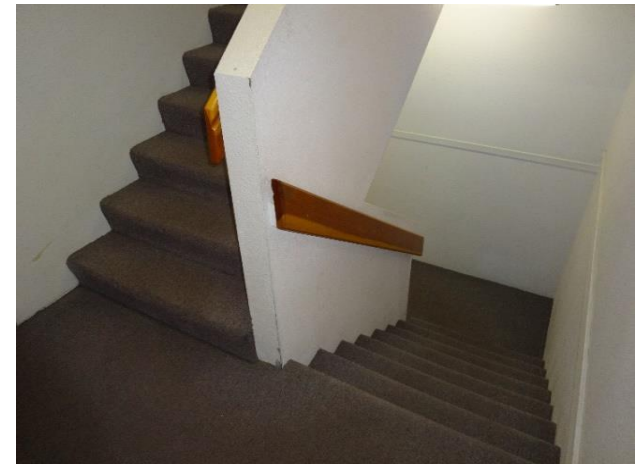
Carpet flooring on stairs

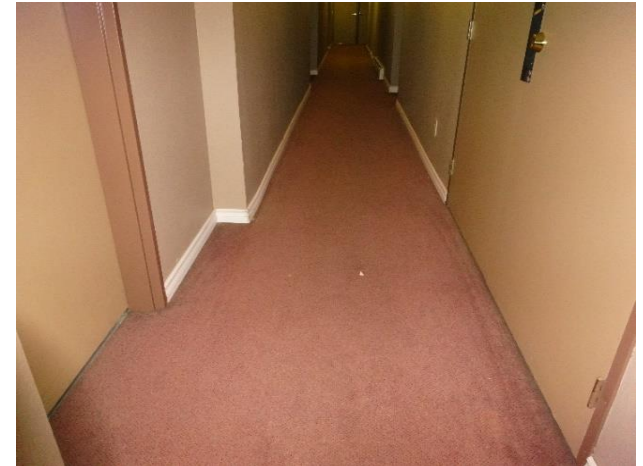
| Reserve Component C30200501 | Flooring finishes | | | | |
|---|---|---|---|---|---|
| Condition Analysis | Deterioration | None apparent. | | | |
| | Overall Condition | Acceptable. | | | |
| Repair History | Carpet flooring replaced on corridors for 2nd and 3rd floor in 2012-2014. | | | | |

Carpet flooring at ground floor corridor

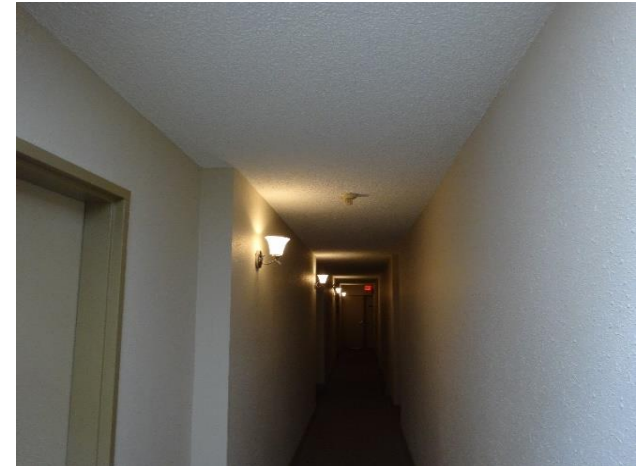
| Condition Analysis | Deterioration | None apparent. | | | |
| | Overall Condition | Good. | | | |

Paint application on walls and ceiling

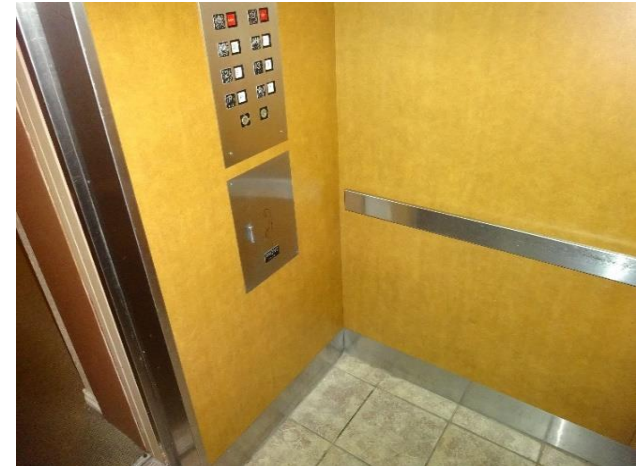
| Condition Analysis | Deterioration | None apparent. | | | |
| | Overall Condition | Good. | | | |

Wall and floor finishes

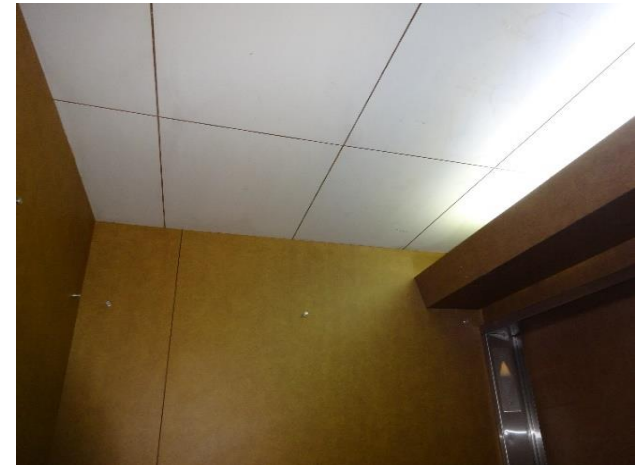
Wall and ceiling finishes

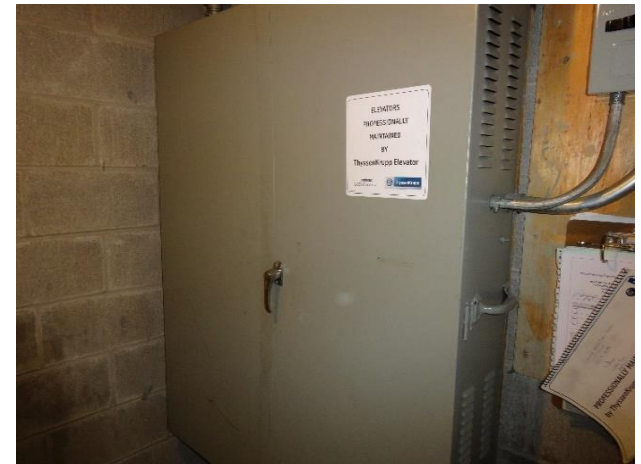
Elevator control panel

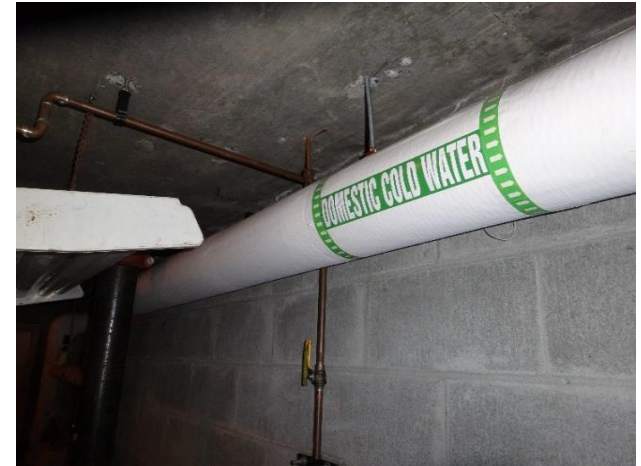
| Reserve Component D20200201 | Domestic cold and hot water distribution system | | | | |
|---|---|---|---|---|---|
| Condition Analysis | Deterioration | None apparent. | | | |
| | Overall Condition | Acceptable. | | | |

Domestic cold water main line

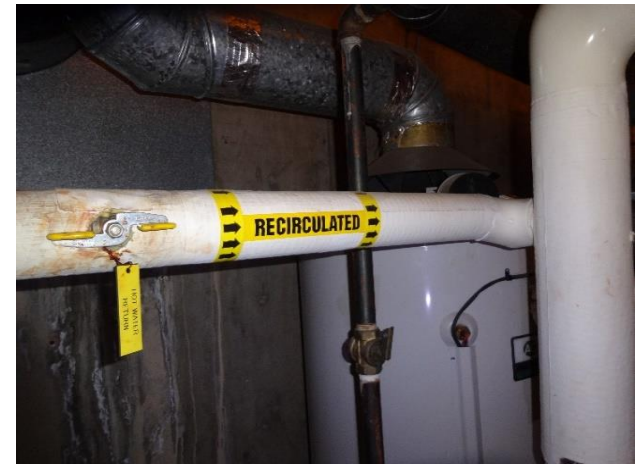
Domestic hot water piping and valves

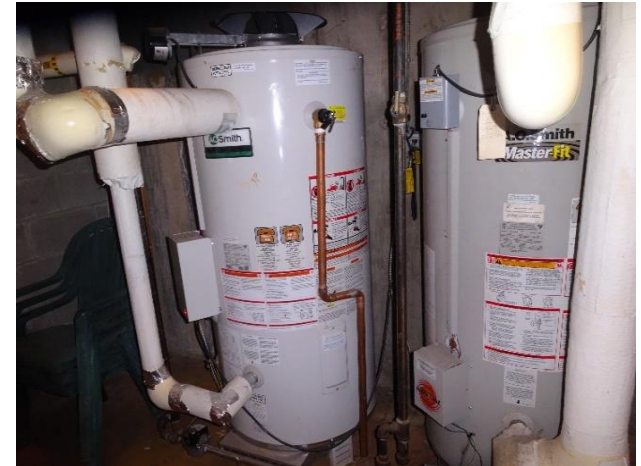
| Condition Analysis | Deterioration | None apparent. | | | |
| | Overall Condition | Acceptable. | | | |

Domestic hot water storage tanks

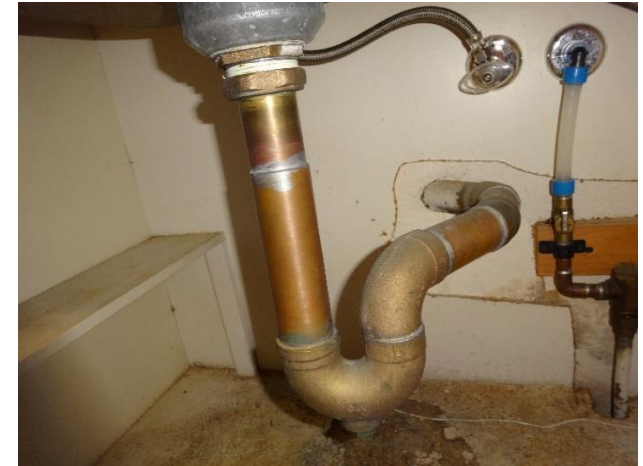
Sink sanitary drain

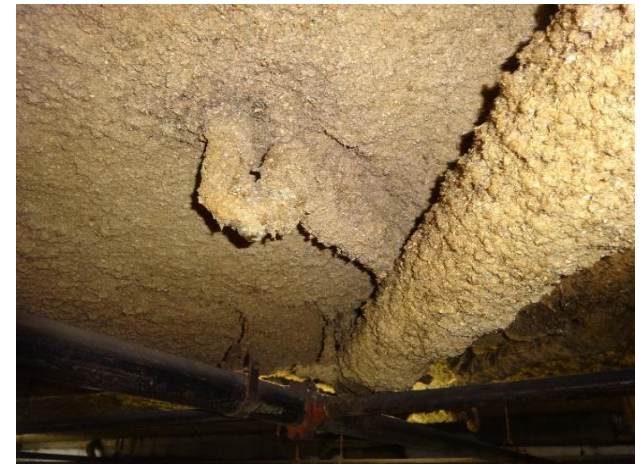
Sanitary piping in parkade area

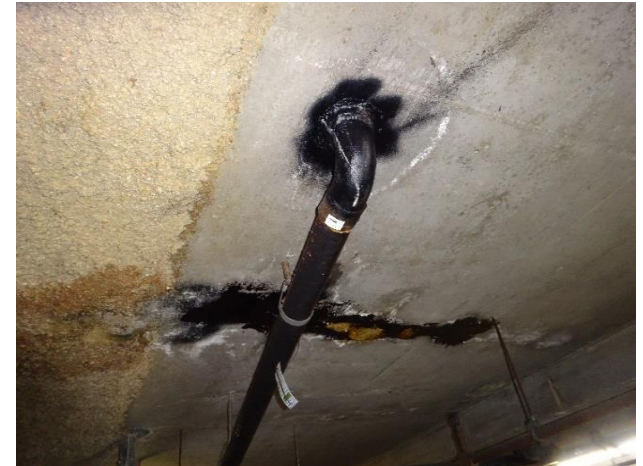
Storm water piping in parkade area

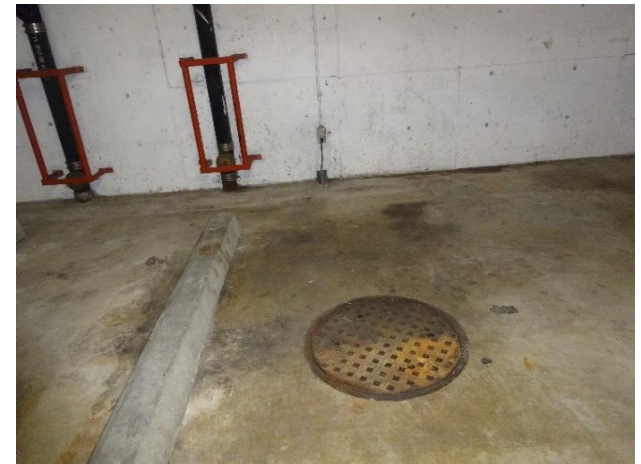
Storm water manhole

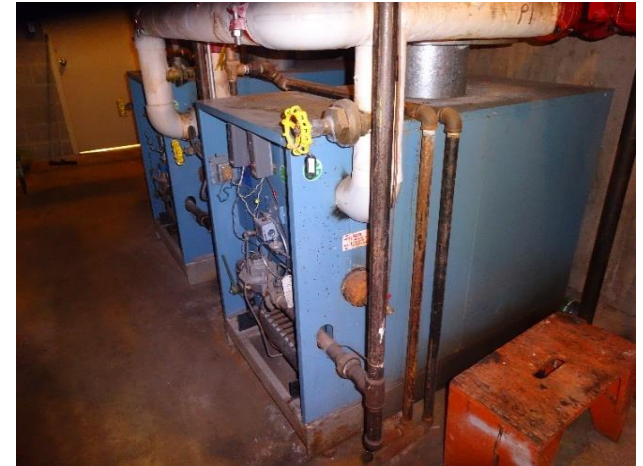
Hot water heating boilers

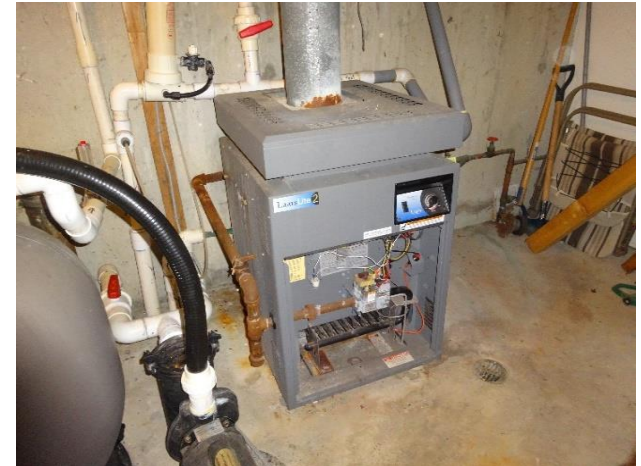
Pool heating boiler

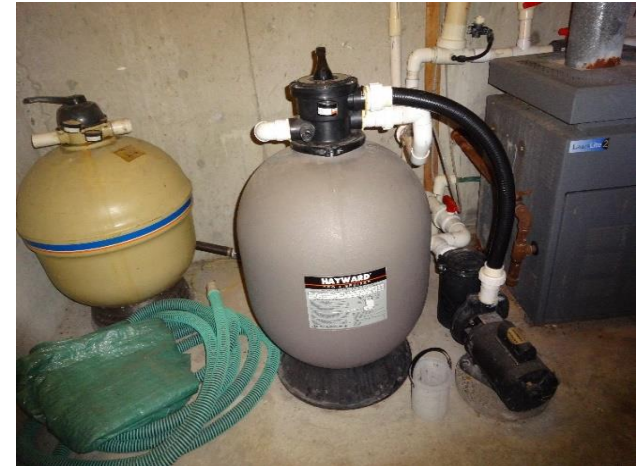
Sand filter, pump and piping

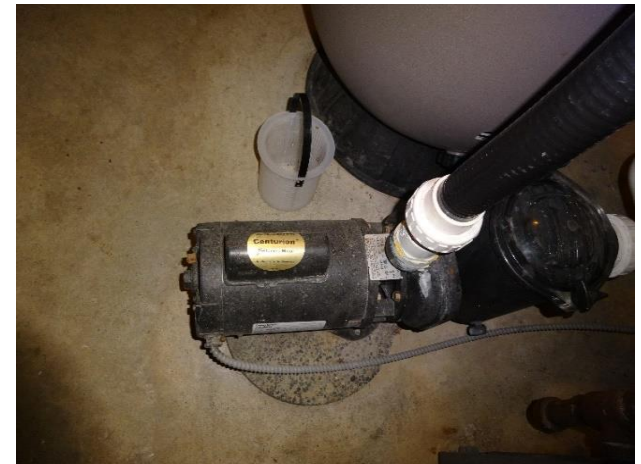
Circulation pump

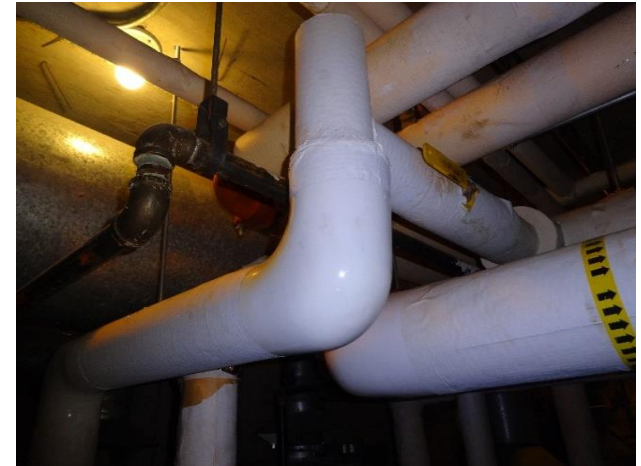
Hot water heating piping and valves

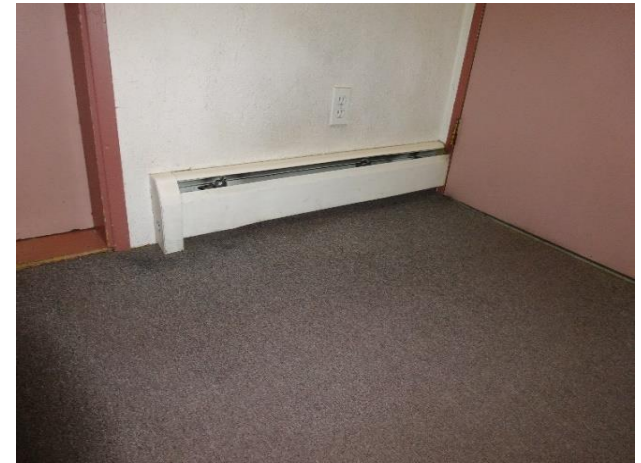
Hot water heating baseboard

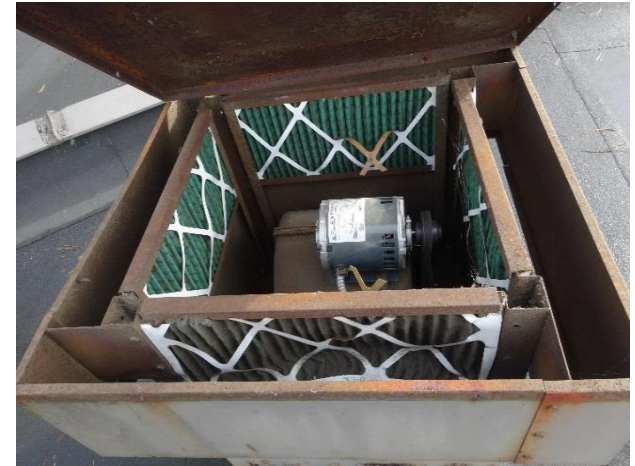
Make-up air unit

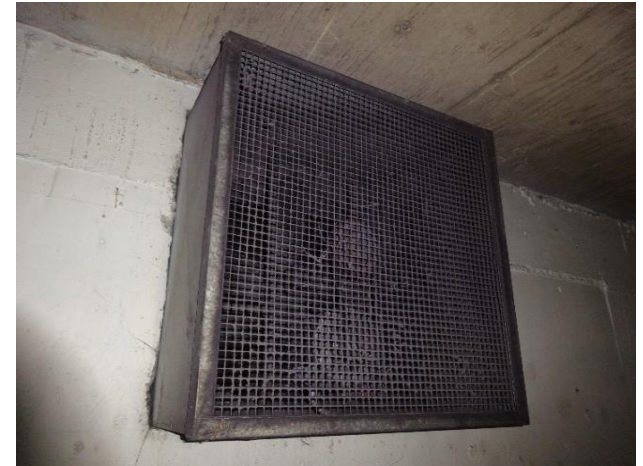
Exhaust fan in parkade

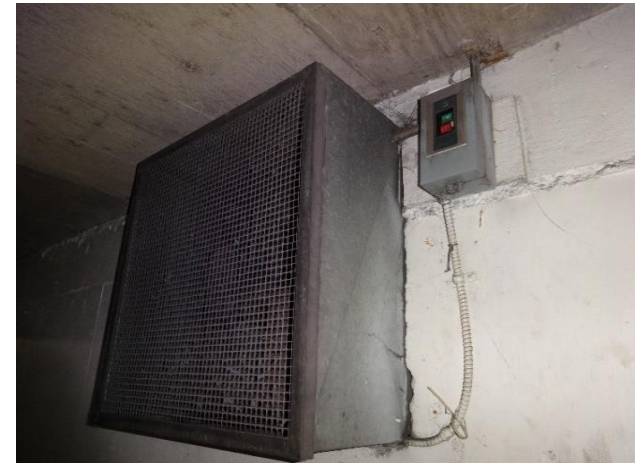
Exhaust fan in parkade

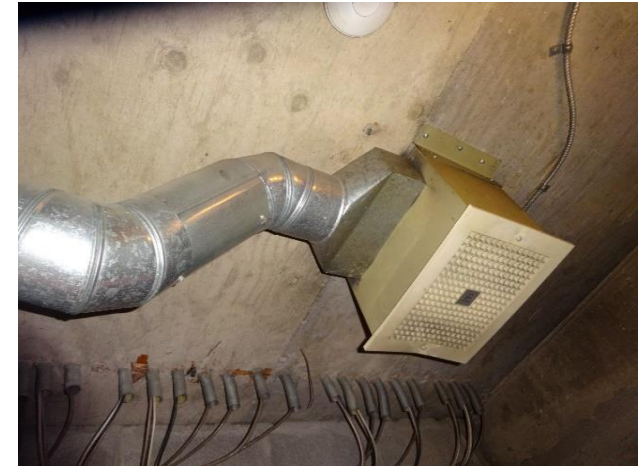
Exhaust fan in service room

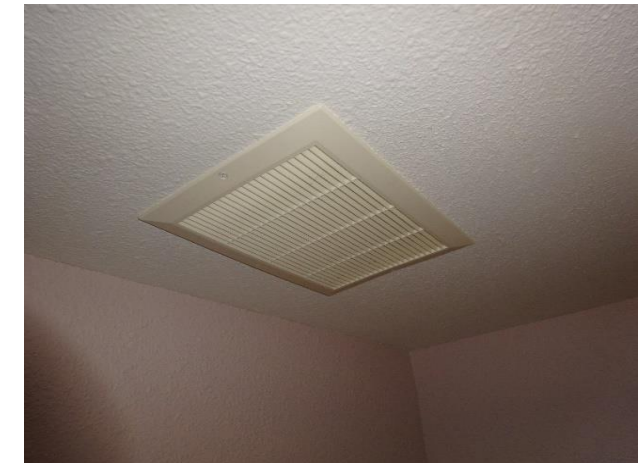
Exhaust fan in washroom

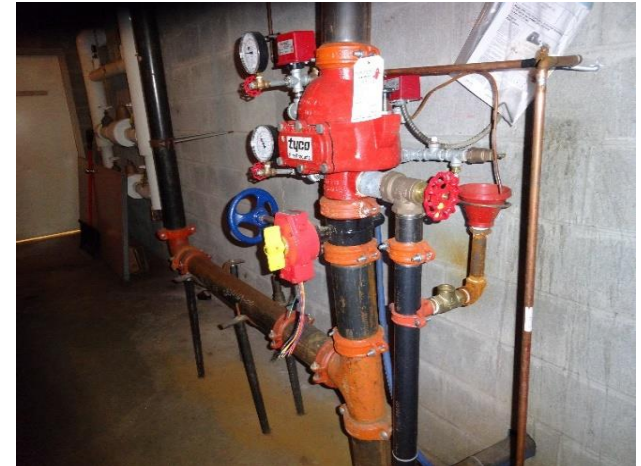
Distribution station and control valve

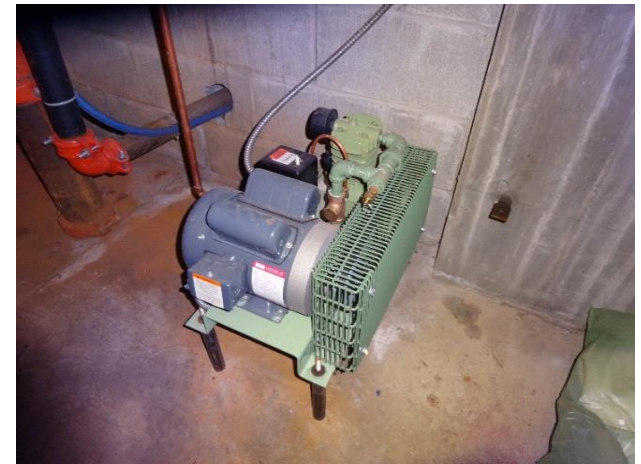
Air compressor

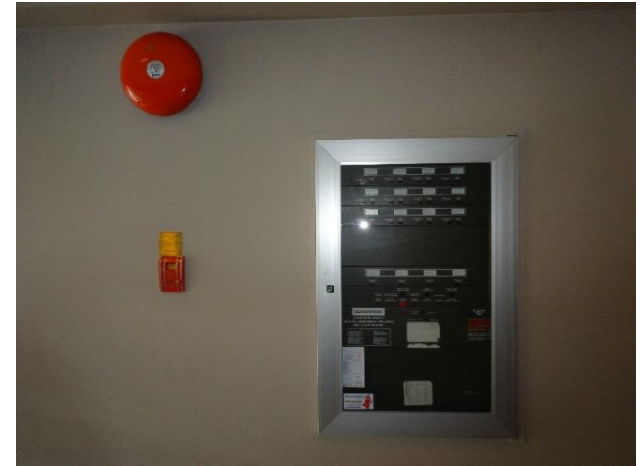
Annunciator panel, alarm bell, pull station

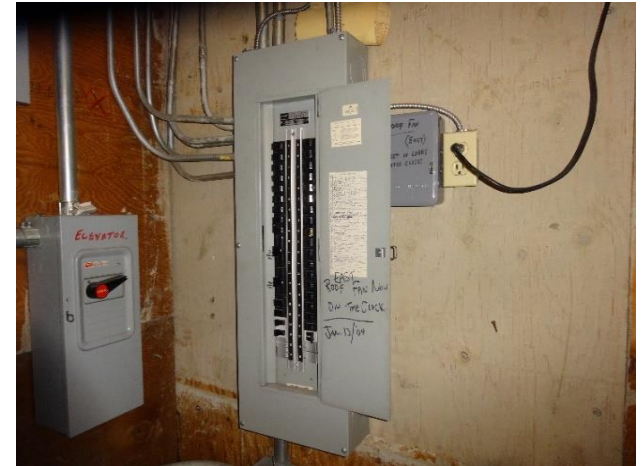
Distribution panel

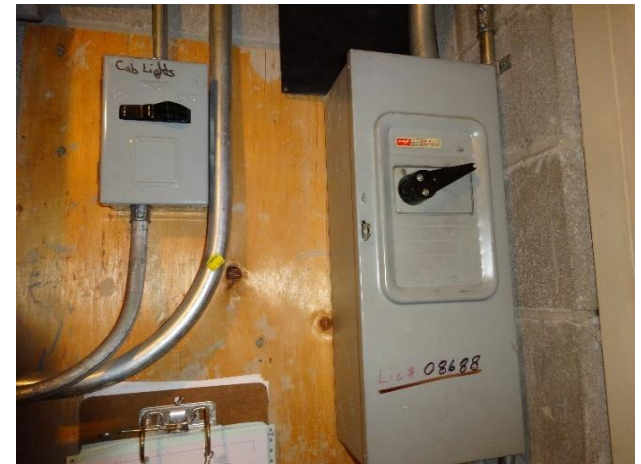
Interrupters

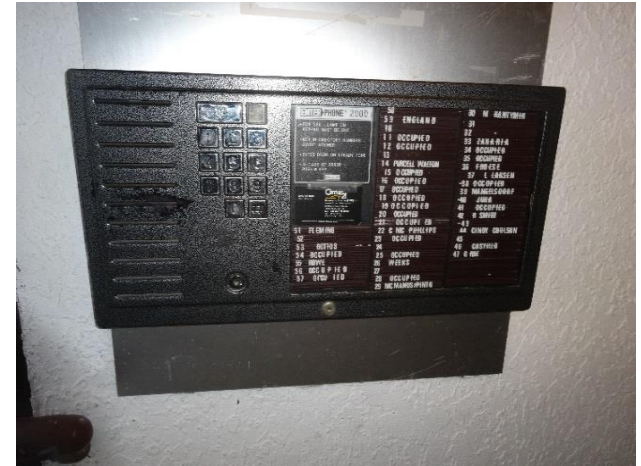
Maine entrance station

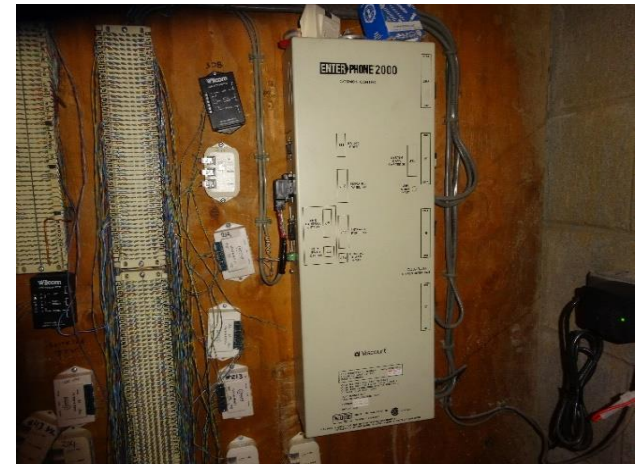
Control panel

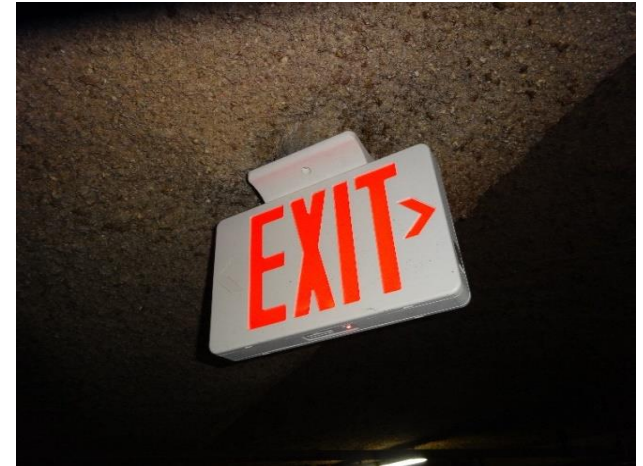
Exit sign

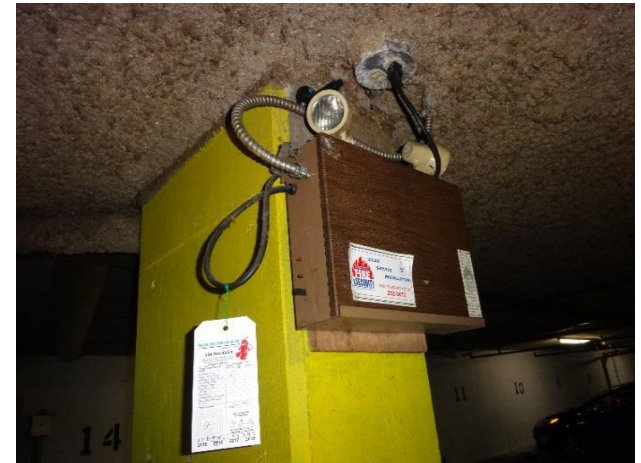
Obsolete emergency lights and battery package

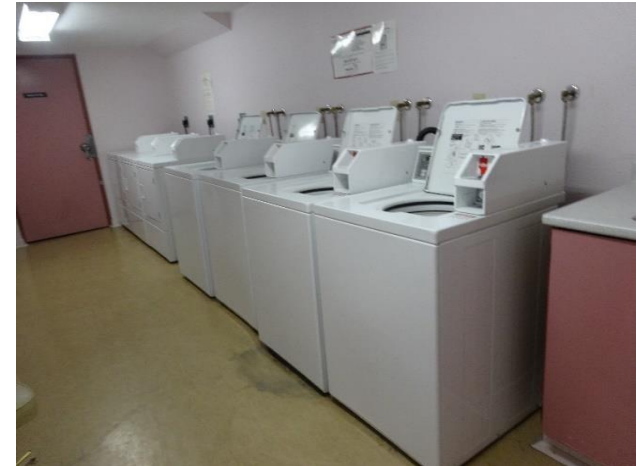
Laundry room - washers and dryers, finishes

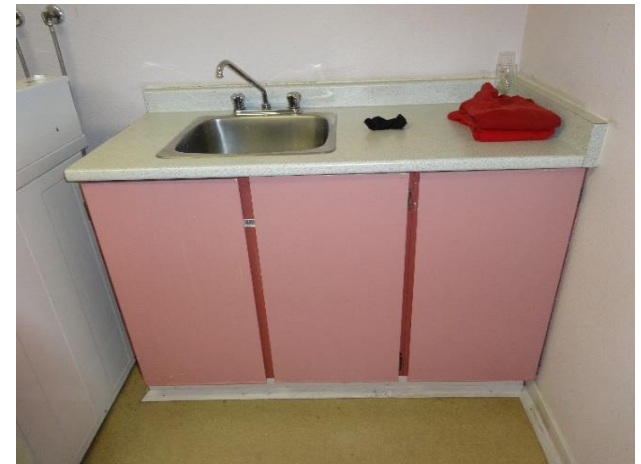
Laundry room - service sink, cabinetry

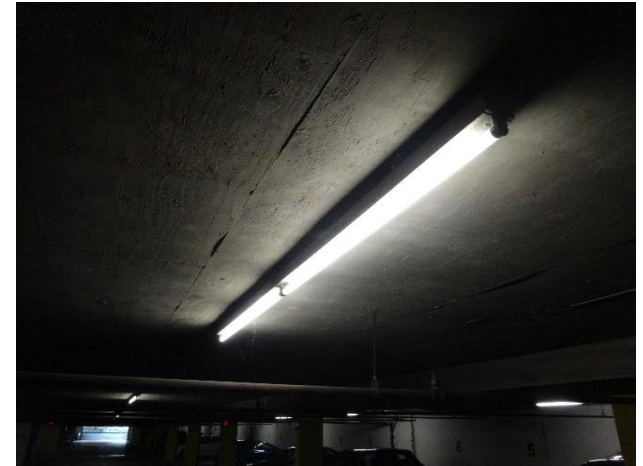
| Reserve Component E10900401 | | Interior light fixtures | | | | |
|---|---|--|---|---|---|--|
| Condition Analysis | | Deterioration | None apparent. | | | |
| | | Overall Condition | Acceptable. | | | |

Fluorescent tube light fixtures

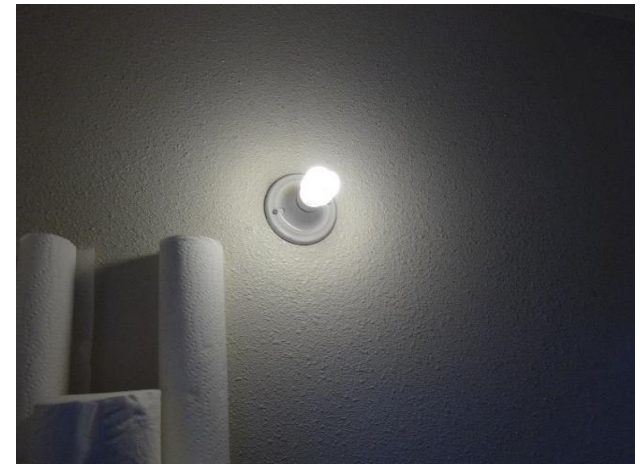
Fluorescent lamp light fixture in service room

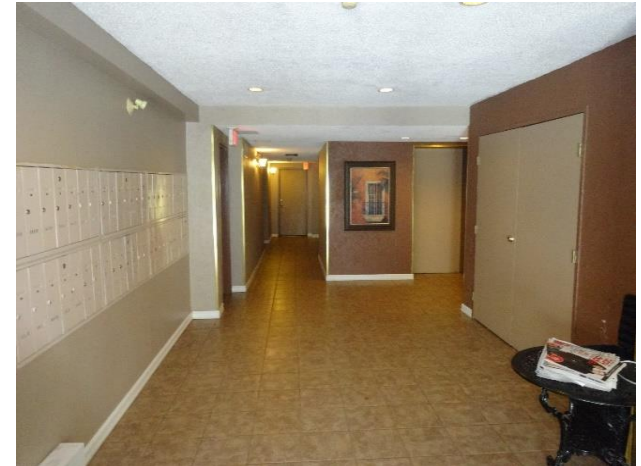
| Reserve Component | Lobby area | | | | |
|---|--|---|---|---|---|
| Condition Analysis | Deterioration | None apparent. | | | |
| | Overall Condition | Good. | | | |

Lobby area

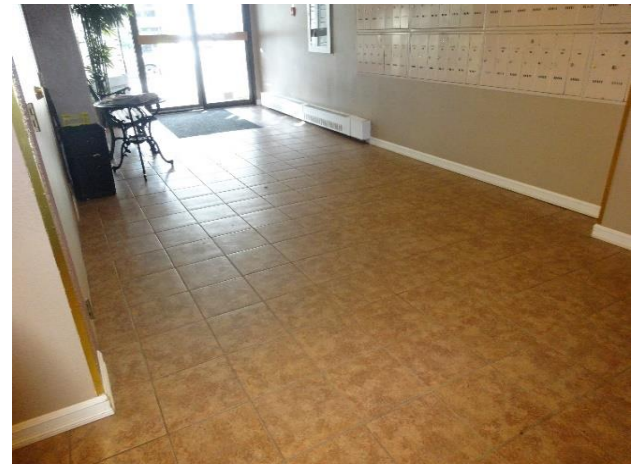
| Reserve Component | Lobby area | | | | |
|---|--|---|---|---|---|
| Repair History | New mailboxes were installed in 2013. Quarry tile flooring was installed in 2013. | | | | |

Quarry tiles flooring

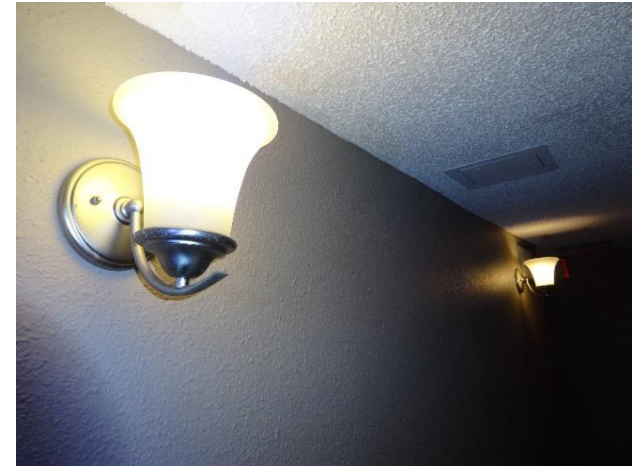
| | Overall Condition | Good. | | | |
| Repair History | New light fixtures were installed on hallways in 2012. | | | | |

Light fixtures on corridor

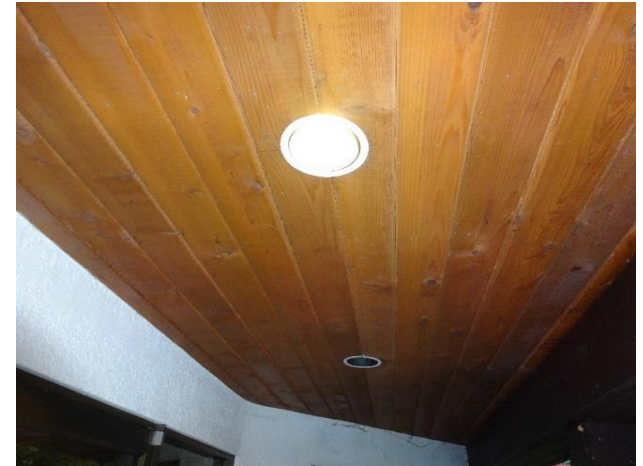
Soffit mounted light fixtures

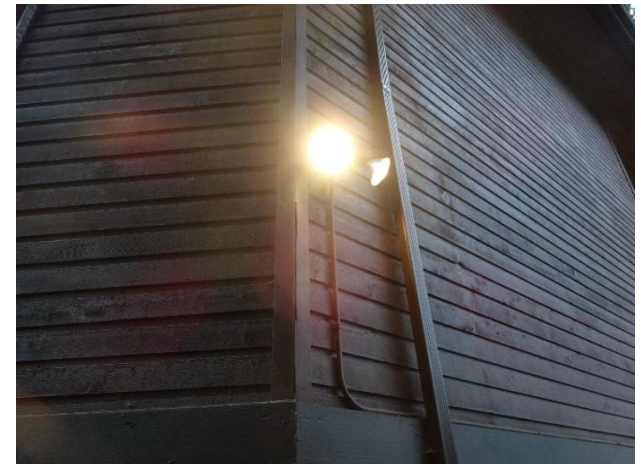
Wall mounted light fixture

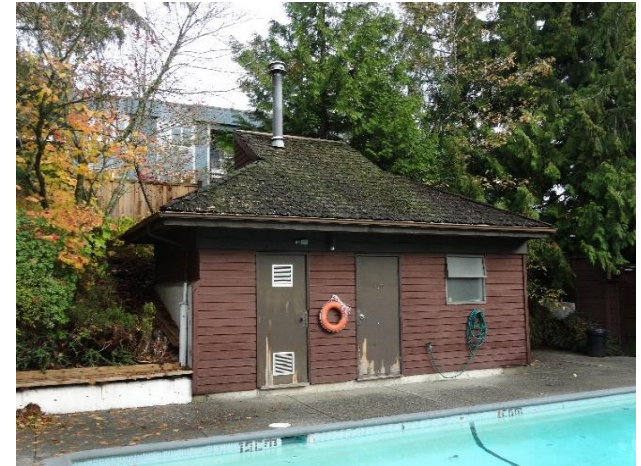
| Condition Analysis | Deterioration | Wood shake roof was observed to be in poor condition. Doors exhibit delamination on exterior side. Weathered areas are visible on the interior walls. Washroom areas were observed to be in acceptable condition. | | | |
| | Overall Condition | Poor/Acceptable | | | |

Pool building

| Funding Method | Budget for 50% partial replacement. | | | | |

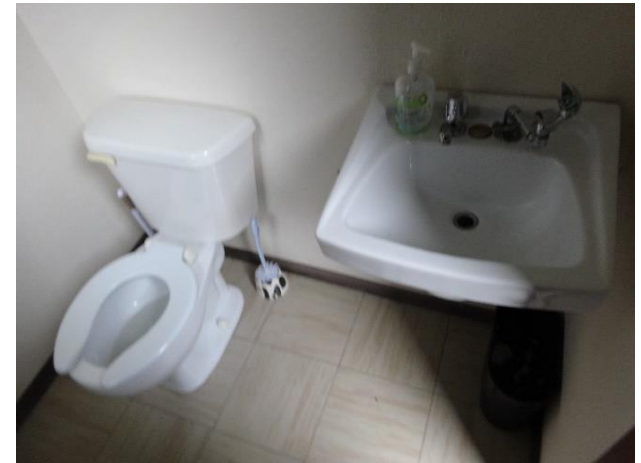
Plumbing fixtures in washroom

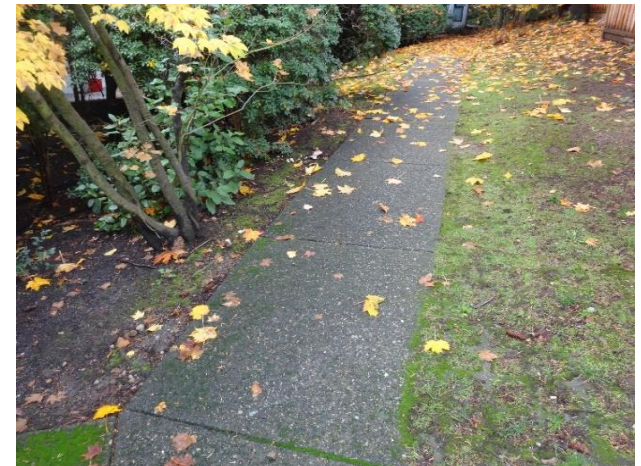
| Condition Analysis | Deterioration | Some delamination were observed at the concrete paved alley to main entrance. Some cracking was observed at the concrete walkway at the back. | | | |

Concrete walkway at the back of the building

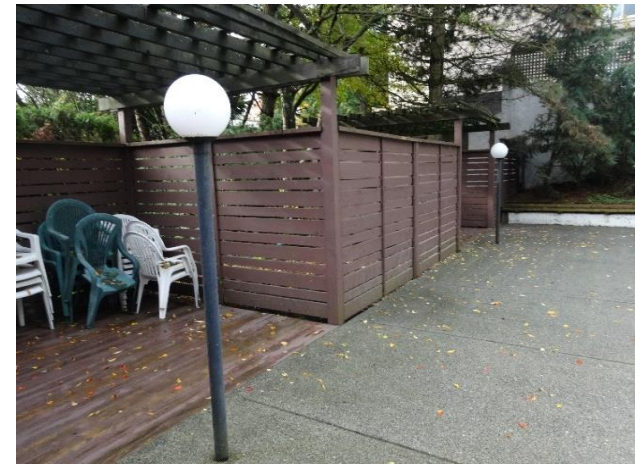
Pool fence, trellis and decking

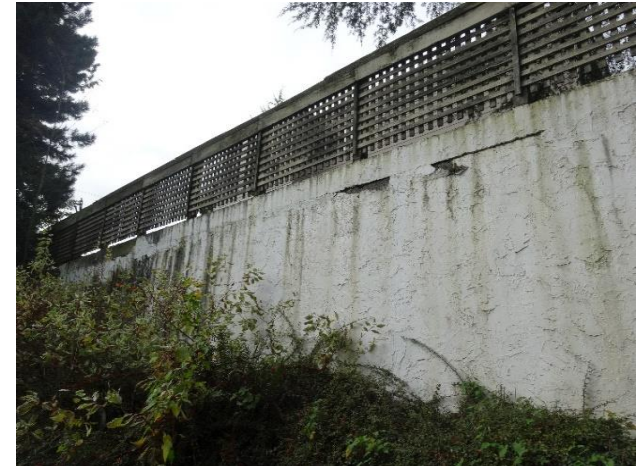
Retaining wall

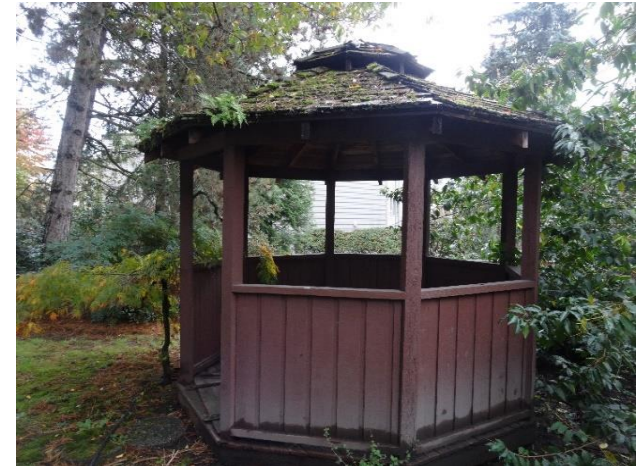
Gazebo

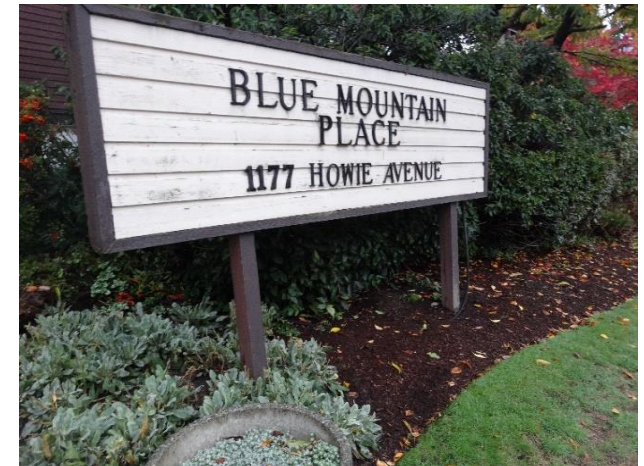
Property sign

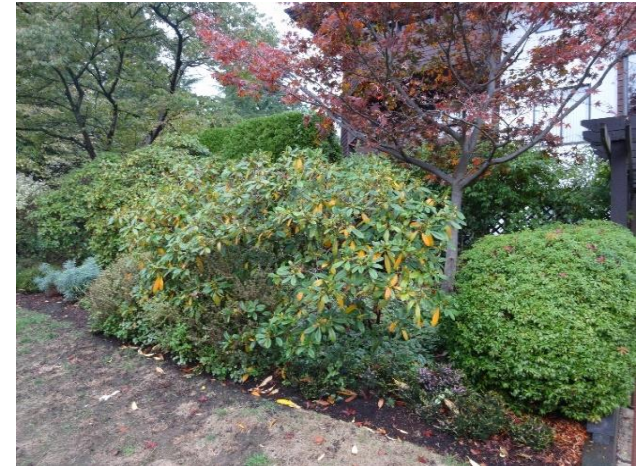
Landscaping

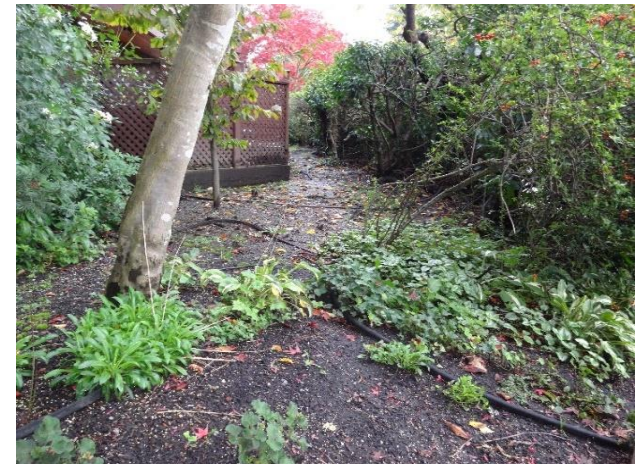
Landscaping
