Engineering Investigation

Parking Garage Condition Assessment

The Willows

Strata Plan NWS1389
The Willows
1121 & 1103 Howie Avenue,
Coquitlam, BC V3J 1T9

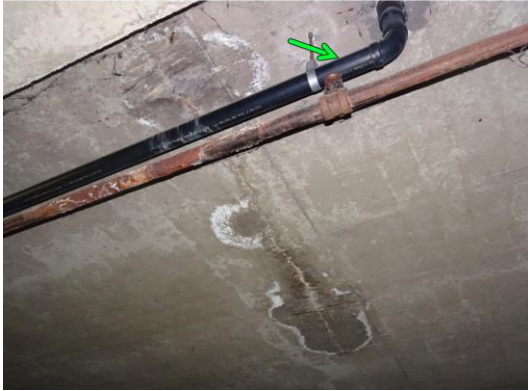
Figure 22

Location: West building garage - Storm drain penetration.

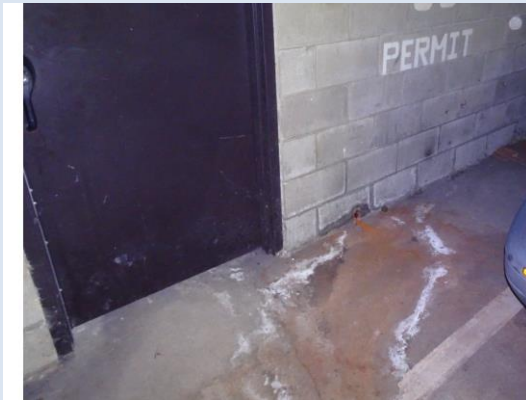
Figure 25

Location: East building garage - Drain from mechanical room.

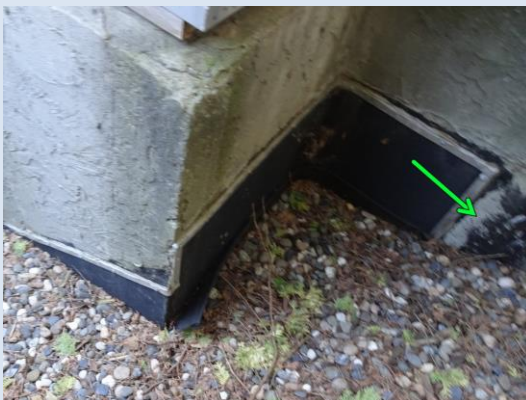
Figure 27

Location: East building exterior - Exhaust penetration waterproofing.

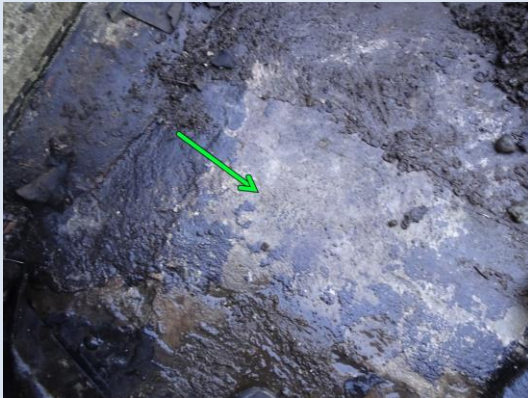
Figure 33

Location: East building exterior - North elevation perimeter.
